Road Safety Audit Response Report

Report title:	Lye Lane, Bricket Wood, Stage 1 RSA Response
Date:	05/06/24
Document reference and revision:	P2584 Stage 1 RSA Response
Prepared by:	Paul Mew Associates
On behalf of:	JD Rudkin (Builders) Ltd

Stage 1 Road Safety Audit

Report title:	Lye Lane,Bricket Wood St Albans
Date:	03 June 2024
Document reference and revision:	MG-SG-24-4422-RSA1
Prepared by:	The Safety Forum
On behalf of:	Hertfordshire County Council

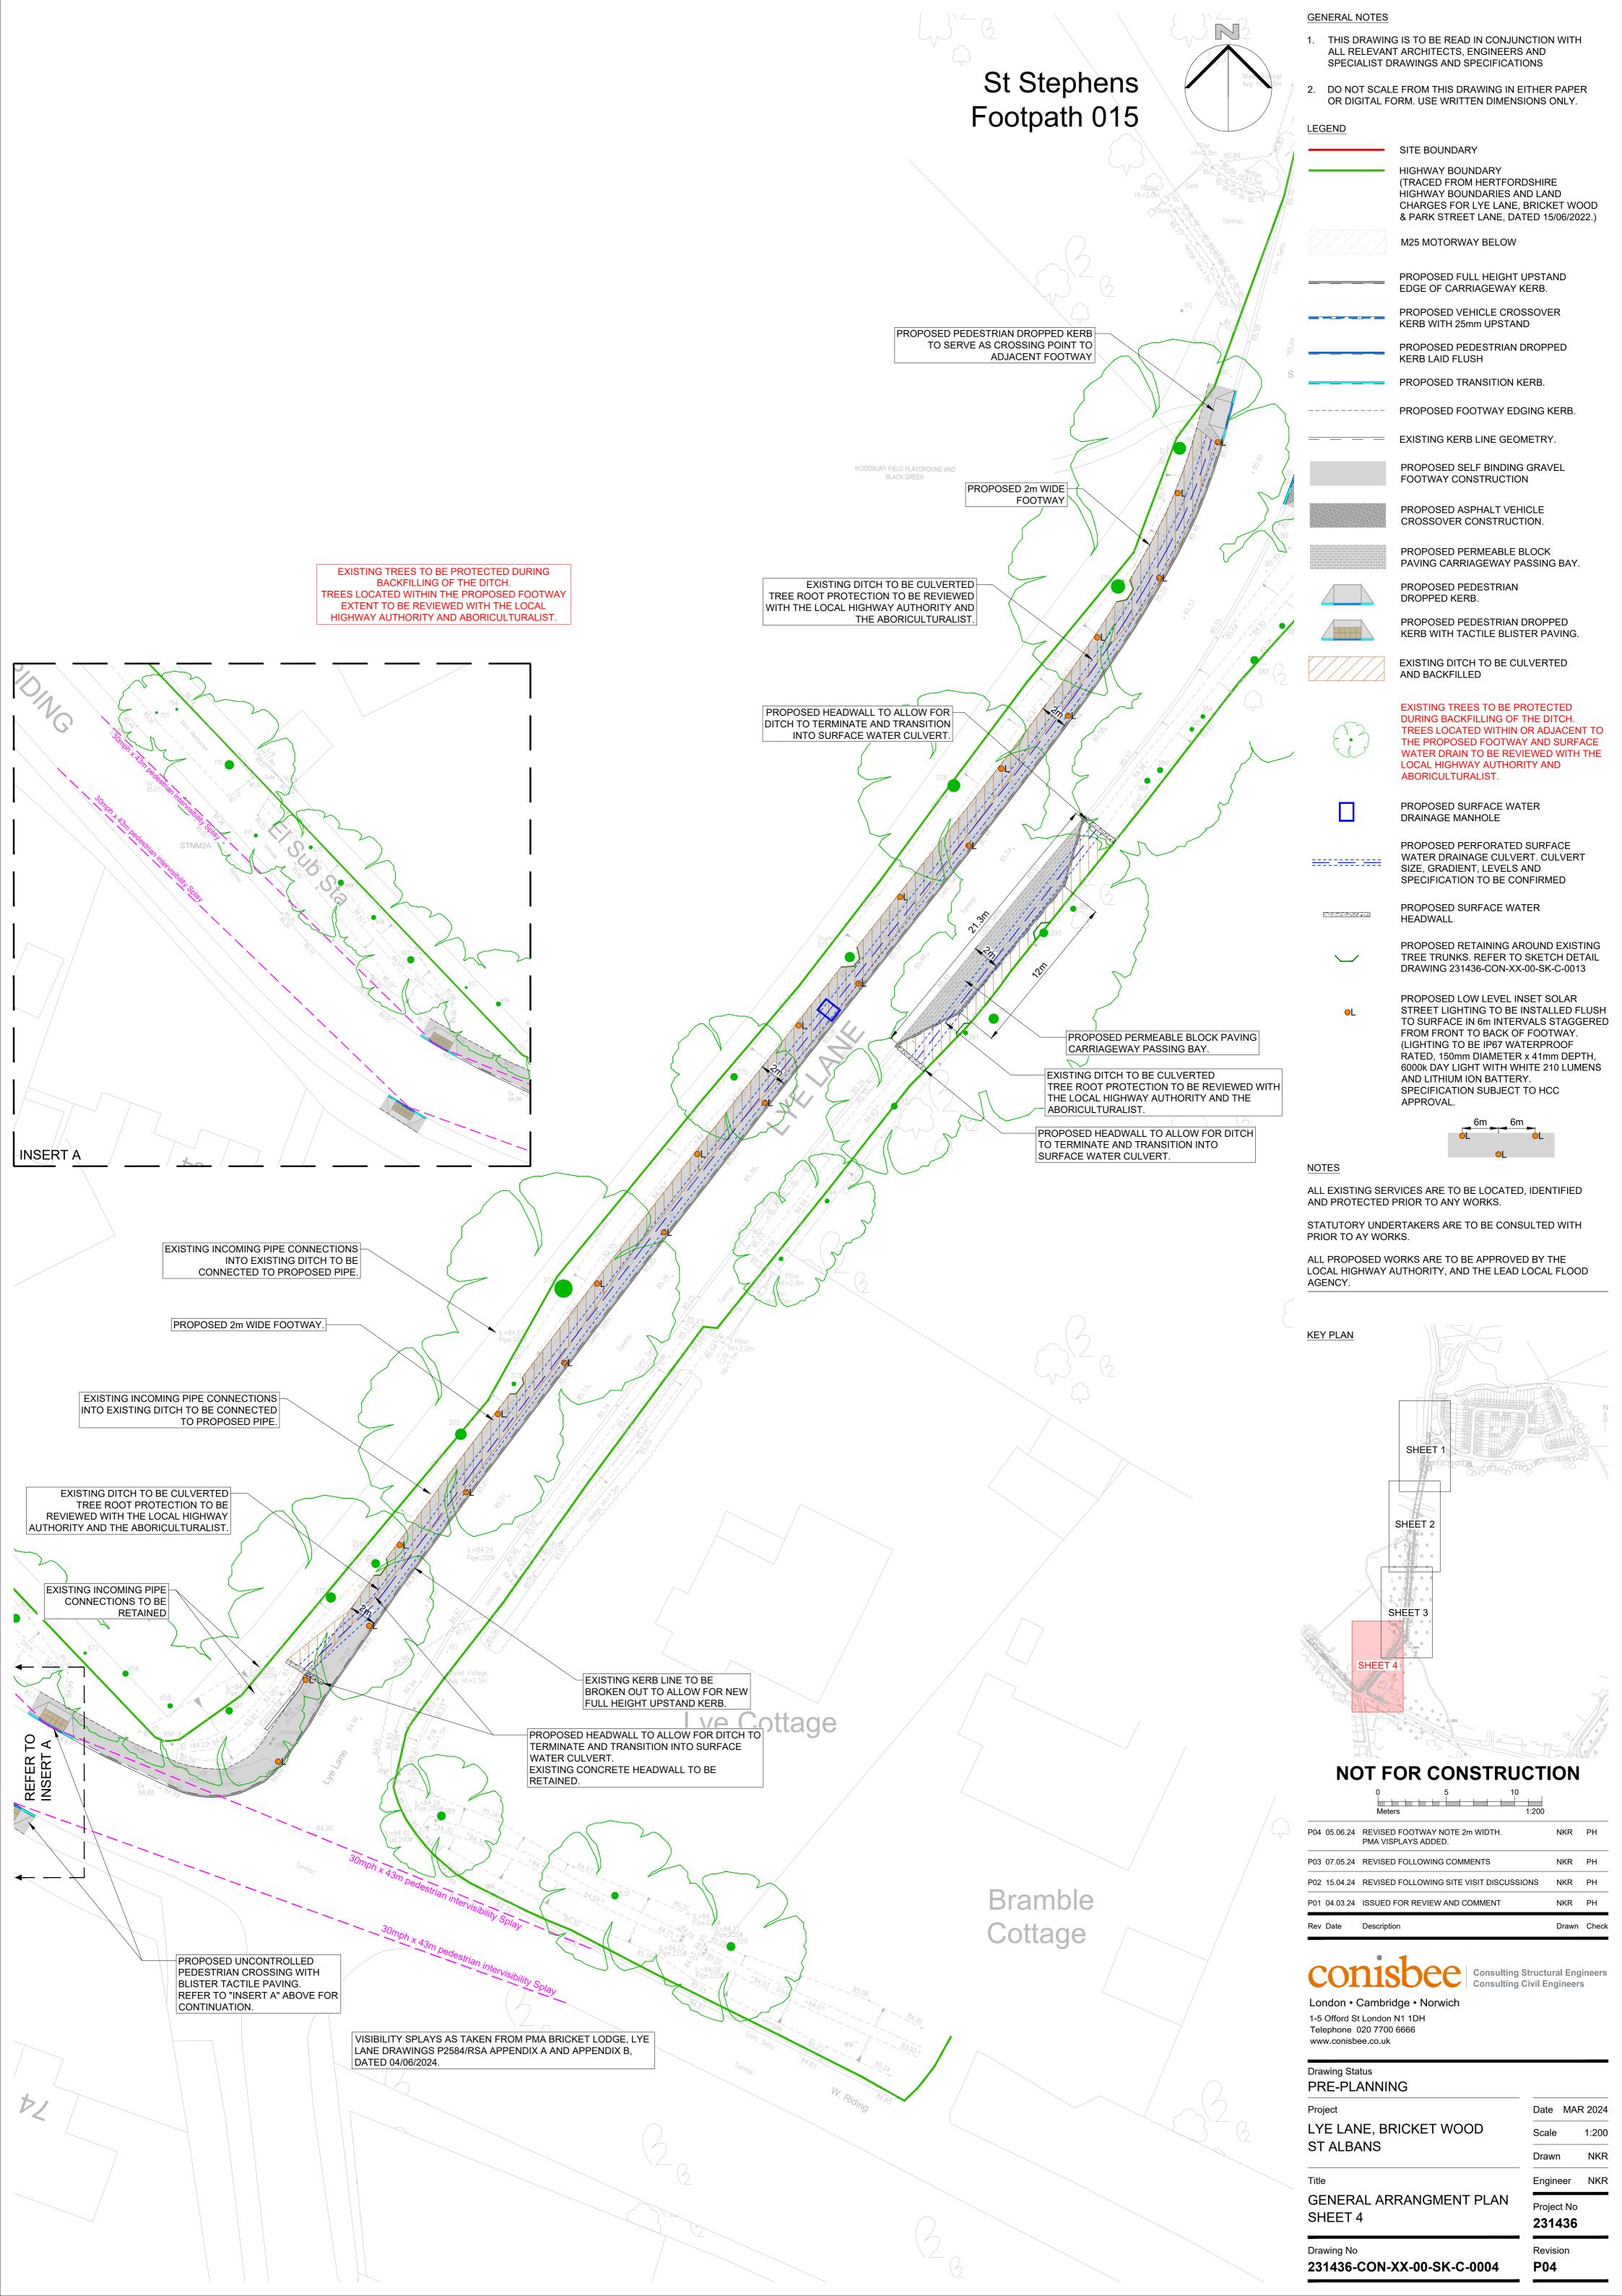
231436-CON-XX-00-SK-C-0004

The proposed uncontrolled crossing point located along the north side of West Riding have a reduced visibility to the right due to the existing bend in the road, the trees and vegetation. This may increase the risk of vehicle to pedestrian type collisions if pedestrians cross the carriageway at this location.

The proposed uncontrolled crossing point located along the south side of West Riding have a reduced visibility to the right due to the existing trees and vegetation located in the verge and also parked vehicles immediately adjacent to the proposed crossing point.

West Riding / Lye Lane Proposed Uncontrolled Crossing

RSA problem	RSA recommendation	Design organisation response	Overseeing Organisation response	Agreed RSA action
3.1 PROBLEM LOCATION: Lye Lane J/w West Riding Uncontrolled crossing points. SUMMARY: Insufficient pedestrian to driver intervisibility. Risk of vehicle to pedestrian type collisions. The proposed uncontrolled crossing point located along the north side of West Riding have a reduced visibility to the right due to the existing bend in the road, the trees and vegetation. This may increase the risk of vehicle to pedestrian type collisions if pedestrians cross the carriageway at this location.	The Audit Team recommend that the driver to pedestrian inter visibility is not compromised at this crossing point	The Proposed uncontrolled Crossing has been moved approximately 8 metres back from the junction. This will allow a better intervisibility splay. The new uncontrolled pedestrian crossing near West Riding / Lye Lane Junction meets the intervisibility splay requirements of 43 m in line with Mfs 30mph speed limit at West Riding Road. The intervisibility splays are within the public highway ownership. Intervisibility splays will be kept clear of any impediments (planting / vegetation, fencing) over 0.6m above ground level that may restrict visibility at these locations. Pedestrian — vehicle intervisibilities of 43m (in line with MfS SSD speeds can be achieved and are shown in the Revised drawings attached to this report 231436-CON-XX-00-SK-C-0004.

3.2 PROBLEM LOCATION: Lye Lane J/w West Riding Uncontrolled crossing points. SUMMARY: Insufficient pedestrian to driver intervisibility. Risk of vehicle to pedestrian type collisions The proposed uncontrolled crossing point located along the south side of West Riding have a reduced visibility to the right due to the existing trees and vegetation located in the verge and also parked vehicles immediately adjacent to the proposed crossing point. This may increase the risk of vehicle to pedestrian type collisions if pedestrians cross the carriageway at this location.	The Audit Team recommend that the driver to pedestrian inter visibility is not compromised at this crossing point.	The Proposed uncontrolled Crossing has been moved approximately 8 metres back from the junction. This will allow a better intervisibility splay. The new uncontrolled pedestrian crossing near West Riding / Lye Lane Junction meets the intervisibility splay requirements of 43 m in line with Mfs 30mph speed limit at West Riding Road. The intervisibility splays are within the public highway ownership. Intervisibility splays will be kept clear of any impediments (planting / vegetation, fencing) over 0.6m above ground level that may restrict visibility at these locations. Pedestrian — vehicle intervisibilities of 43m (in line with MfS SSD speeds can be achieved and are shown in the Revised drawings attached to this report 231436-CON-XX-00-SK-C-0004.

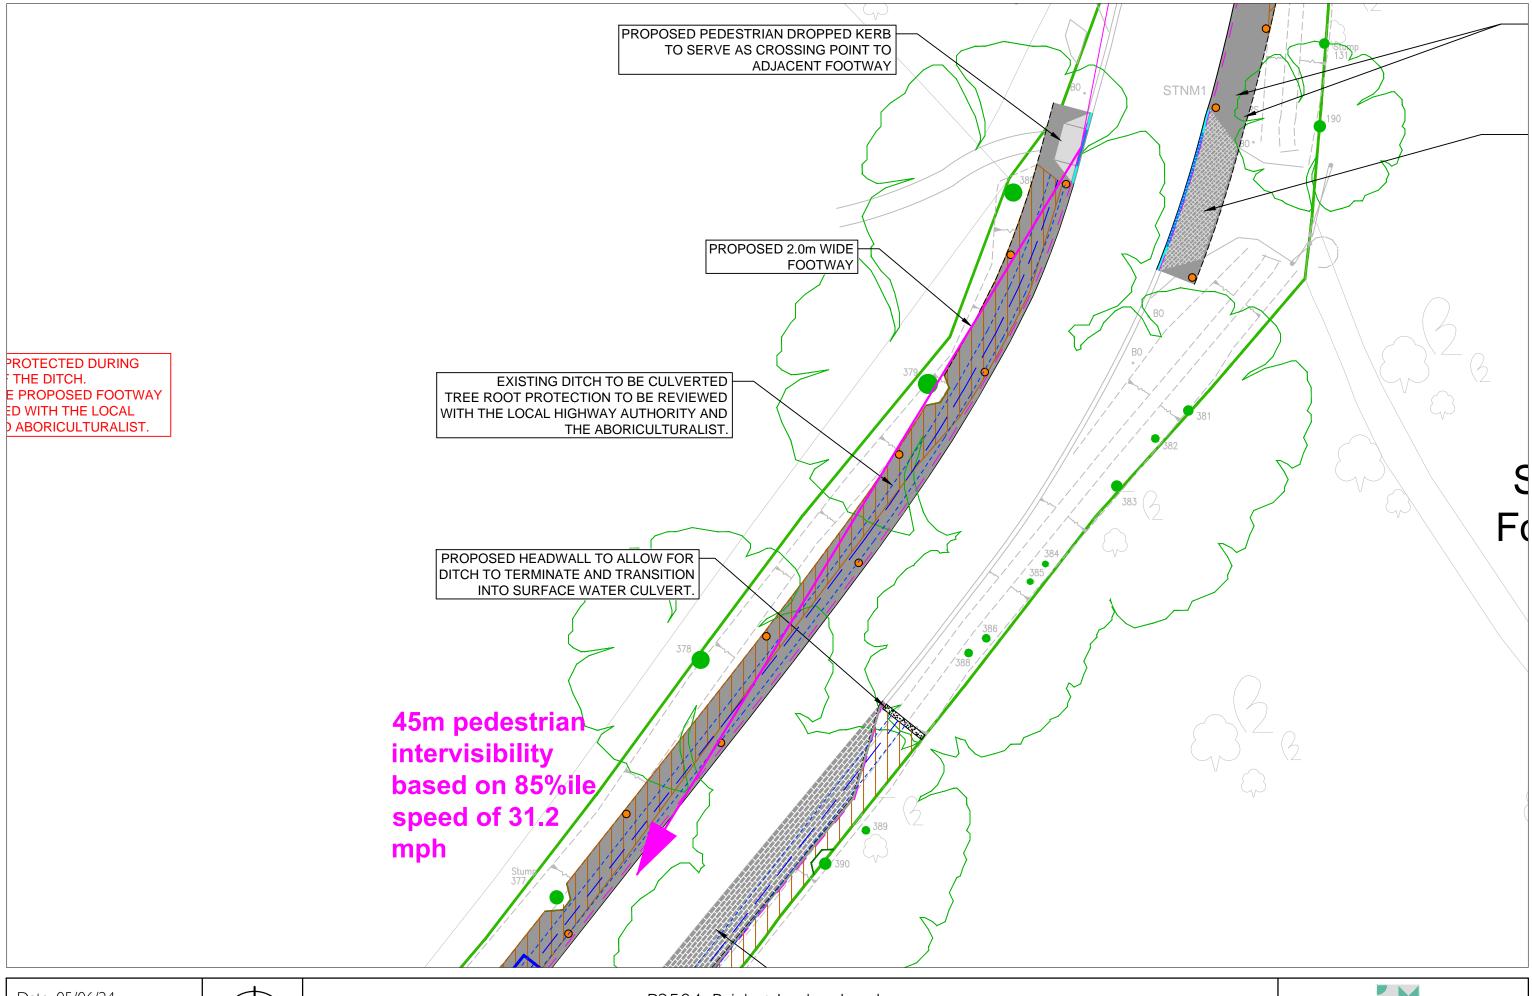
Lye Lane / St. Stephens Footpath 015 Crossing Intervisibility Splay

The proposed uncontrolled crossing point located along the west side of Lye Lane has a reduced visibility to the right due to the existing trees and vegetation located in the verge.

Insufficient pedestrian to driver intervisibility at this location may increase the risk of vehicle to pedestrian type collisions

3.4 PROBLEM	The Audit Team	This is an existing established informal crossing location between	
	recommend that the driver	Black Green to the west and the accessible woodland to the east.	
LOCATION: Lye Lane-Proposed uncontrolled crossing	to pedestrian inter	The proposed footpath and improved informal crossing facility on	
between Black Green Woods and St.Stephens Footpath 015.	visibility is not	Lye Lane results in better pedestrian to vehicle intervisibility	
	compromised at this	looking to the right from the west side of the road than the existing	
SUMMARY: Insufficient pedestrian to driver intervisibility.	crossing point.	arrangements.	
Risk of vehicle to pedestrian type collisions The proposed			
uncontrolled crossing point located along the west side of		As can be seen from Appendix B the intervisibility splays to the right	
Lye Lane has a reduced visibility to the right due to the		of the crossing are within the public highway ownership. The

existing trees and vegetation located in the verge.		provision of a footpath extending to the south to West Riding will	
Insufficient pedestrian to driver intervisibility at this location		result in the removal of existing low-level vegetation in the existing	
may increase the risk of vehicle to pedestrian type collisions		highway verge/ditch which might otherwise impede visibility for	
		people looking to the right when crossing Lye Lane at this location.	
		Intervisibility splays will be kept clear of any impediments (planting	
		/ vegetation, fencing) over 0.6m above ground level that may	
		restrict visibility at this location. Pedestrian – vehicle	
		intervisibilities of 45m (in line with 85th %ile speeds can be	
		achieved.

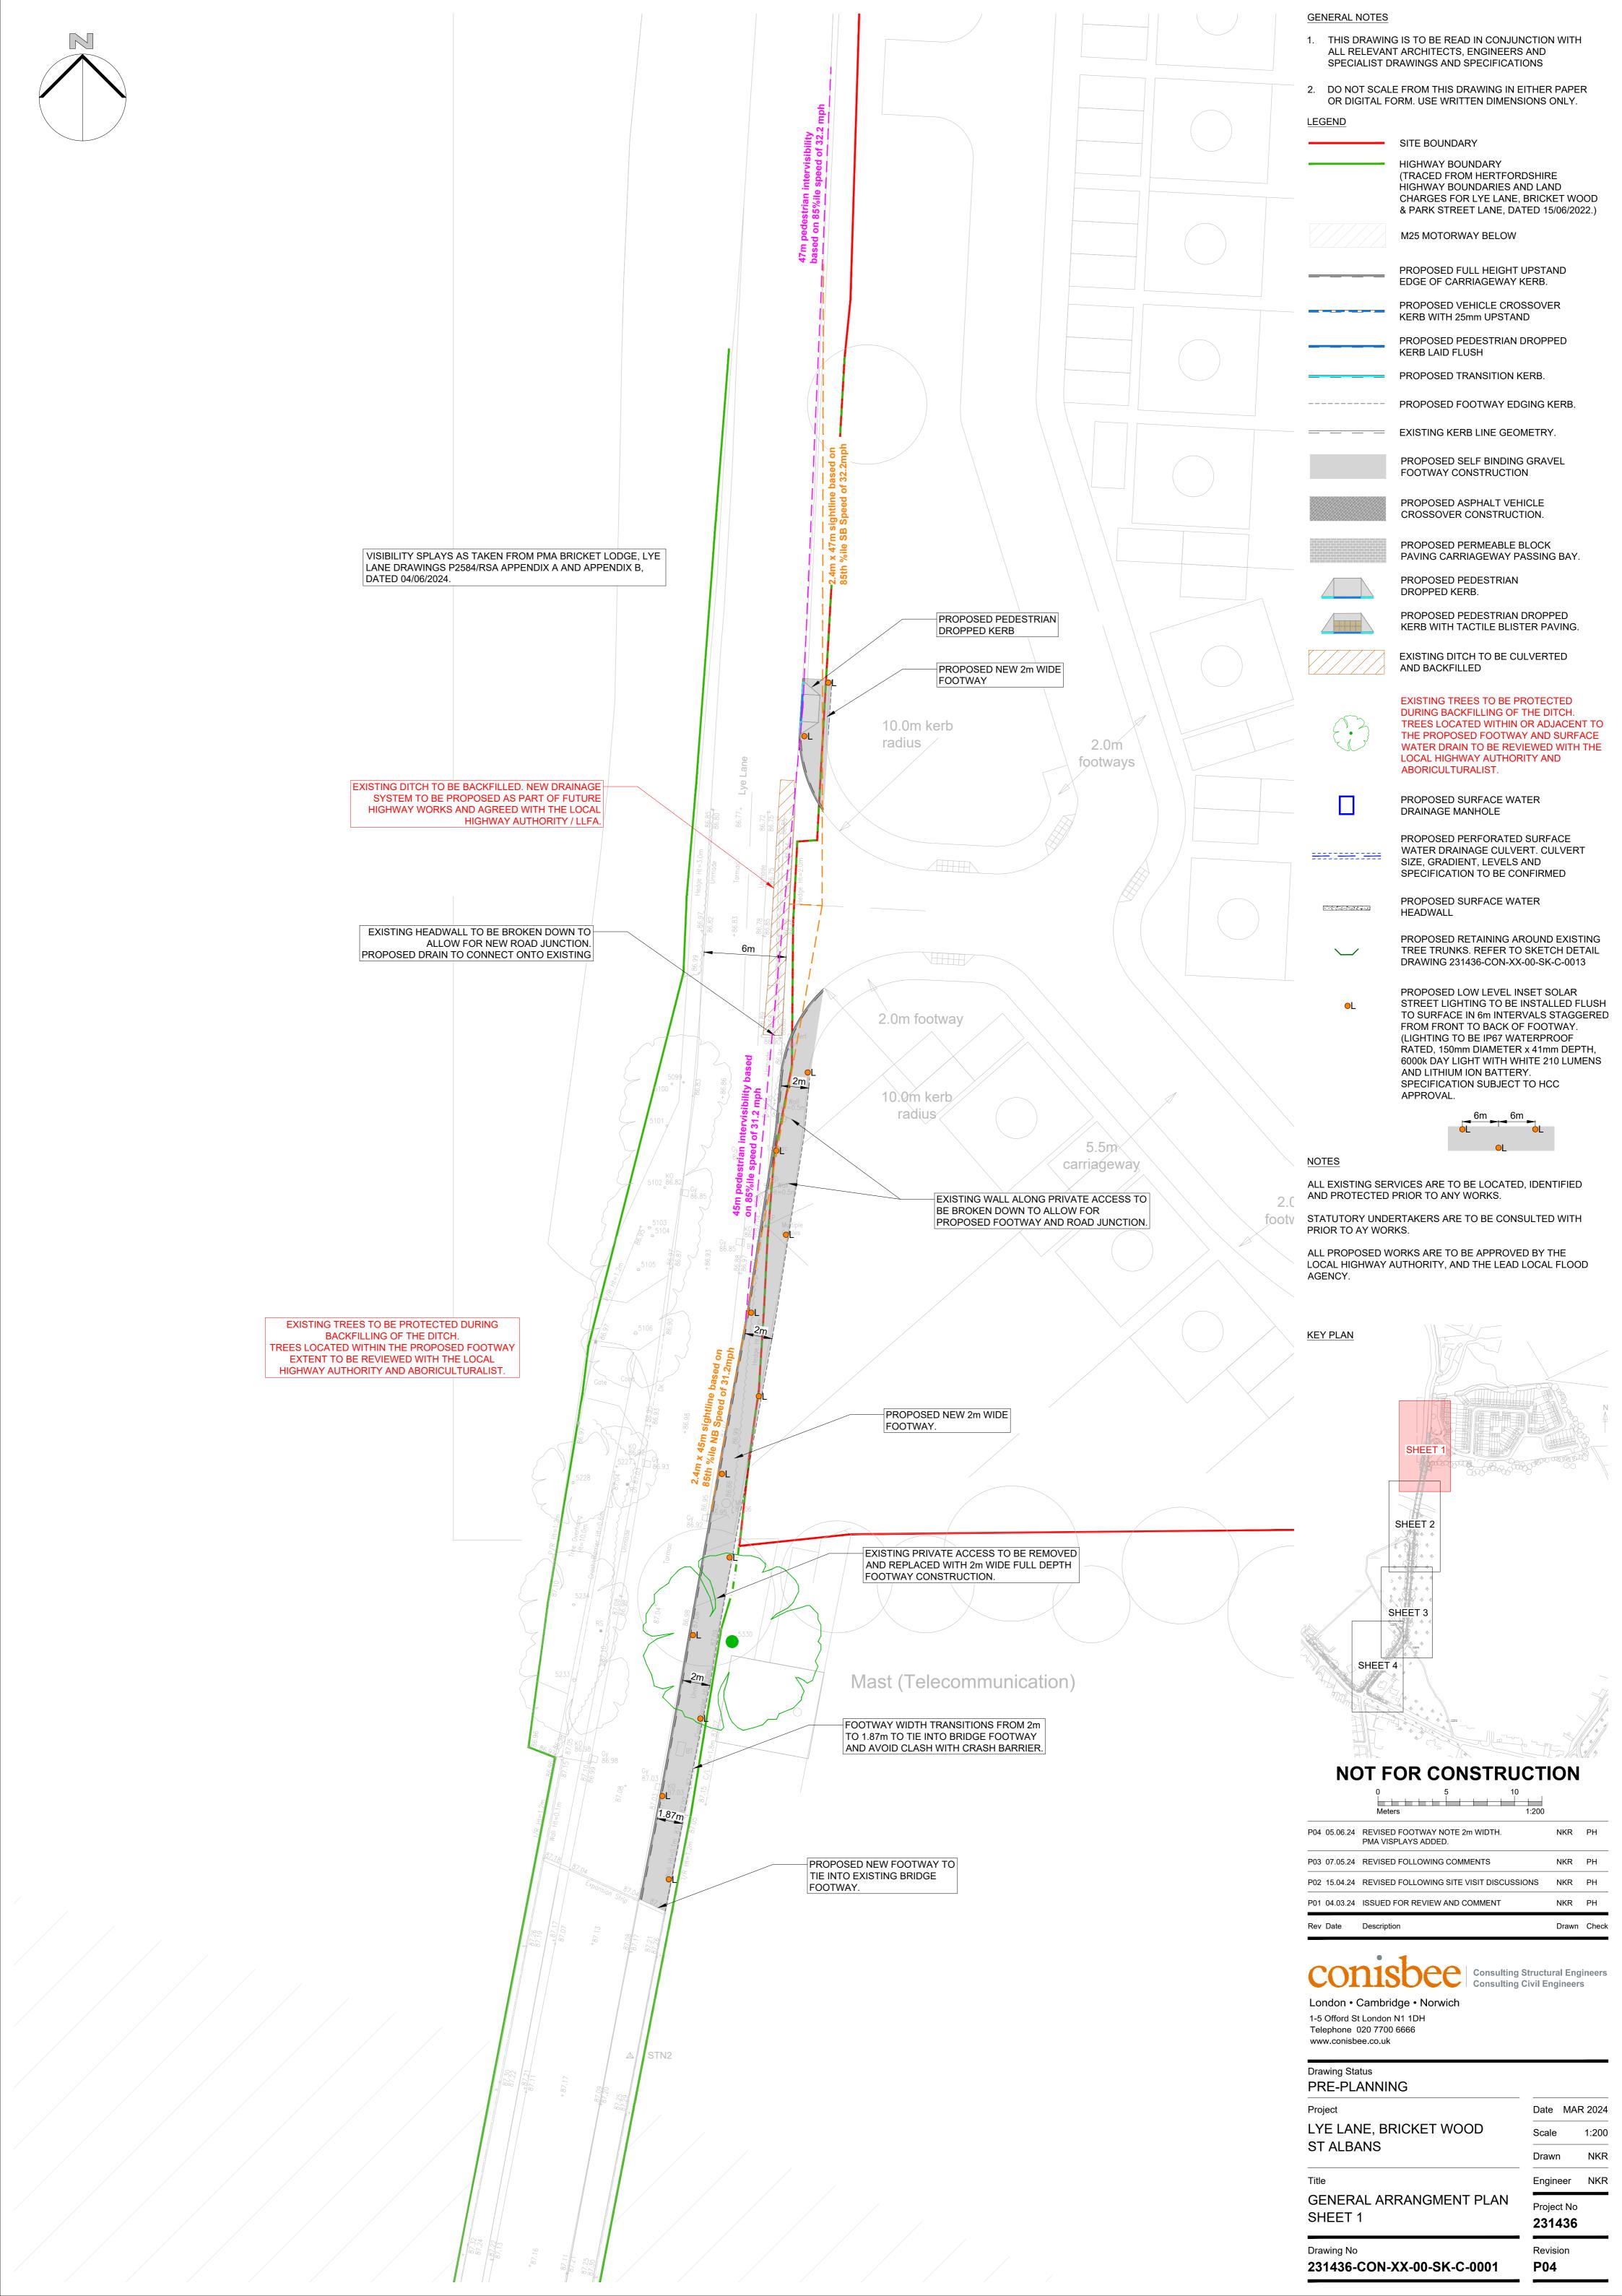
231436-CON-XX-00-SK-C-0001 Bricket Lodge – Site Access Visibility Splay

The drawings provided show that the proposed give way markings are to be located behind the existing ditch. No visibility splays have been indicated on the General Arrangement drawings and there is no evidence on the site clearance drawings that the existing hedges within the visibility splay are to be removed.

Insufficient visibility splays may increase the risk of vehicle to vehicle pull out type collisions.

3.7 PROBLEM LOCATION: Proposed Bricket Lodge Access. SUMMARY: Insufficient visibility splay may increase the risk of vehicle to vehicle pull out type collisions. The drawings provided show that the proposed give way markings are to be located behind the existing ditch. No visibility splays have been indicated on the General Arrangement drawings and there is no evidence on the site clearance drawings that the existing hedges within the visibility splay are to be removed. Insufficient visibility splays may increase the risk of vehicle to vehicle pull out type collisions.	The Audit Team recommend that the visibility splays at the junction are not compromised by any hedges or other obstructions.	Vehicle visibility splays of 47 m facing north (in line with 85th %ile speeds of 32.2 mph) can be achieved and are shown in the Revised drawings in 231436-CON-XX-00-SK-C-0001. Vehicle visibility splays of 45 m facing south (in line with 85th %ile speeds of 31.2 mph) can be achieved and are shown in the Revised drawings in 231436-CON-XX-00-SK-C-0001. Intervisibility splays will be kept clear of any impediments (planting / vegetation, fencing) over 0.6m above ground level that may restrict visibility at these locations. Pedestrian — vehicle intervisibilities of 47/45m (in line with 85th %ile speeds can be achieved and are shown in the Revised drawings attached to this report 231436-CON-XX-00-SK-C-0001.

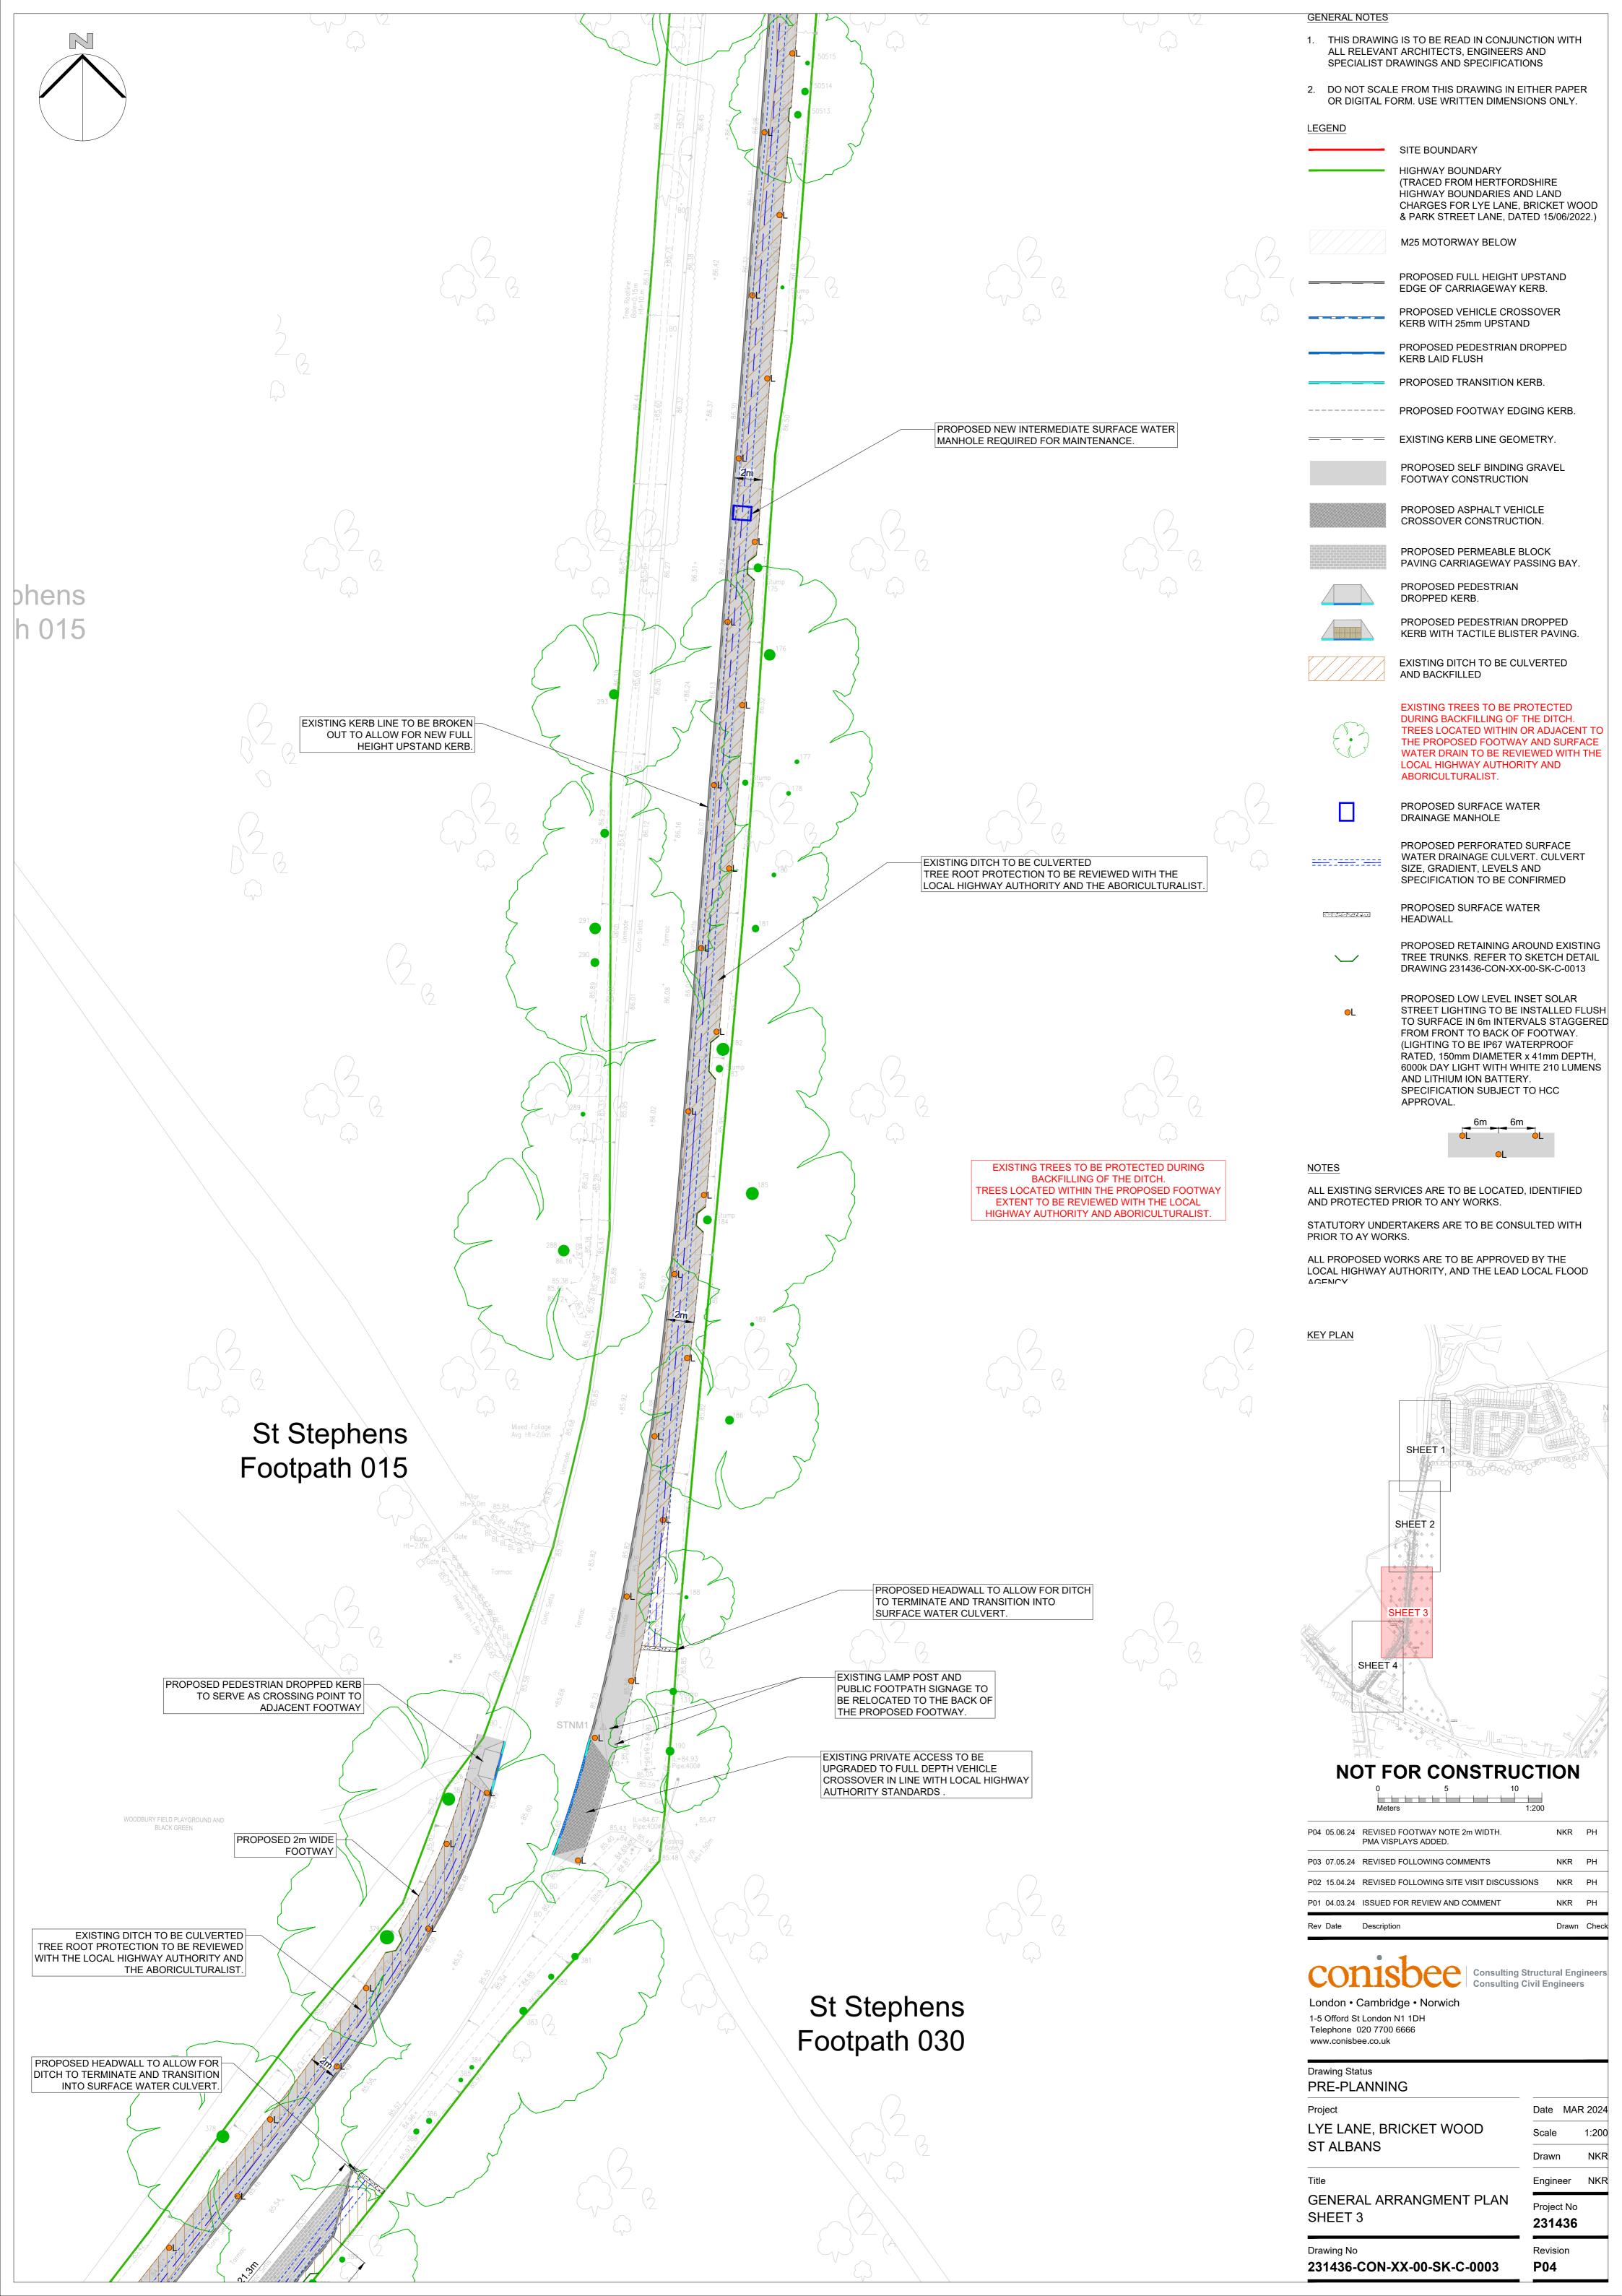
231436-CON-XX-00-SK-C-0003-P04 Lye Lane Footpath Error Correction Plan

- 1.16 No Departures from Standard have been provided by the Design Team. However there are a number of locations along the Lye Lane footway proposals where the footway width is reduced to 1.2 m. The Design Team should confirm that this has been accepted by the Highway Authority together with any associated mitigation measures.

provided by the Design Team. However there are a number of locations along the Lye Lane footway proposals where the footway width is reduced to 1.2 m. The Design Team should confirm that this has been accepted by the Highway Authority together with any associated mitigation measures.	This is a drafting error, an annotation states 1.2m footpath and should read 2m. This has since been corrected and reissued to the RSA team. The planned footpath is uniform at 2m wide. There are 7 narrow sections around tree trunks where the footpath does not measure less than 1.5m. this can be seen in the revised plans attached to this report 231436-CON-XX-00-SK-C-0003-P04
Design organisation and Overseeing Organisation stat	tements
Include the following statements to be signed by the design organisation	n and the Overseeing Organisation.
Design organisation statement	
On behalf of the design organisation I certify that:
