Sustainable Drainage Strategy Update - Survey of Blackgreen Wood

Appeal Inquiry – APP/B1930/W/24/3338501

Bricket Wood Sports and Country Club, Paintball Site and Bricket Lodge, Lye Lane, St Albans AL2 3TF

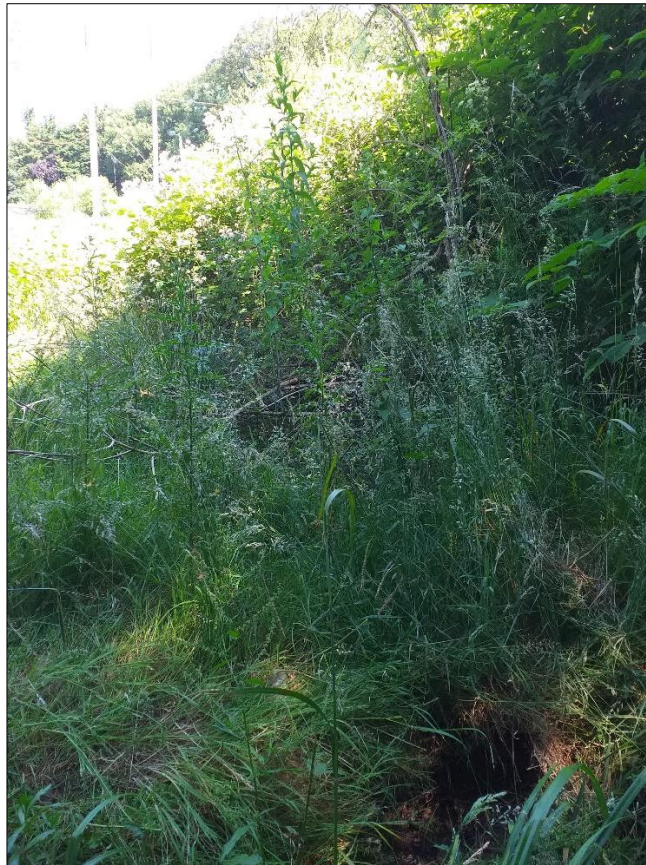
Photo 1: the outlet (dark circle in bottom right-hand corner) feeding Ditch 2

8. SDP identified that the outlet as a drain from the Appeal Site into Ditch 2 (see the DDS). There was no running or standing water in the ditch.
9. Ditch 2 ran eastwards for c. 30 metres to a very boggy area, with no running or standing water over, which had been a laid a temporary bridge (Photo 2).

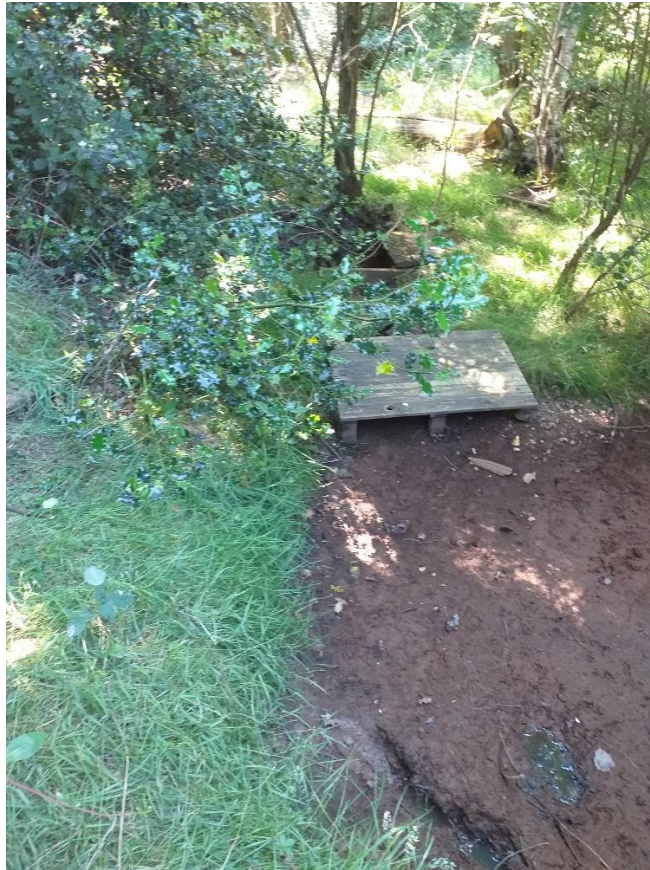
Photo 2: an area where water appears to have pooled in the past, identified by a blue circle on Ditch 2 (Appendix 1). The bed was very boggy and did not take my weight (hence the two footprints which subsequently filled with water). A concrete catchpit can be seen on the far side of the 'bridge'.

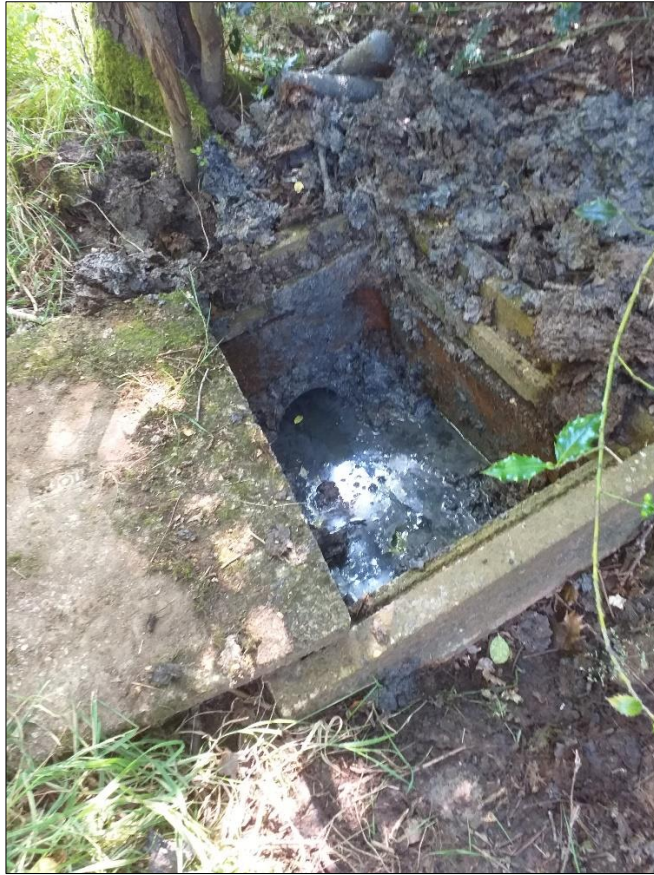
10. Immediately beyond the bog is a catchpit from which the concrete cover had been removed. A catchpit is an empty chamber that is installed into a drainage system to prevent silt and debris from building up. Catchpits play an important role in preventing blockages and water contamination in drainage systems. Without them water could back up in a drainage system and cause localised flooding.
11. The catchpit on Ditch 2 was found to be completely filled with mud which explains why water had backed up and caused the pooling. The mud was dug out and the presence of pipes (1 x 100mm and 1 x 150mm) was confirmed. By the end of the survey, it was noted that the catchpit had begun to fill with water (Photo 3).

Photo 3: after the catchpit was cleared of mud, the presence of pipes was confirmed and the chamber began to fill with water.

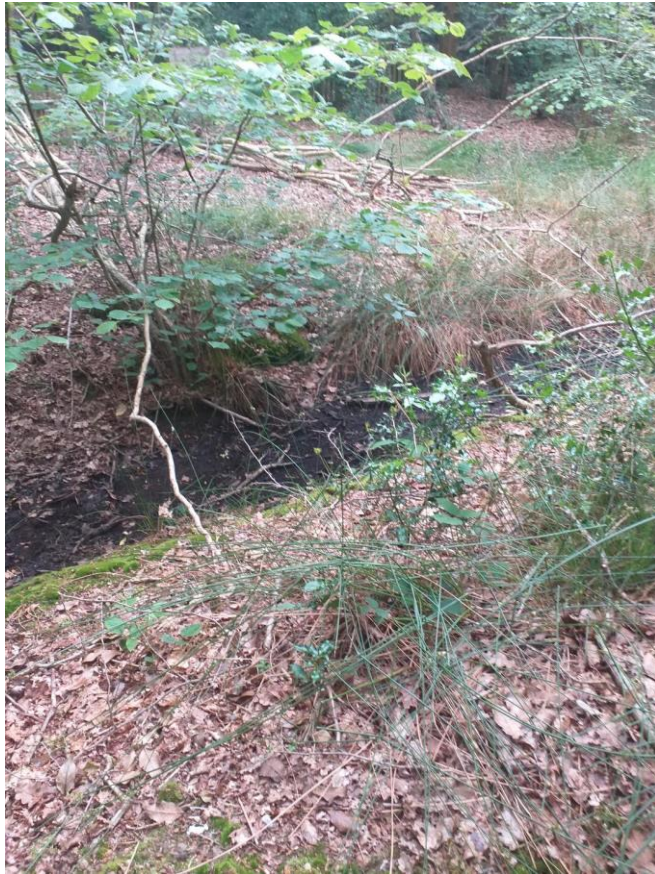
Photo 4: part of Ditch 1

12. To the east of the catchpit, the route of Ditch 2 could be followed but it was found to be filled with dry leaves and other detritus. There was no running or standing water. The ditch ran eastwards to the boundary between the woodland and the rear curtilages of houses on Park Street Lane and then southwards where it was joined by Ditch 1 (see the DDS).
13. Ditch 1, which ran in a north-eastwards direction from the southern boundary of the woodland, was dry, too, with no running or standing water (Photo 4):

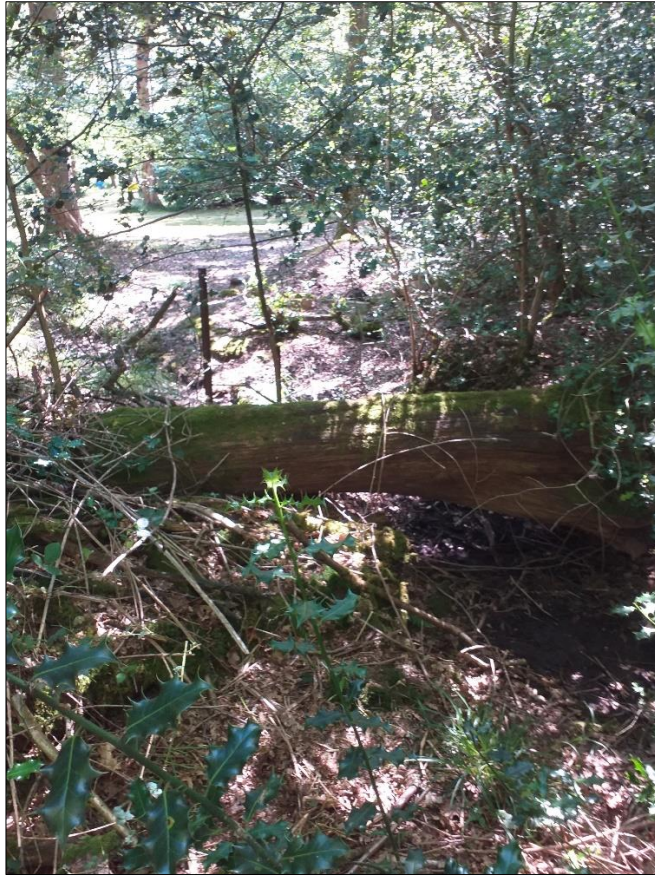
14. Where Ditches 1 and 2 joined, a ditch ran eastwards into the rear garden of 222a Park Street Lane. This ditch, too, had no running or standing water (Photo 5).

Photo 5: the fallen tree marks the approximate rear boundary of 222a Park Street Lane.
A dry ditch can be seen entering the garden from the woodland.
