Report prepared for: Brian Parker

For the Site of: Bricket Lodge Sport and Country Club, Lye Lane, Hertfordshire AL2  
3TF

# Ecological Appraisal (EA)

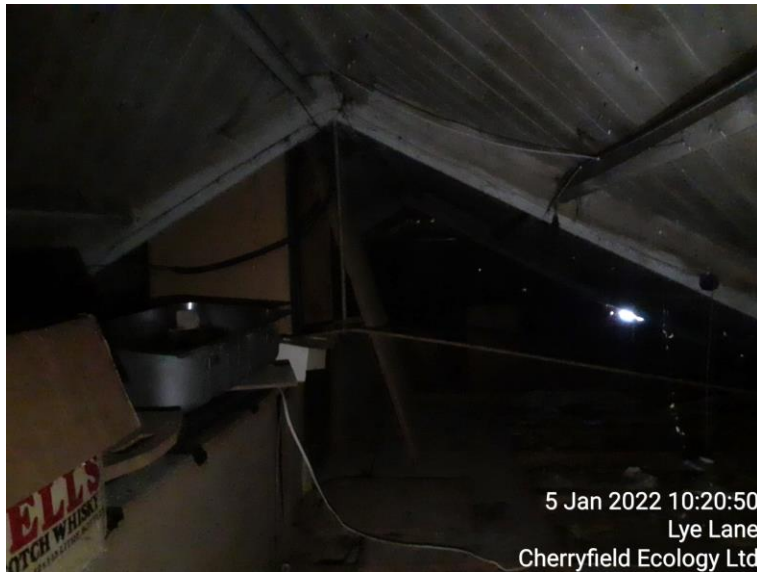
Figure 13: Loft Space 1 of B1

Internally, B1 has two loft spaces (Loft Space 1 and Loft Space 2). Both loft spaces have a king post beam structure. The underside of the roof of Loft Space 1 was fully lined with sarking boards. The underside of the roof of Loft Space 2 is lined with bitumen felt. The floor of both loft spaces was lined with insulation and boards which have significant damage due to flooding.

Bats found	No bats were found at the time of the survey.
Evidence of bat use	11 bat droppings were found within Loft Space 1 of B1 at the time of the survey.

**B1 - Full roost characterisation surveys** will be required to determine species, population and the entry/exit points used (three surveys, a minimum of two weeks apart).

A total of four surveyors to cover B1 will be required. These surveys must be undertaken within the May to September window (with September considered sub-optimal). Two of these surveys will need to be undertaken during the optimal timeframe of mid-May to August.

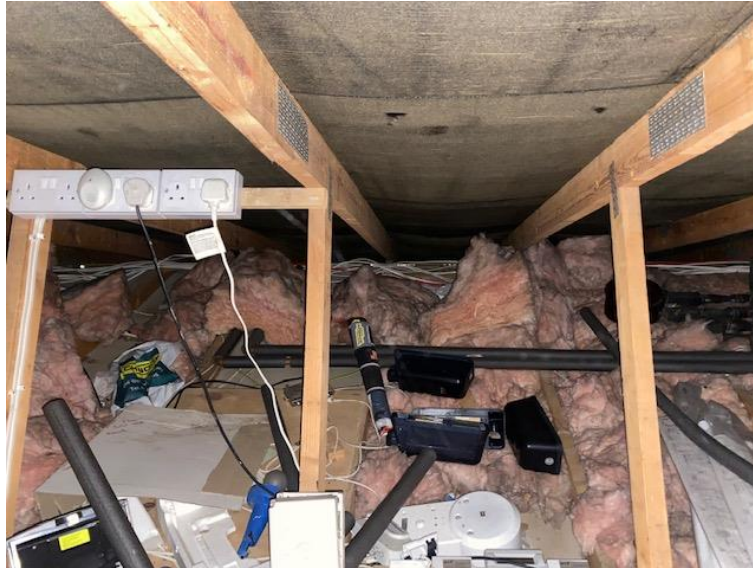
Figure 15: Loft space within B2

Internally, B2 has one loft space with a braced king post beam structure. The underside of the roof is lined with bitumen felt and the floor has insulation and is partly boarded. This loft space floor has been damaged by flooding.

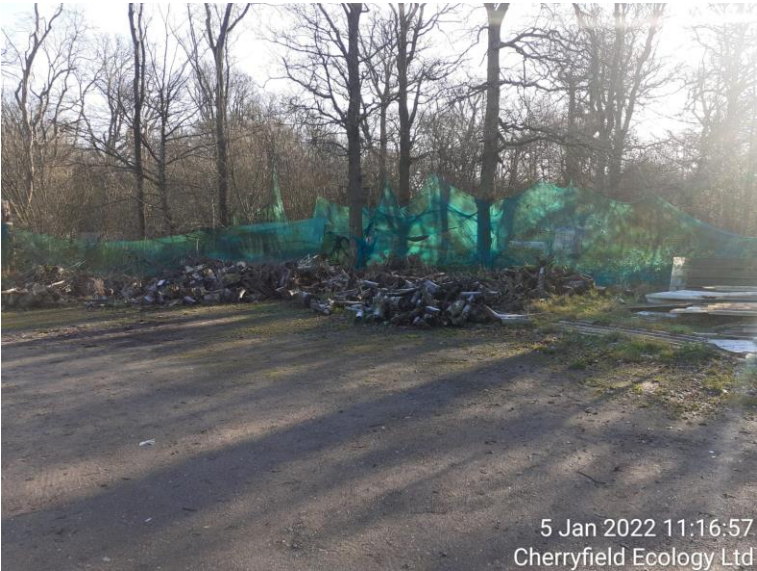
Target Note	Description
TN1	<p>Log piles were found to be present on site which could be used as refugia for reptiles and GCN.</p>

Figure 28: Log piles

GCN - No further survey is necessary. A qualified ecologist will be required to supervise the clearance, via a destructive search, of potential hibernacula such as the log and debris piles found on site. If GCN are found all works must stop and advice sought from a qualified ecologist.

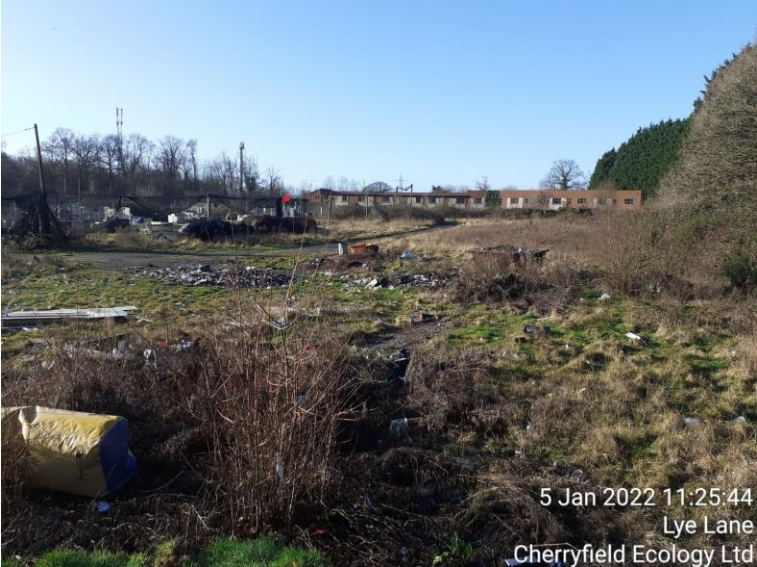
<p>TN2</p>	<p>Debris piles were scattered across the scrub, tall ruderal and improved grassland habitats which could be used as refugia for reptiles and GCN.</p>

<p>5 Jan 2022 11:25:44 Lye Lane Cherryfield Ecology Ltd</p> <p>Figure 29: Example of debris</p>
------------	---

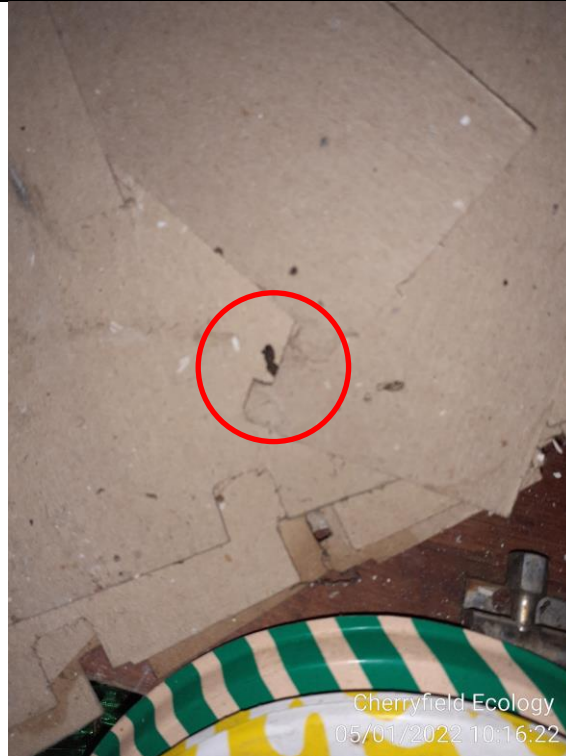
Figure 31: Example of bat droppings in B1

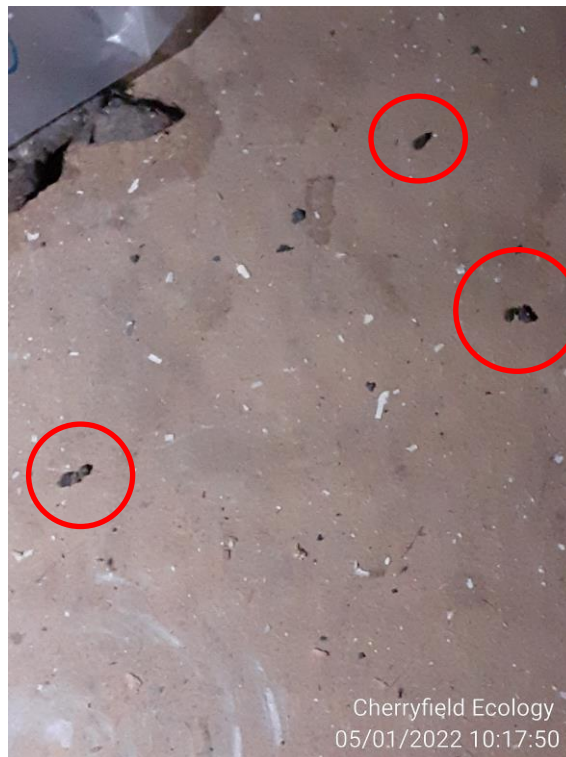
Figure 32: Example of bat droppings in B1

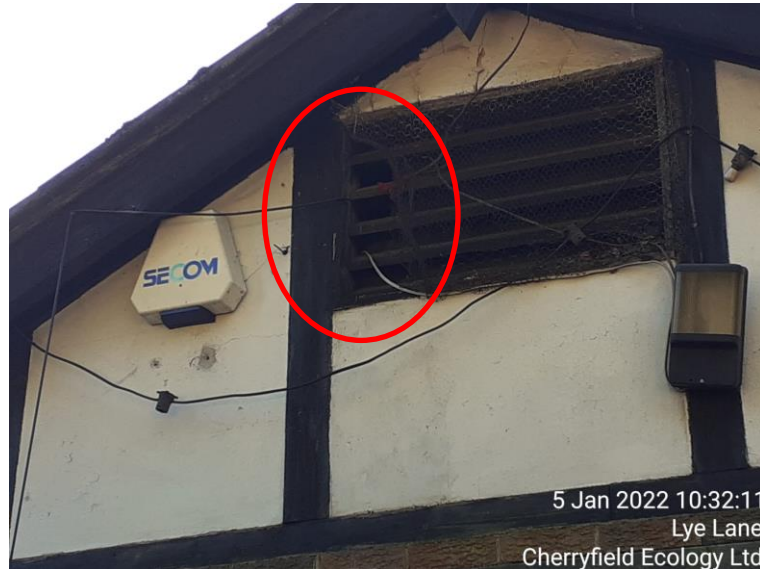
Numerous access/exit points were found to be present within the air vent and broken windows of B1. Furthermore, gaps were found to be present between the slate tiles of B1.

Figure 33: Example of access/exit point in air vent of B1

**Bat presence is confirmed** through dropping evidence that was found in Loft Space 1 of B1. Furthermore, there were access/exit points in the air vent, and broken windows and there were gaps found between the roof tiles, all of which provide **high** potential for bats in this building.

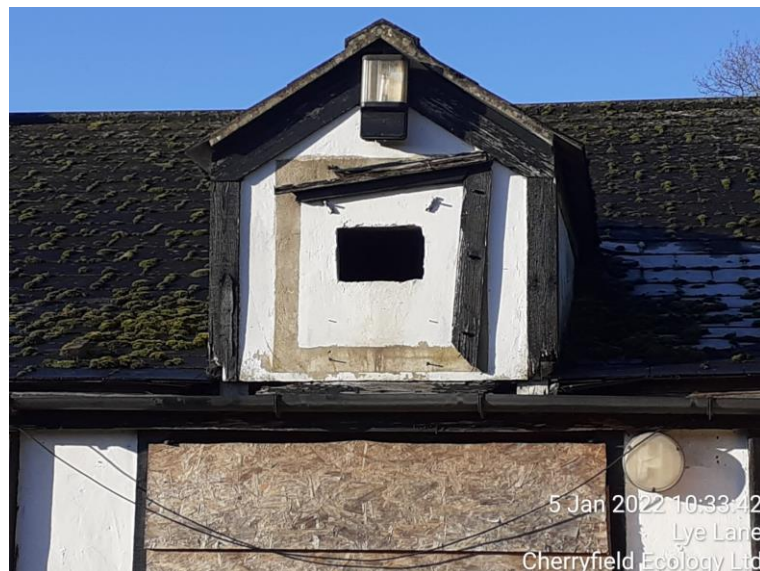
Figure 34: Example of access/exit point in dormer of B1

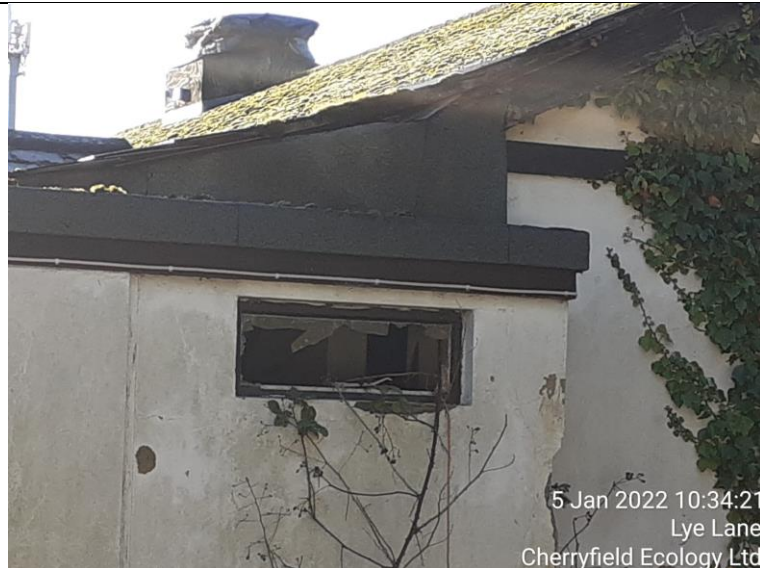
Figure 35: Example of access/exit point in window of B1

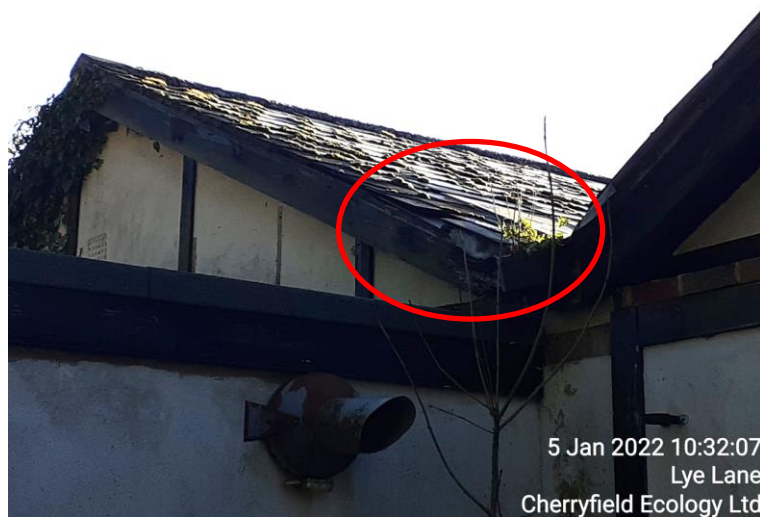
Figure 36: Example of gap between tiles of B1

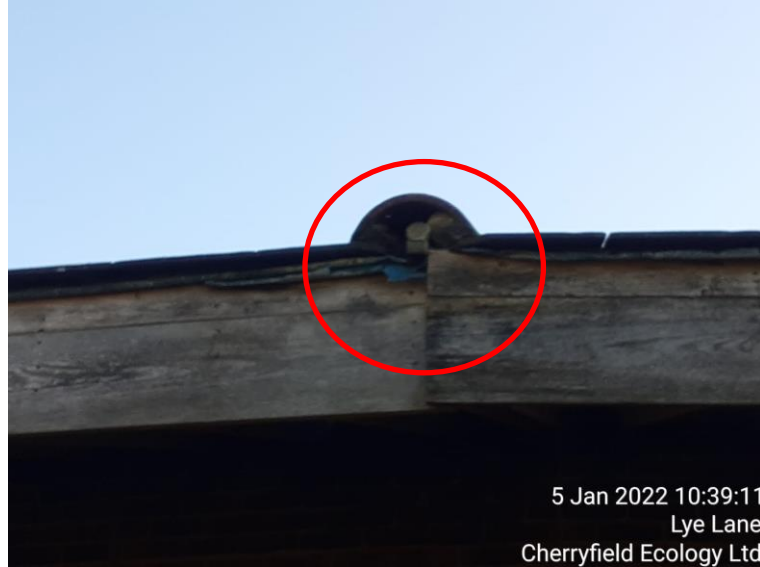
Numerous access/exit points were found to be present in the broken windows and between the bricks of the external wall of B3. Furthermore, gaps were found to be present underneath the ridge tiles of B3.

Figure 37: Example of gaps underneath the ridge tiles of B3

The building B3 provides **moderate** potential for bats due to access/exit points found to be present through the broken windows, as well as suitable potential roosting features found in gaps under the ridge tiles of this building.

**B3 - Presence/likely absence surveys** will be required (two surveys, at least two weeks apart), four surveyors will be required to cover building **B3**; one of these surveys must be undertaken between May to August. If bats are found to be using B3, one further survey will be required.

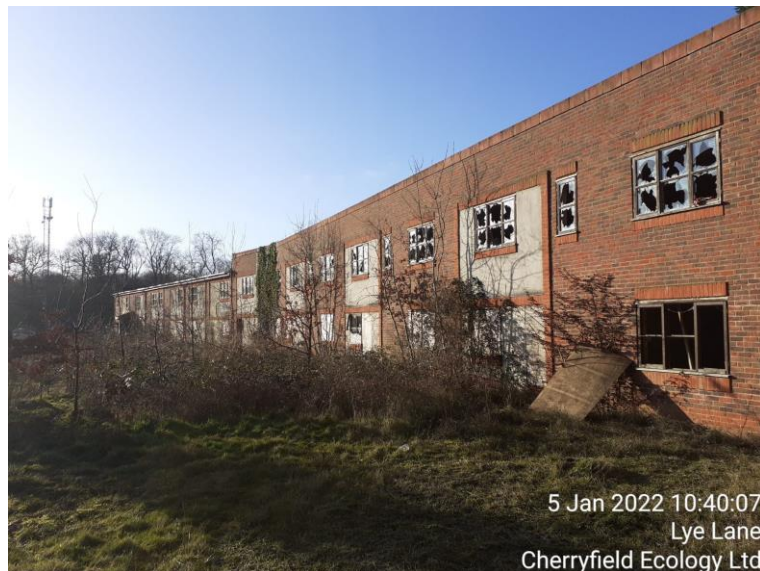
Figure 38: Example of broken windows found on B3

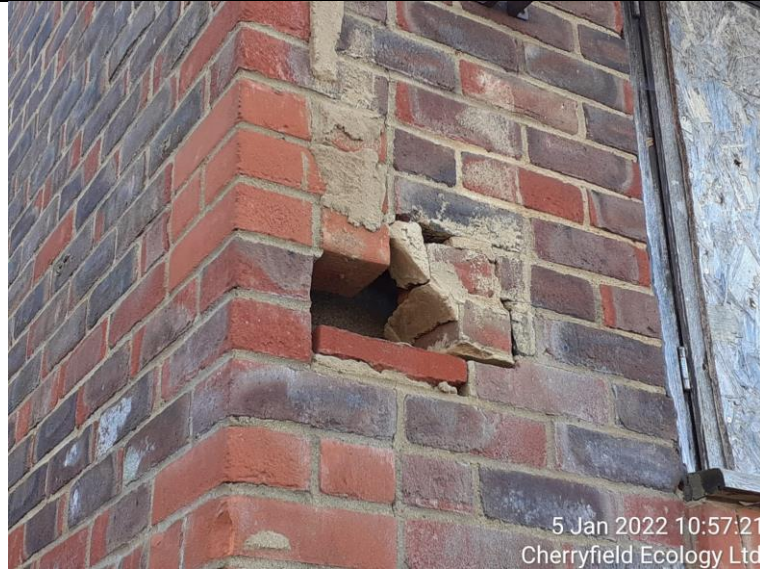
Figure 39: Gap between B3's external brickwork

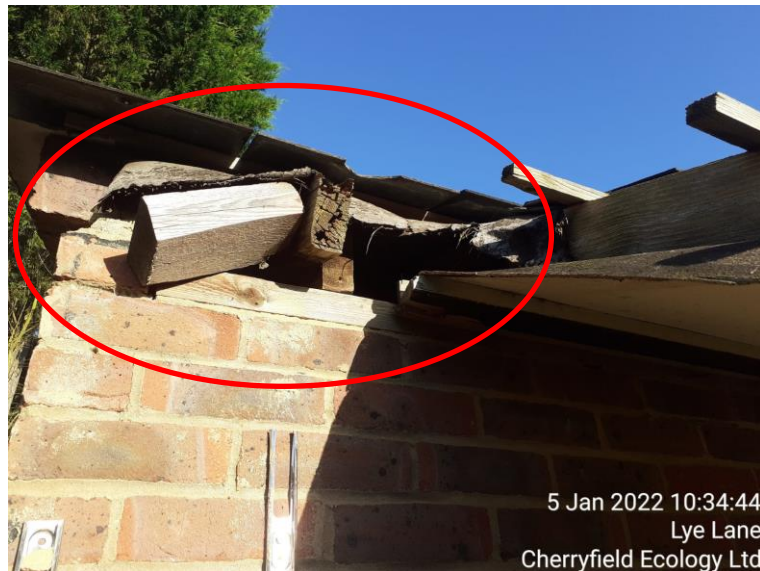
A large access/exit point was found to be present at the eaves of B2.

Figure 40: Example of gap at eaves of B2

The buildings B2 and B8 provide **low** potential for bats due to limited gaps and access/exit points at the eaves of B2 and between the loose and broken roof tiles of B8.

**B2 and B8 - Presence/likely absence surveys** will be required (one survey), two surveyors will be required to cover building **B2**, and two surveyors will be required to cover building **B8**; this survey must be undertaken between May to August. If bats are found to be using B2 and/or B8, two further surveys will be required.

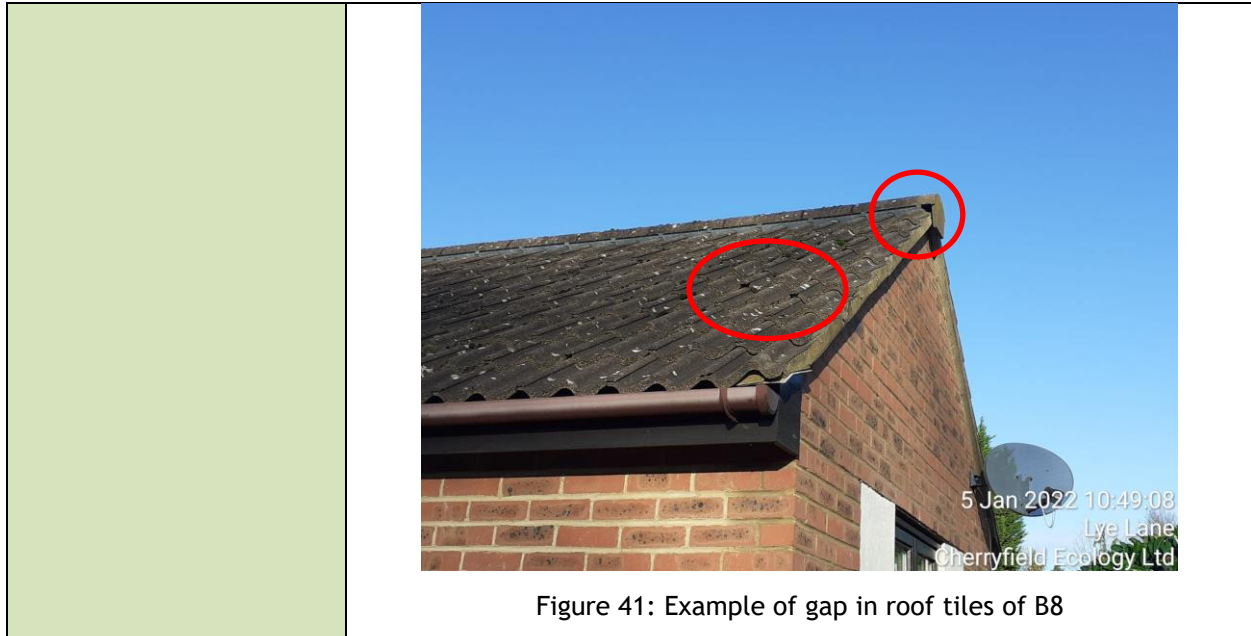
There were limited gaps found to be present within the broken and loose roof tiles of B8.

Figure 41: Example of gap in roof tiles of B8
