# Watling Street, Park Street, St Albans

## Phase 1 Desk Study

Doc ref: 20880-HYD-XX-XX-RP-GE-1000

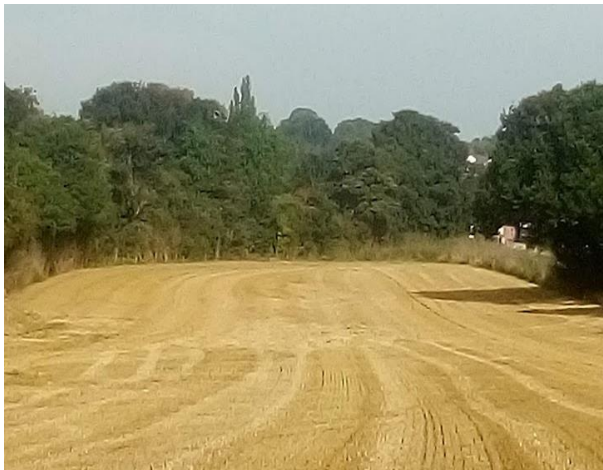
Figure 2.3: Looking north from the middle of the site, drop in elevation visible

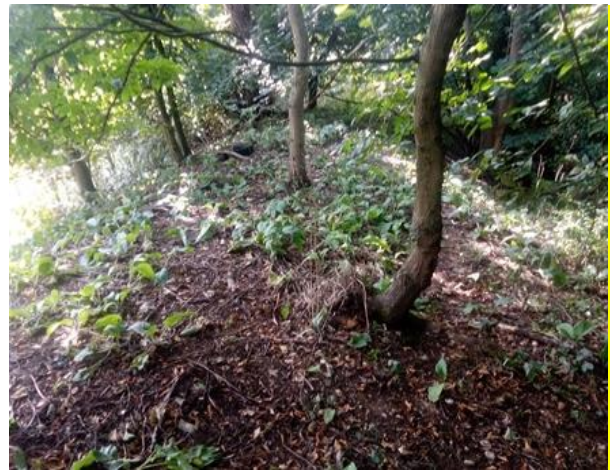
Figure 2.4: Berm running along the western site boundary

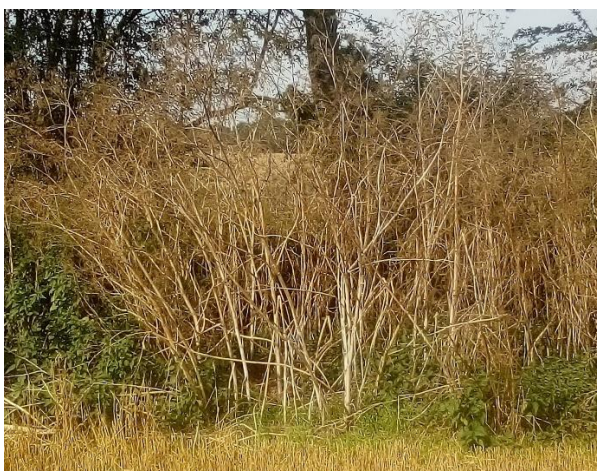
Figure 2.5: Evidence of Giant Hogweed along western site boundary.

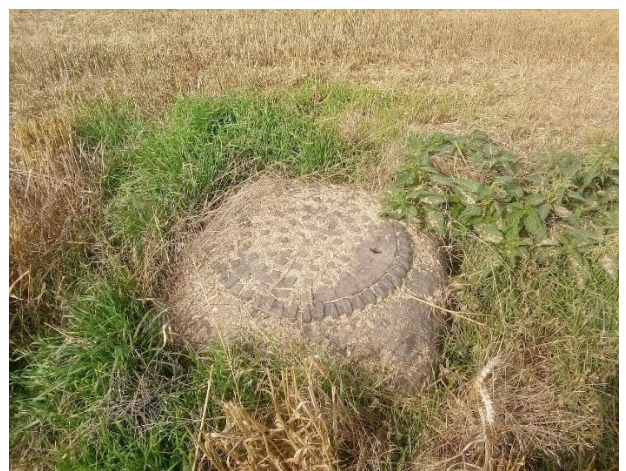
Figure 2.6: Manhole and inspection pit for sewer line running across the site.
