**Land at
Sandridgebury
Lane, St Albans**

**Heritage and
Archaeology
Appraisal**

Prepared by:
**The Environmental
Dimension
Partnership Ltd**

March 2021
Report Reference:
edp6902_r002a

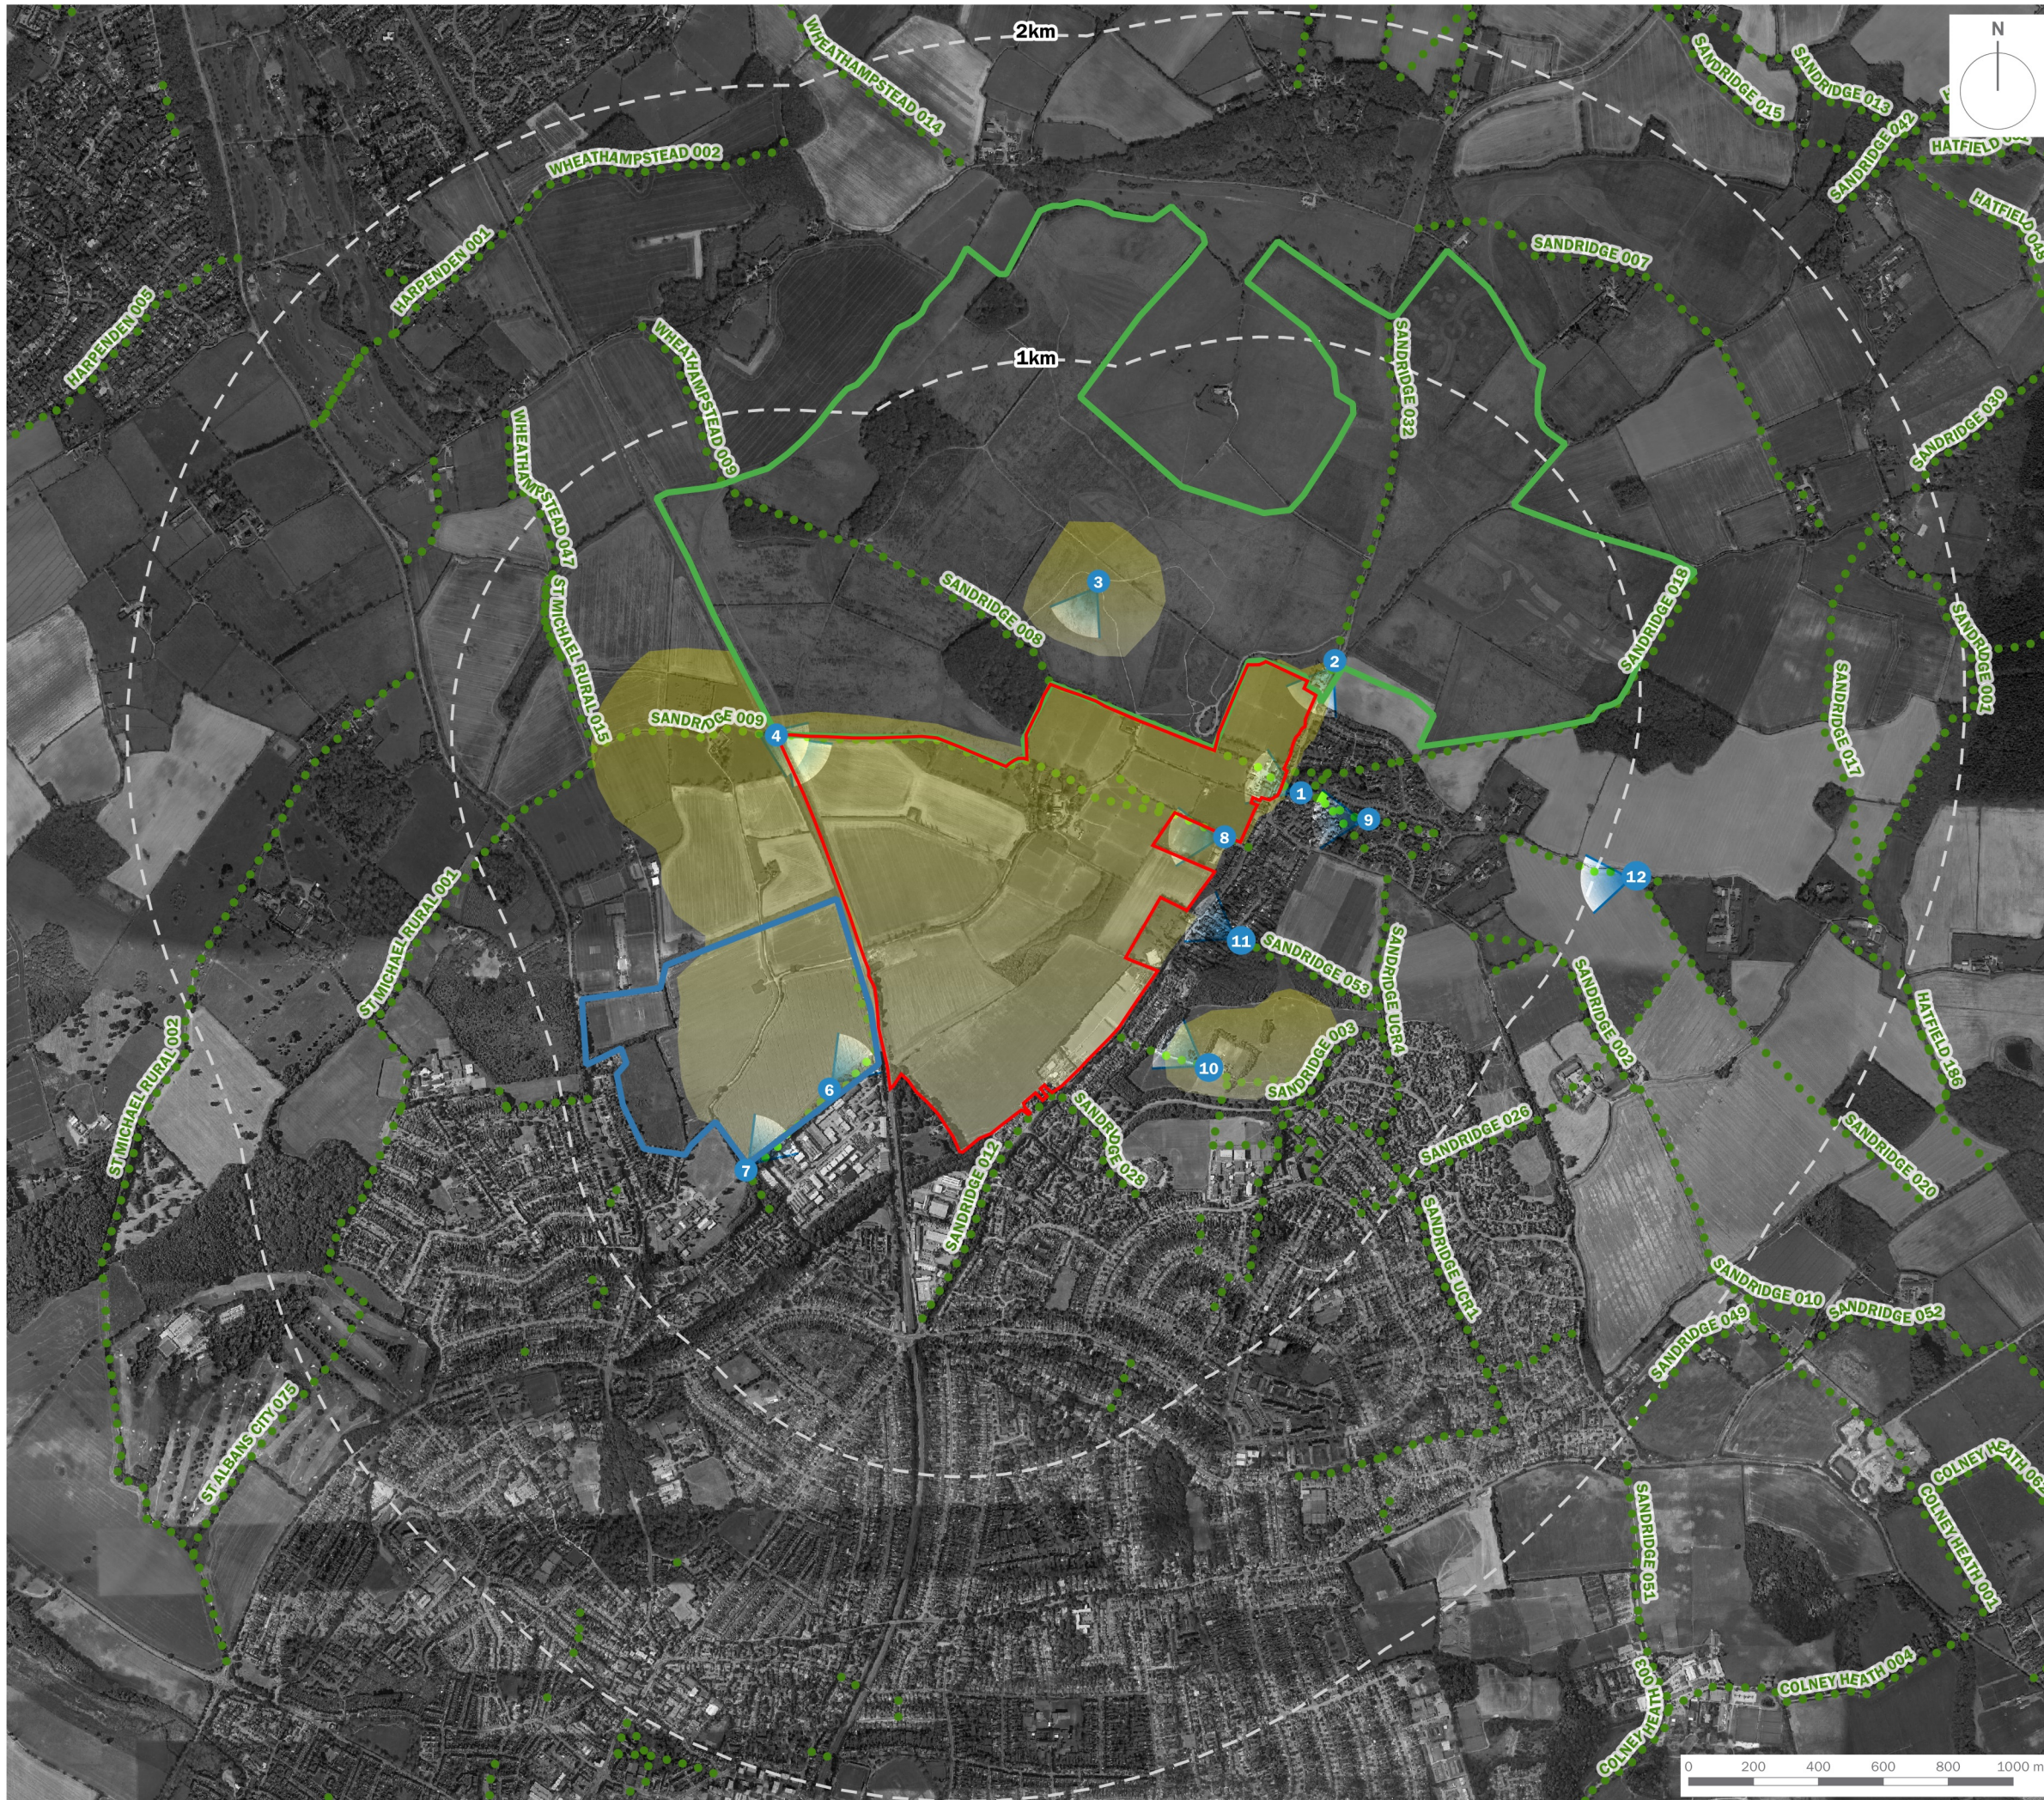
drawing title
Plan EDP 8: Findings of EDP's Visual Appraisal

- Study Area
- North St Albans Draft Allocation
- Range Rings (at 1km intervals)
- Public Right of Way
- Heartwood Forest
- Zone of Primary Visibility (ZPV)
- 12 Photoviewpoint Locations

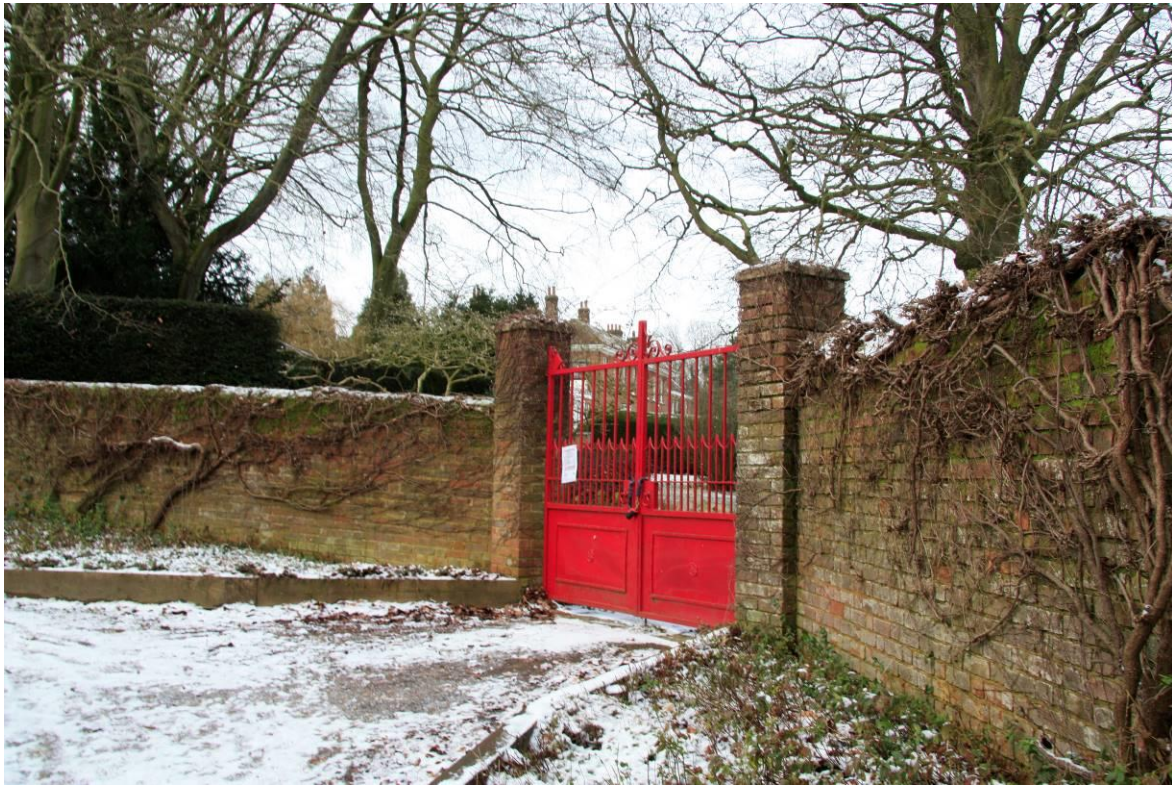
Image EDP 1: General view of the former eastern access to Sandridgebury House, showing the house through the gates, looking west.

- 3.21 The former access to the east, once the likely principal access, now appears to be unused (**Image EDP 1**), and the primary access is from the south, where the entrance

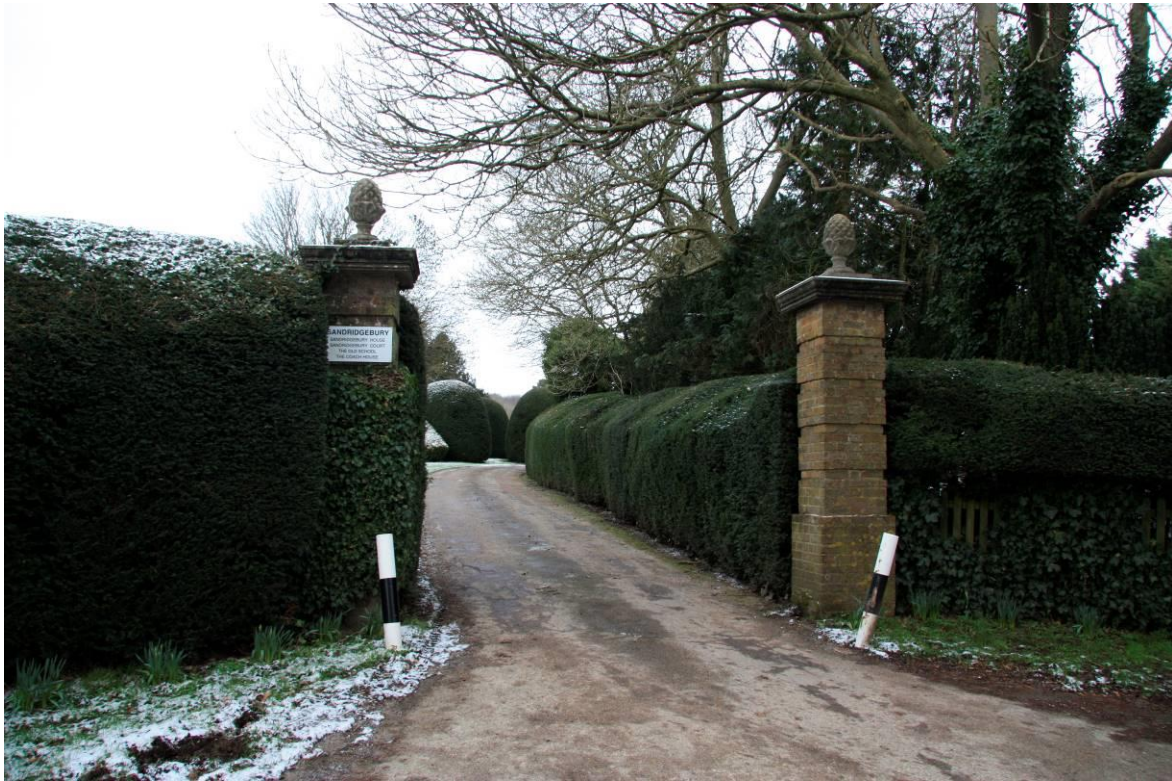
Image EDP 2: The southern access to Sandridgebury House, looking north. Now the principal access to the properties is here.

drive passes through brick piers, and passes along a manicured driveway (**Image EDP 2**). The house still maintains a relationship with a former coach-house (now converted) and to the farmyard, which is physically located to the south-east and comprises historically associated buildings, some listed in their own right, although no longer in the same ownership and use (**Image EDP 3**).

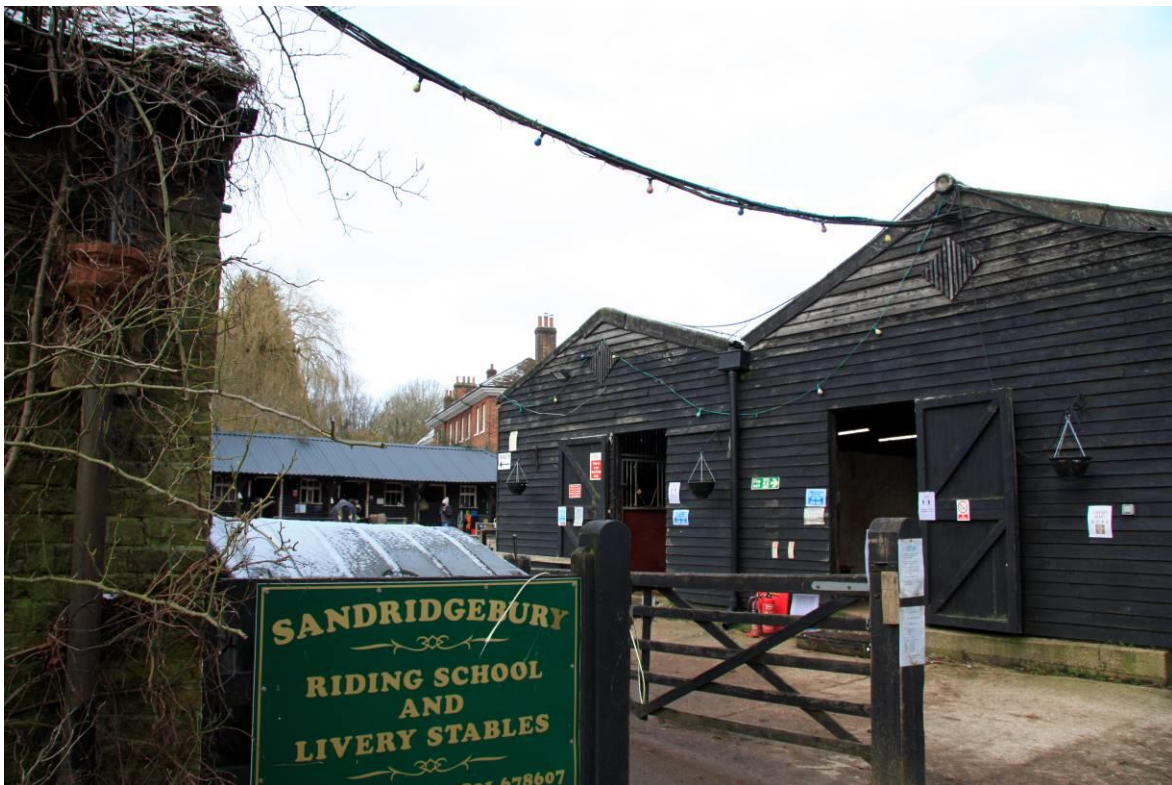
Image EDP 3: View of Sandridgebury farm complex looking north-west. The timber clad buildings are later 19th century. The house can just be seen in the background.
