Phase 1 Habitat Survey

Target Notes

1	INTRODUCTION.....	6
2	EXISTING SITE CONDITIONS.....	7
3	POLICY CONTEXT FOR PROPOSED DEVELOPMENT.....	10
4	DEVELOPMENT PROPOSALS.....	13
5	PROBABILITY OF FLOODING.....	14
6	SURFACE WATER MANAGEMENT.....	17
7	CONCLUSIONS.....	21

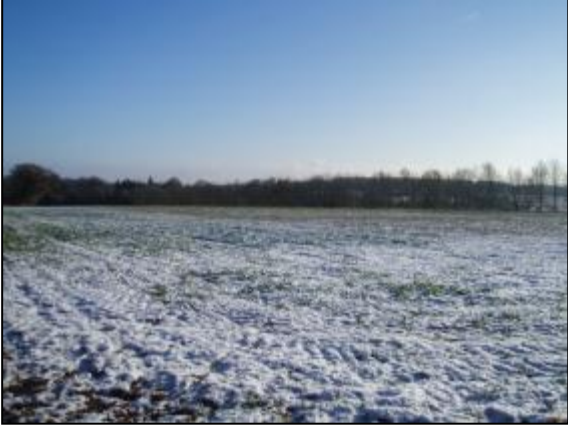
Target Note	Habitat Description	Photo
1	<p>An arable field had been recently cultivated, and as a result no weed species were evident. A volunteer crop of broadleaved plants, likely <i>Brassica</i>, had started to grow. Narrow grassland margins (up to 1m wide), surrounded the field.</p>

- 5.5. Due to snow covering it is recommended that a full floristic survey of the cropped area is undertaken between the end of April and the end of June to determine whether arable weed species are present.
- 5.6. If works can be confined to the arable part of the site (with no impact on the hedgerows or mature trees) it was considered that impacts on local flora and fauna would be negligible and the site could be enhanced for wildlife if some of the following recommendations are implemented:

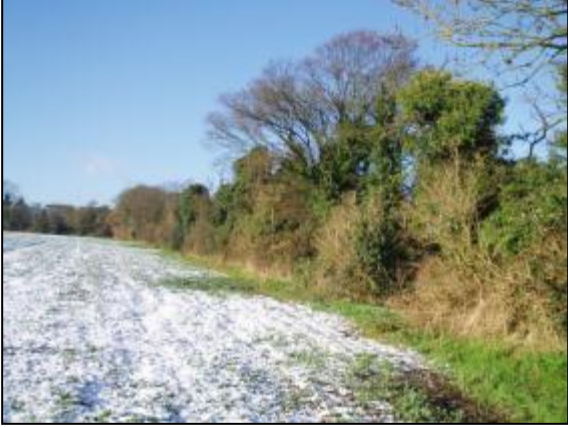
2	<p>A hedge line bordering the northern boundary of the site adjacent to Hill Dyke Road, with occasional mature standard trees. There was a bank on one side of the hedgerow leading down to the adjacent road. Species included oak (<i>Quercus robur</i>), elder (<i>Sambucus nigra</i>), hawthorn (<i>Crataegus monogyna</i>) and hazel (<i>Corylus avellana</i>). Ground flora included cow parsley (<i>Anthriscus sylvestris</i>), common mallow (<i>Malva sylvestris</i>) and cleavers (<i>Galium aparine</i>). The hedge was unmanaged, between three and six meters tall, 2 meters wide and 170 meters long.</p>

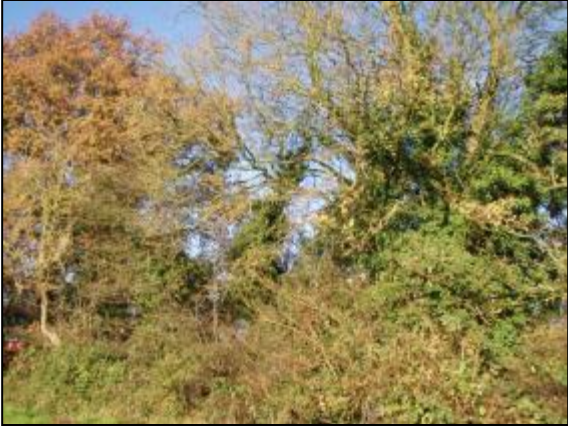
3	<p>A number of ivy clad oak trees within the northern boundary hedge line with splits in branches and aerial deadwood. These were considered to have high potential to support roosting bats.</p>

- 4.6 There were a number of mature trees with bat roost potential along the hedges bordering the site (Target Notes 3, 4, 6, 10, 13, 15, 16 and 19) which were considered to provide moderate or high roosting opportunities for bats (Category 2b or 1). Aerial dead wood, fissures in bark and ivy cladding provided numerous crevice roosting opportunities for bats. Several other mature trees were present in the northern boundary hedge in Target Note 2. There were no other suitable trees or buildings within the site.
- 4.7 The site was dominated by arable land, which provides poor quality foraging habitat for bats. The woodland area to the east (beyond the site boundary) provided good quality foraging habitat for bats. Hedgerows along the site boundaries provided suitable commuting routes.

- 4.8 Further survey is recommended if the mature trees identified with bat roosting potential will be impacted by the proposed development. These surveys should follow BCT best practice guidelines (2012), and can be carried out between May and September. Outside this season, it may be possible for a bat-licensed tree-climber to assess the roost status of the trees.

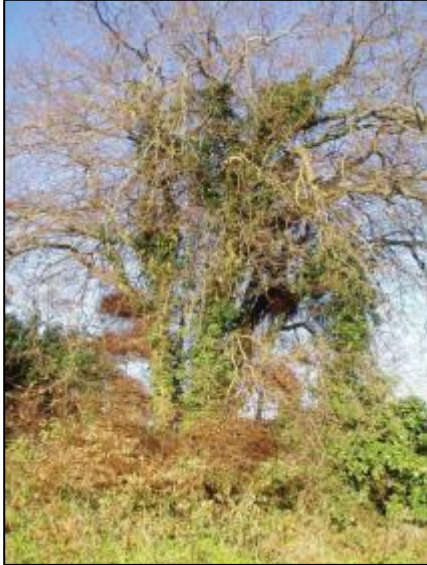
<p>4</p>	<p>A hornbeam (<i>Carpinus betulus</i>) within the northern boundary hedge with aerial dead wood, ivy and epicormic growth. This tree was considered to have medium bat roost potential.</p>

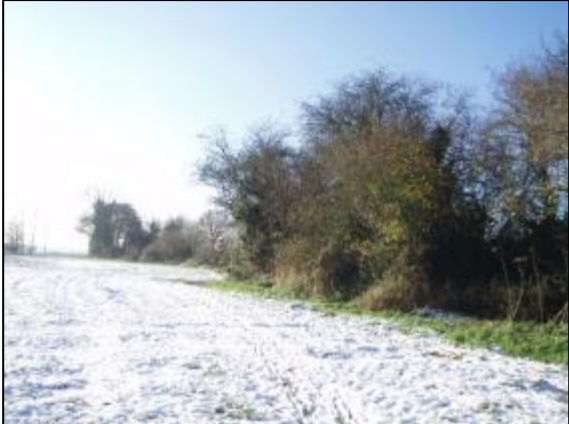
<p>5</p>	<p>An outgrown hedge bordering the western boundary of the site with occasional semi mature and mature standards. Tree species present included ash (<i>Fraxinus excelsior</i>), field maple (<i>Acer campestre</i>) and hazel. A dense understory of scrub was present, species present included bramble (<i>Rubus fruticosus</i>) and rose (<i>rosa sp.</i>) The hedge was unmanaged, approximately three to six meters tall, three to four meters wide and 130 meters long.</p>

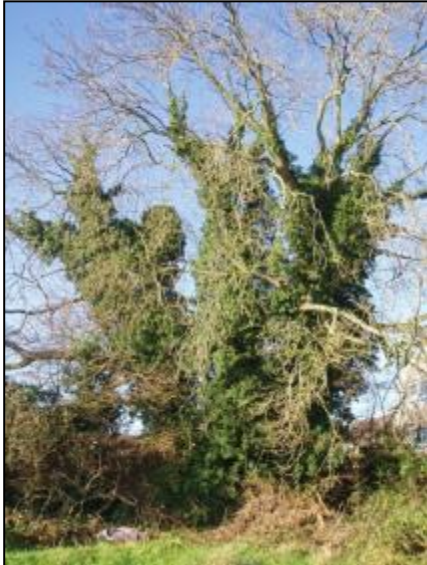
<p>6</p>	<p>An ash tree within the western boundary hedge which was heavily ivy clad. Due to fissuring bark and aerial deadwood, it was considered to have high bat roosting potential.</p>

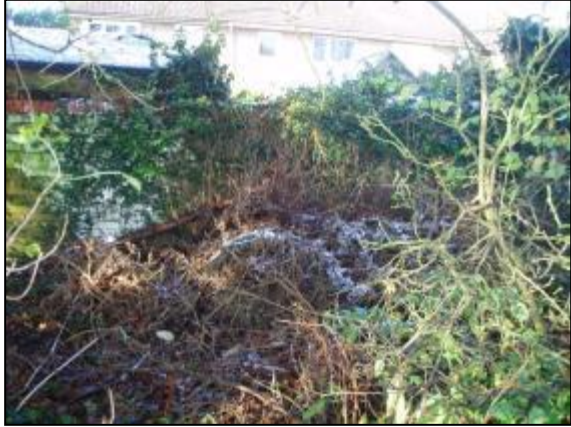
<p>7</p>	<p>Pile of garden debris by the western boundary hedge, potentially suitable for hibernating reptiles.</p>

- 4.12 Due to the small extent of suitable reptile habitat, further surveys are not considered necessary. However, if small areas of the narrow grass margins which border the field are impacted, then precautionary clearance is recommended to prevent harm to widespread reptiles which could potentially be using these areas. This should be carried out following a method statement which is likely to include the following methods:

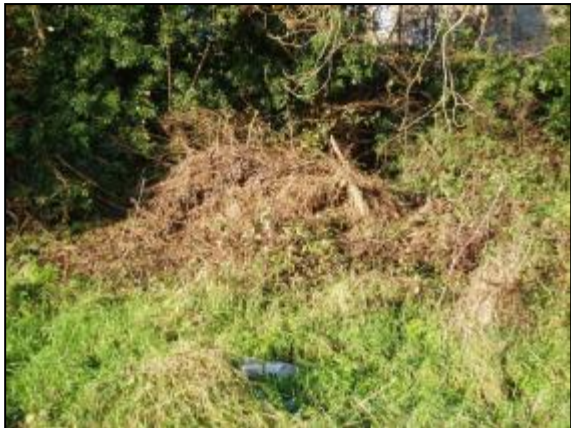
<p>8</p>	<p>Pile of dead wood by the western boundary hedge, potentially suitable for hibernating reptiles.</p>

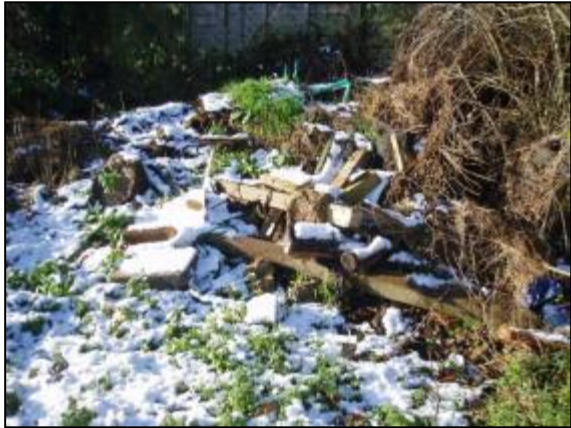
<p>9</p>	<p>Rubble pile beside the western boundary hedge, potentially suitable for hibernating reptiles.</p>

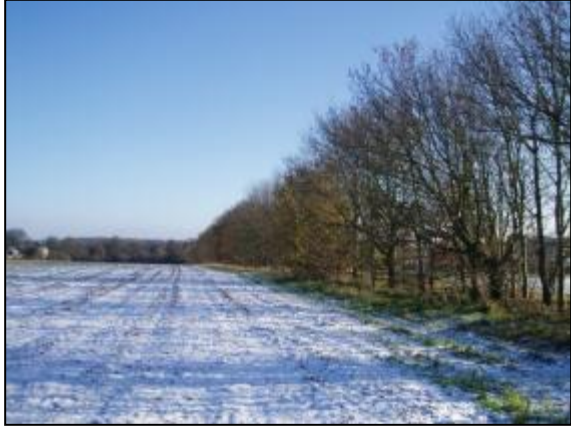
<p>11</p>	<p>A row of semi-mature trees on the southern boundary of the site, on a small raised grassy bank, five to seven metres wide. Species included ash, oak and beech (<i>Fagus sylvatica</i>).</p>

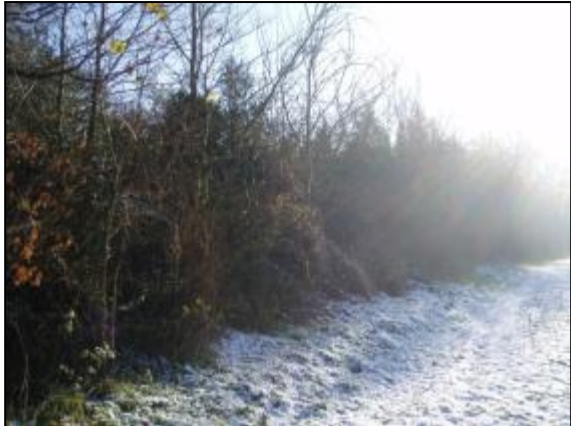
<p>12</p>	<p>A hedge line along the eastern boundary of the site running adjacent to a footpath and dyke lane. Species included oak, elm (<i>Ulmus sp.</i>) and field maple. The hedge was unmanaged, approximately six meters tall, three to four meters wide and 75 meters long.</p>

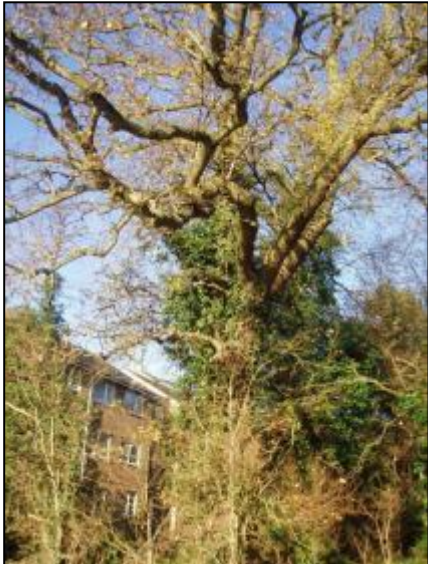
<p>13</p>	<p>Oak tree on the north eastern boundary corner, with ivy covering and aerial dead wood. This tree was considered to have medium bat roost potential.</p>

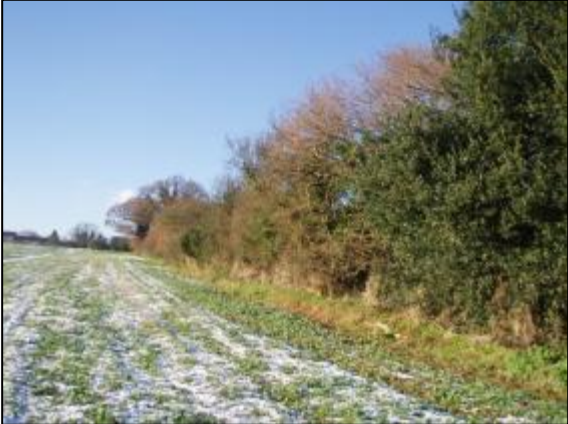
<p>14</p>	<p>Hedge line bordering the northern boundary of the site adjacent to residential properties off Davys close. Species included oak, elm and field maple. The hedge was unmanaged, approximately three to four meters tall, two meters wide and 150 meters long.</p>

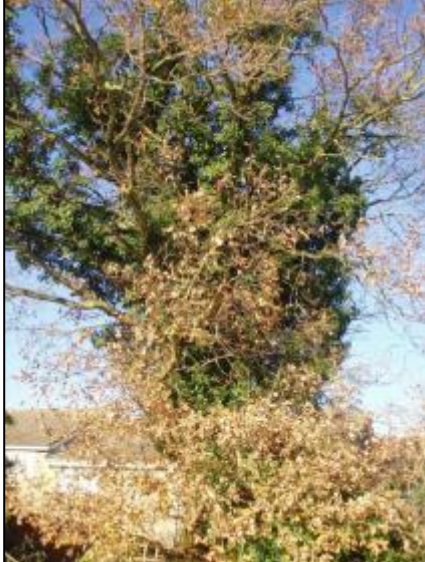
<p>15</p>	<p>Oak in northern boundary hedge, with aerial deadwood and some ivy covering. This tree was considered to have medium potential to support roosting bats.</p>

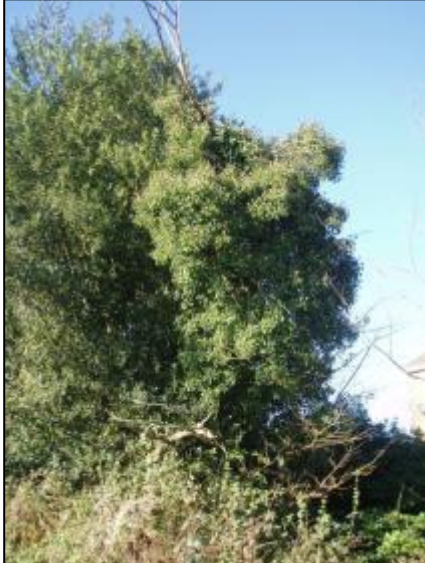
<p>16</p>	<p>Ivy covered, dead tree in northern boundary hedge, with medium bat roost potential.</p>

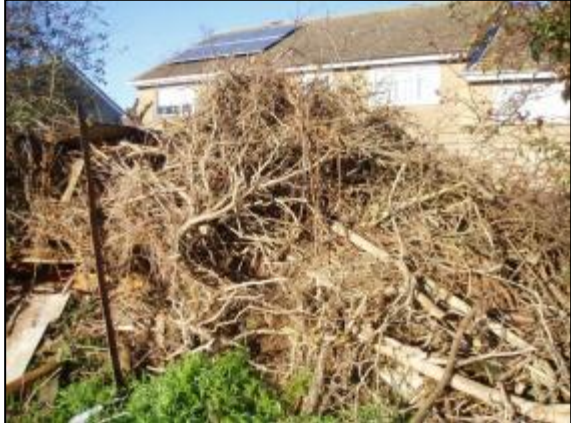
<p>17</p>	<p>Dead wood pile by northern boundary hedge, suitable for hibernating reptiles.</p>

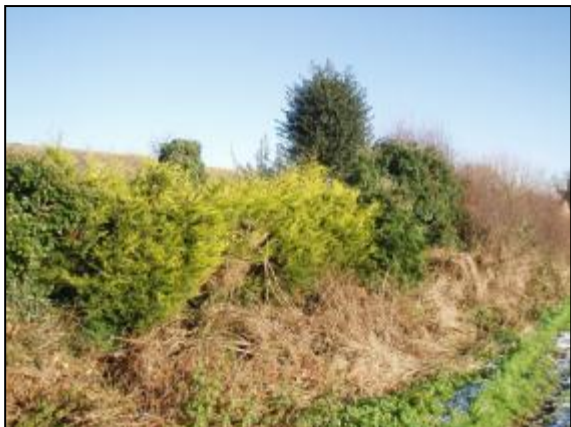
<p>18</p>	<p>A section of hedge on the northern boundary of the site, where cypress has been grown adjacent to residential properties of Davys close.</p>

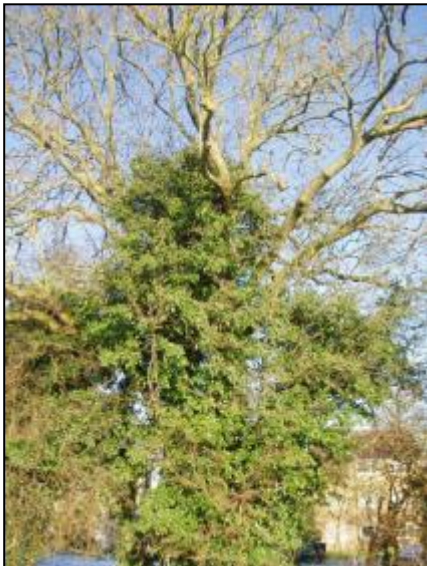
<p>19</p>	<p>Ivy clad ash tree on northern boundary hedge with fissures in the bark. This tree was considered to have medium to high bat roost potential.</p>

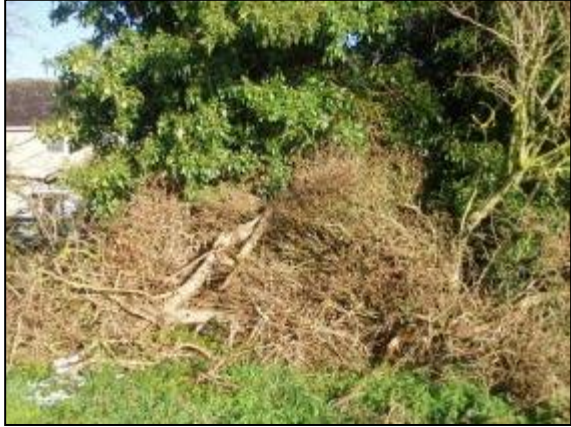
<p>20</p>	<p>Garden waste pile along the northern boundary hedge, adjacent to Hill Dyke Road.</p>

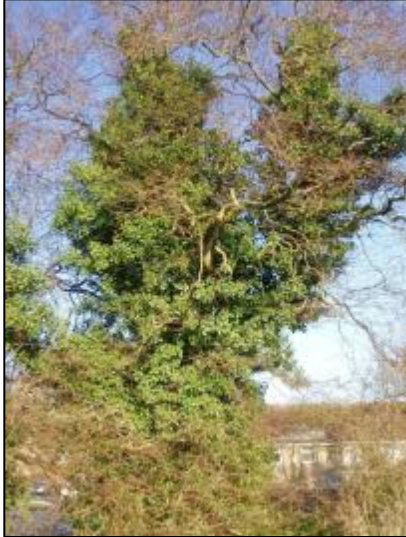
<p>21</p>	<p>Ash tree at the corner of the northern hedgerow, adjacent to Hill Dyke Lane, of medium bat roosting potential due to fissures in the bark</p>

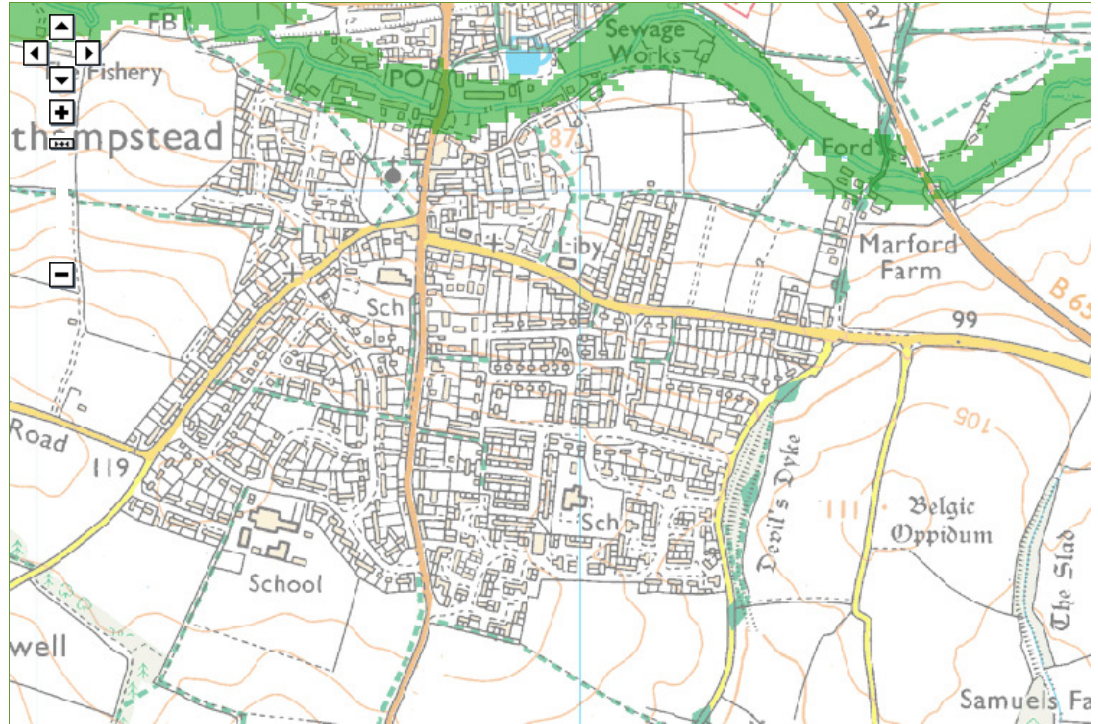
This map shows the largest area that might be flooded if a reservoir were to fail and release the water it holds. Since this is a prediction of a worst case scenario, it's unlikely that any actual flood would be this large.

If your property is within the green highlighted area, then you could be affected by reservoir flooding. To find out more about the reservoirs that could cause this flooding, click on the map within the green highlighted area. You will find the name and ownership details of the reservoirs that could cause flooding in your area.

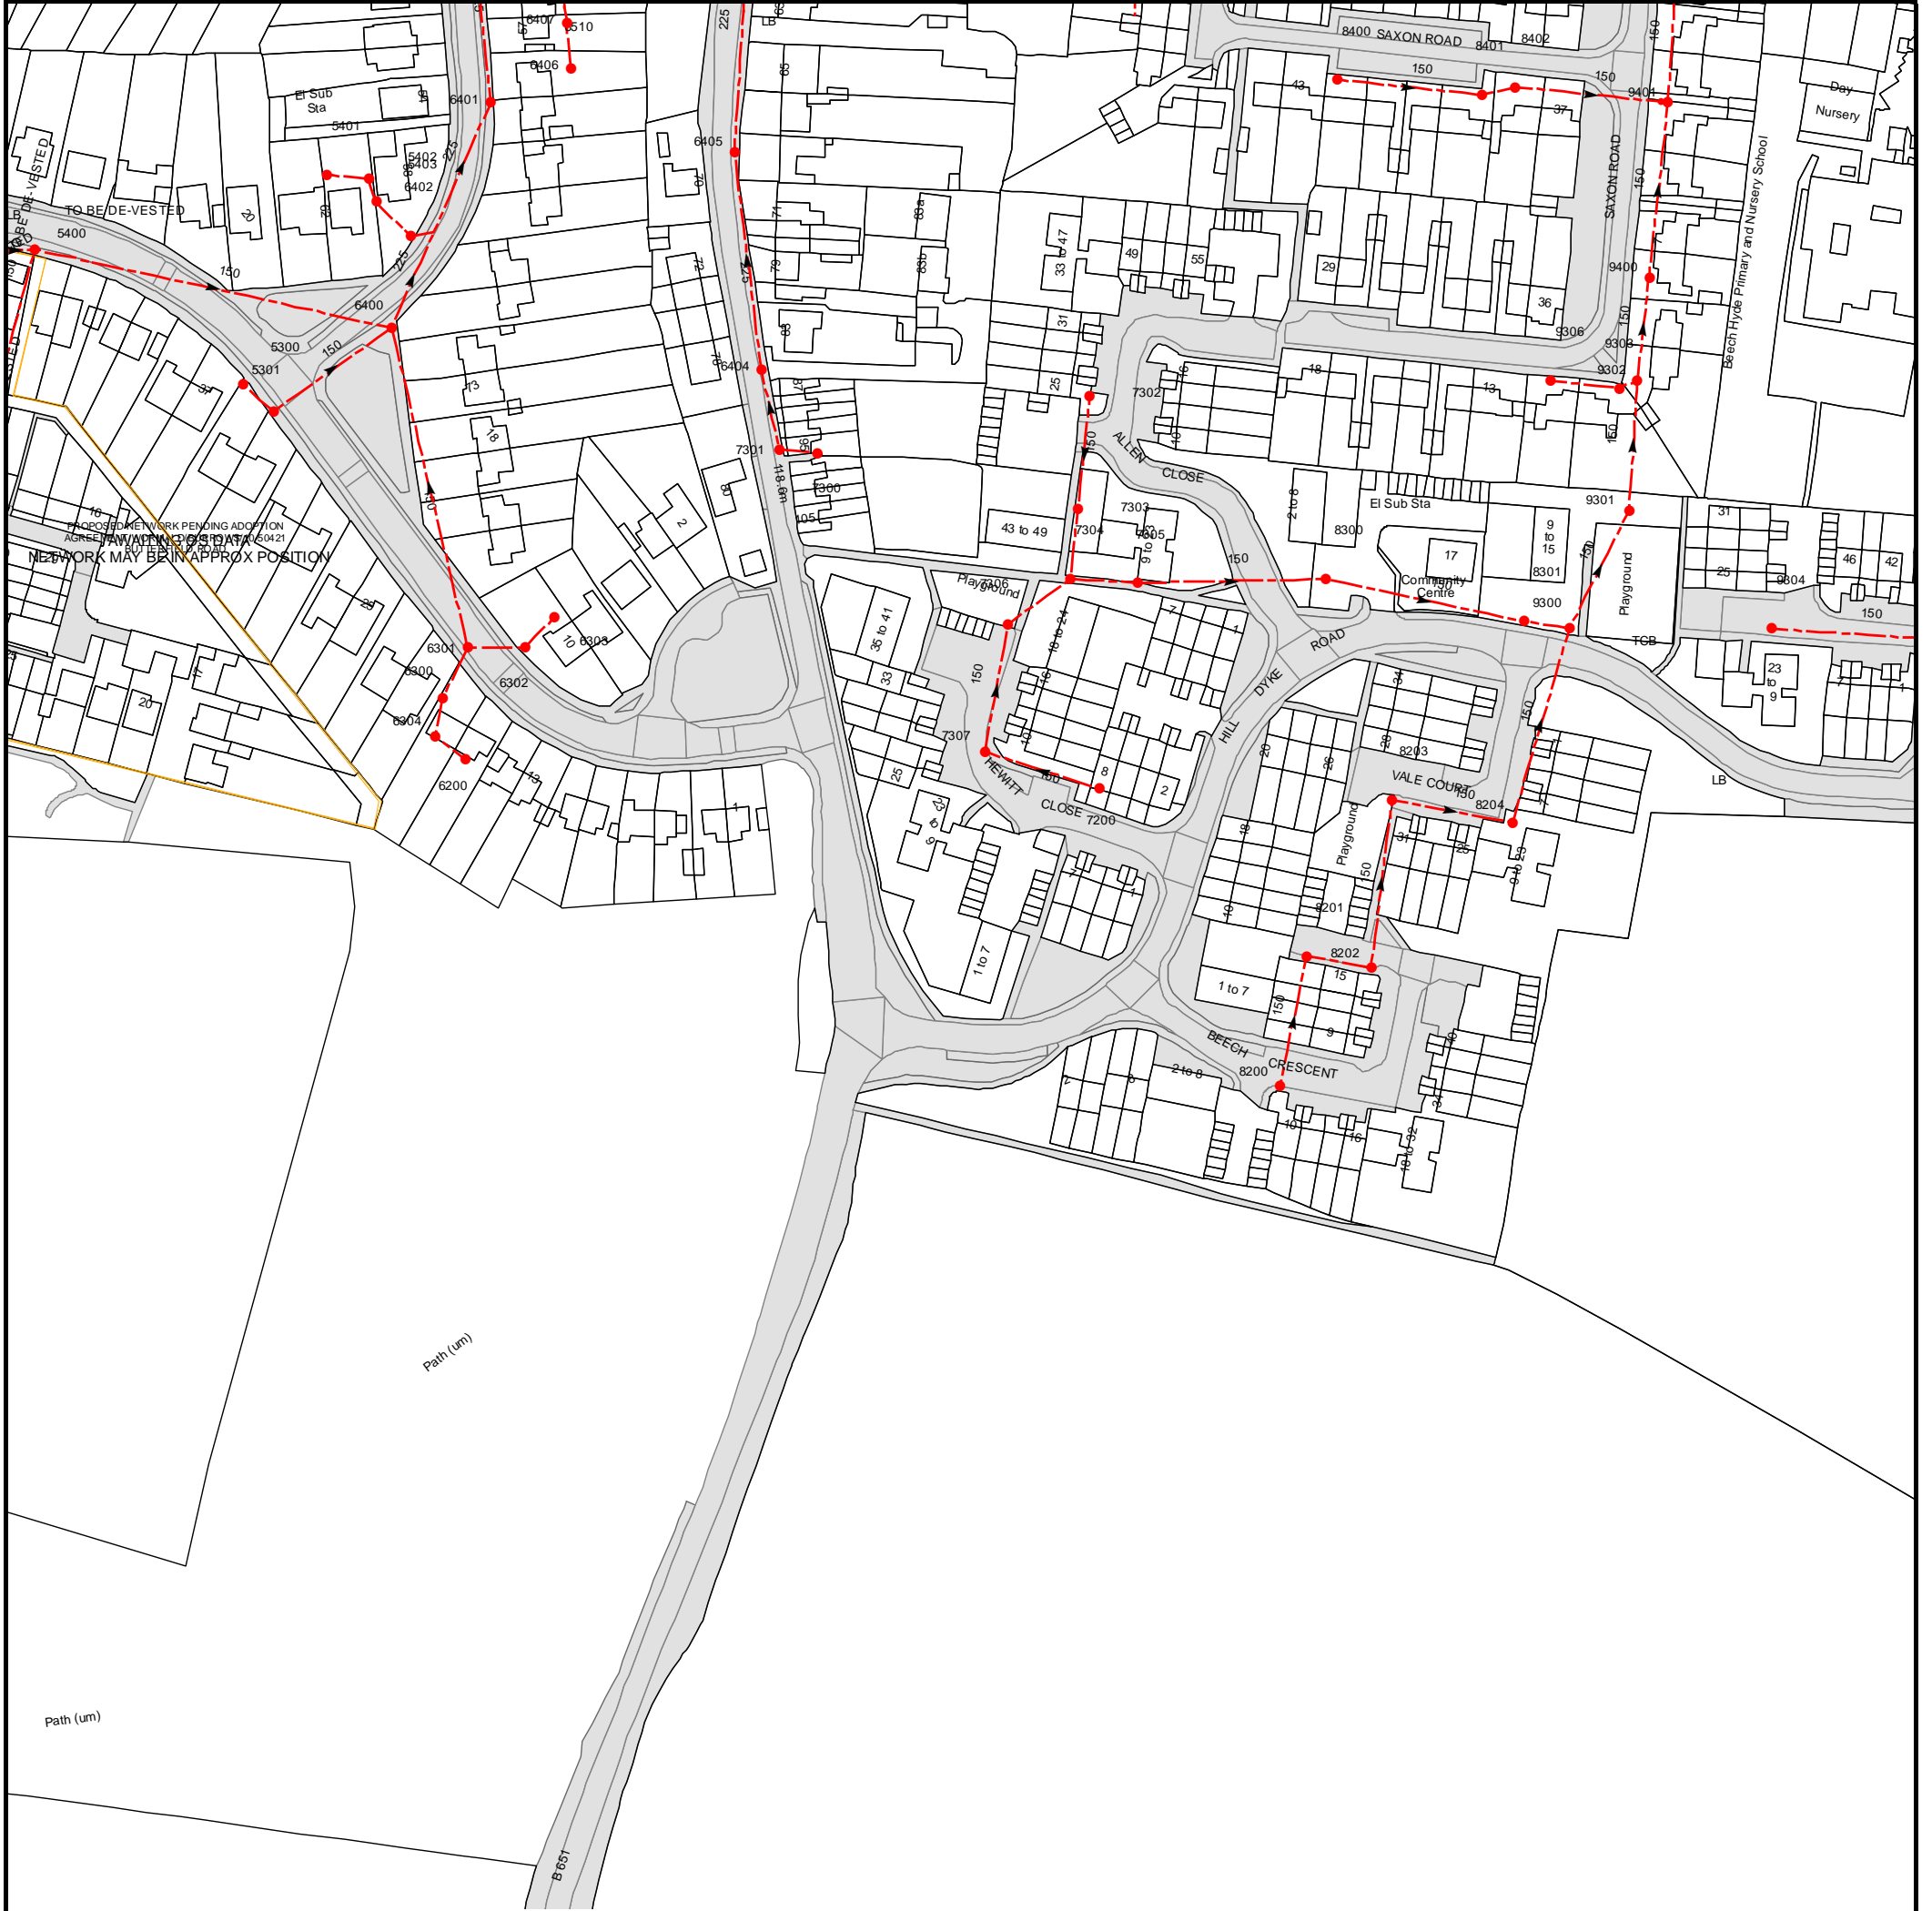
The width of the displayed area is 500m and the centre of the map is located at OS coordinates 517750,213250

Manhole Reference	Manhole Cover Level	Manhole Invert Level
9401	114.69	112.4
8402	115.47	114.37
5301	118.94	115.91
5401	118.53	117.21
5402	118.48	116.99
5403	118.5	116.83
6400	118.56	115.5
6402	118.45	116.62
9304	112.69	111.38
9300	115.68	113.69
8301	115.95	113.82
9301	114.93	113.4
9303	114.23	113.39
9302	113.91	113.24
9306	114.31	113.6
9400	114.61	112.74
6200	118.88	116.58
6304	118.86	116.47
6300	118.9	116.29
6301	118.83	116.05
6302	118.88	116.36
6303	118.95	116.76
6401	118.46	114.49
6406	118.05	116.67
6407	117.88	116.44
7200	118.03	116.36
7307	117.97	115.84
7306	117.81	115.5
7305	117.6	114.69
7304	118.07	115.06
8300	116.43	114.2
7303	118.03	115.44
7300	118.3	117.49
7301	118.51	116.94
7302	117.49	115.99
6404	118.52	116.78
6405	118.54	116.44
8401	115.87	114.59
8400	116.49	115.2
8200	116.78	115.19
8202	116.76	114.57
8201	117.09	114.87
8204	116.24	113.98
8203	116.81	114.06
5400	119.23	116.64
5300	118.78	116.81

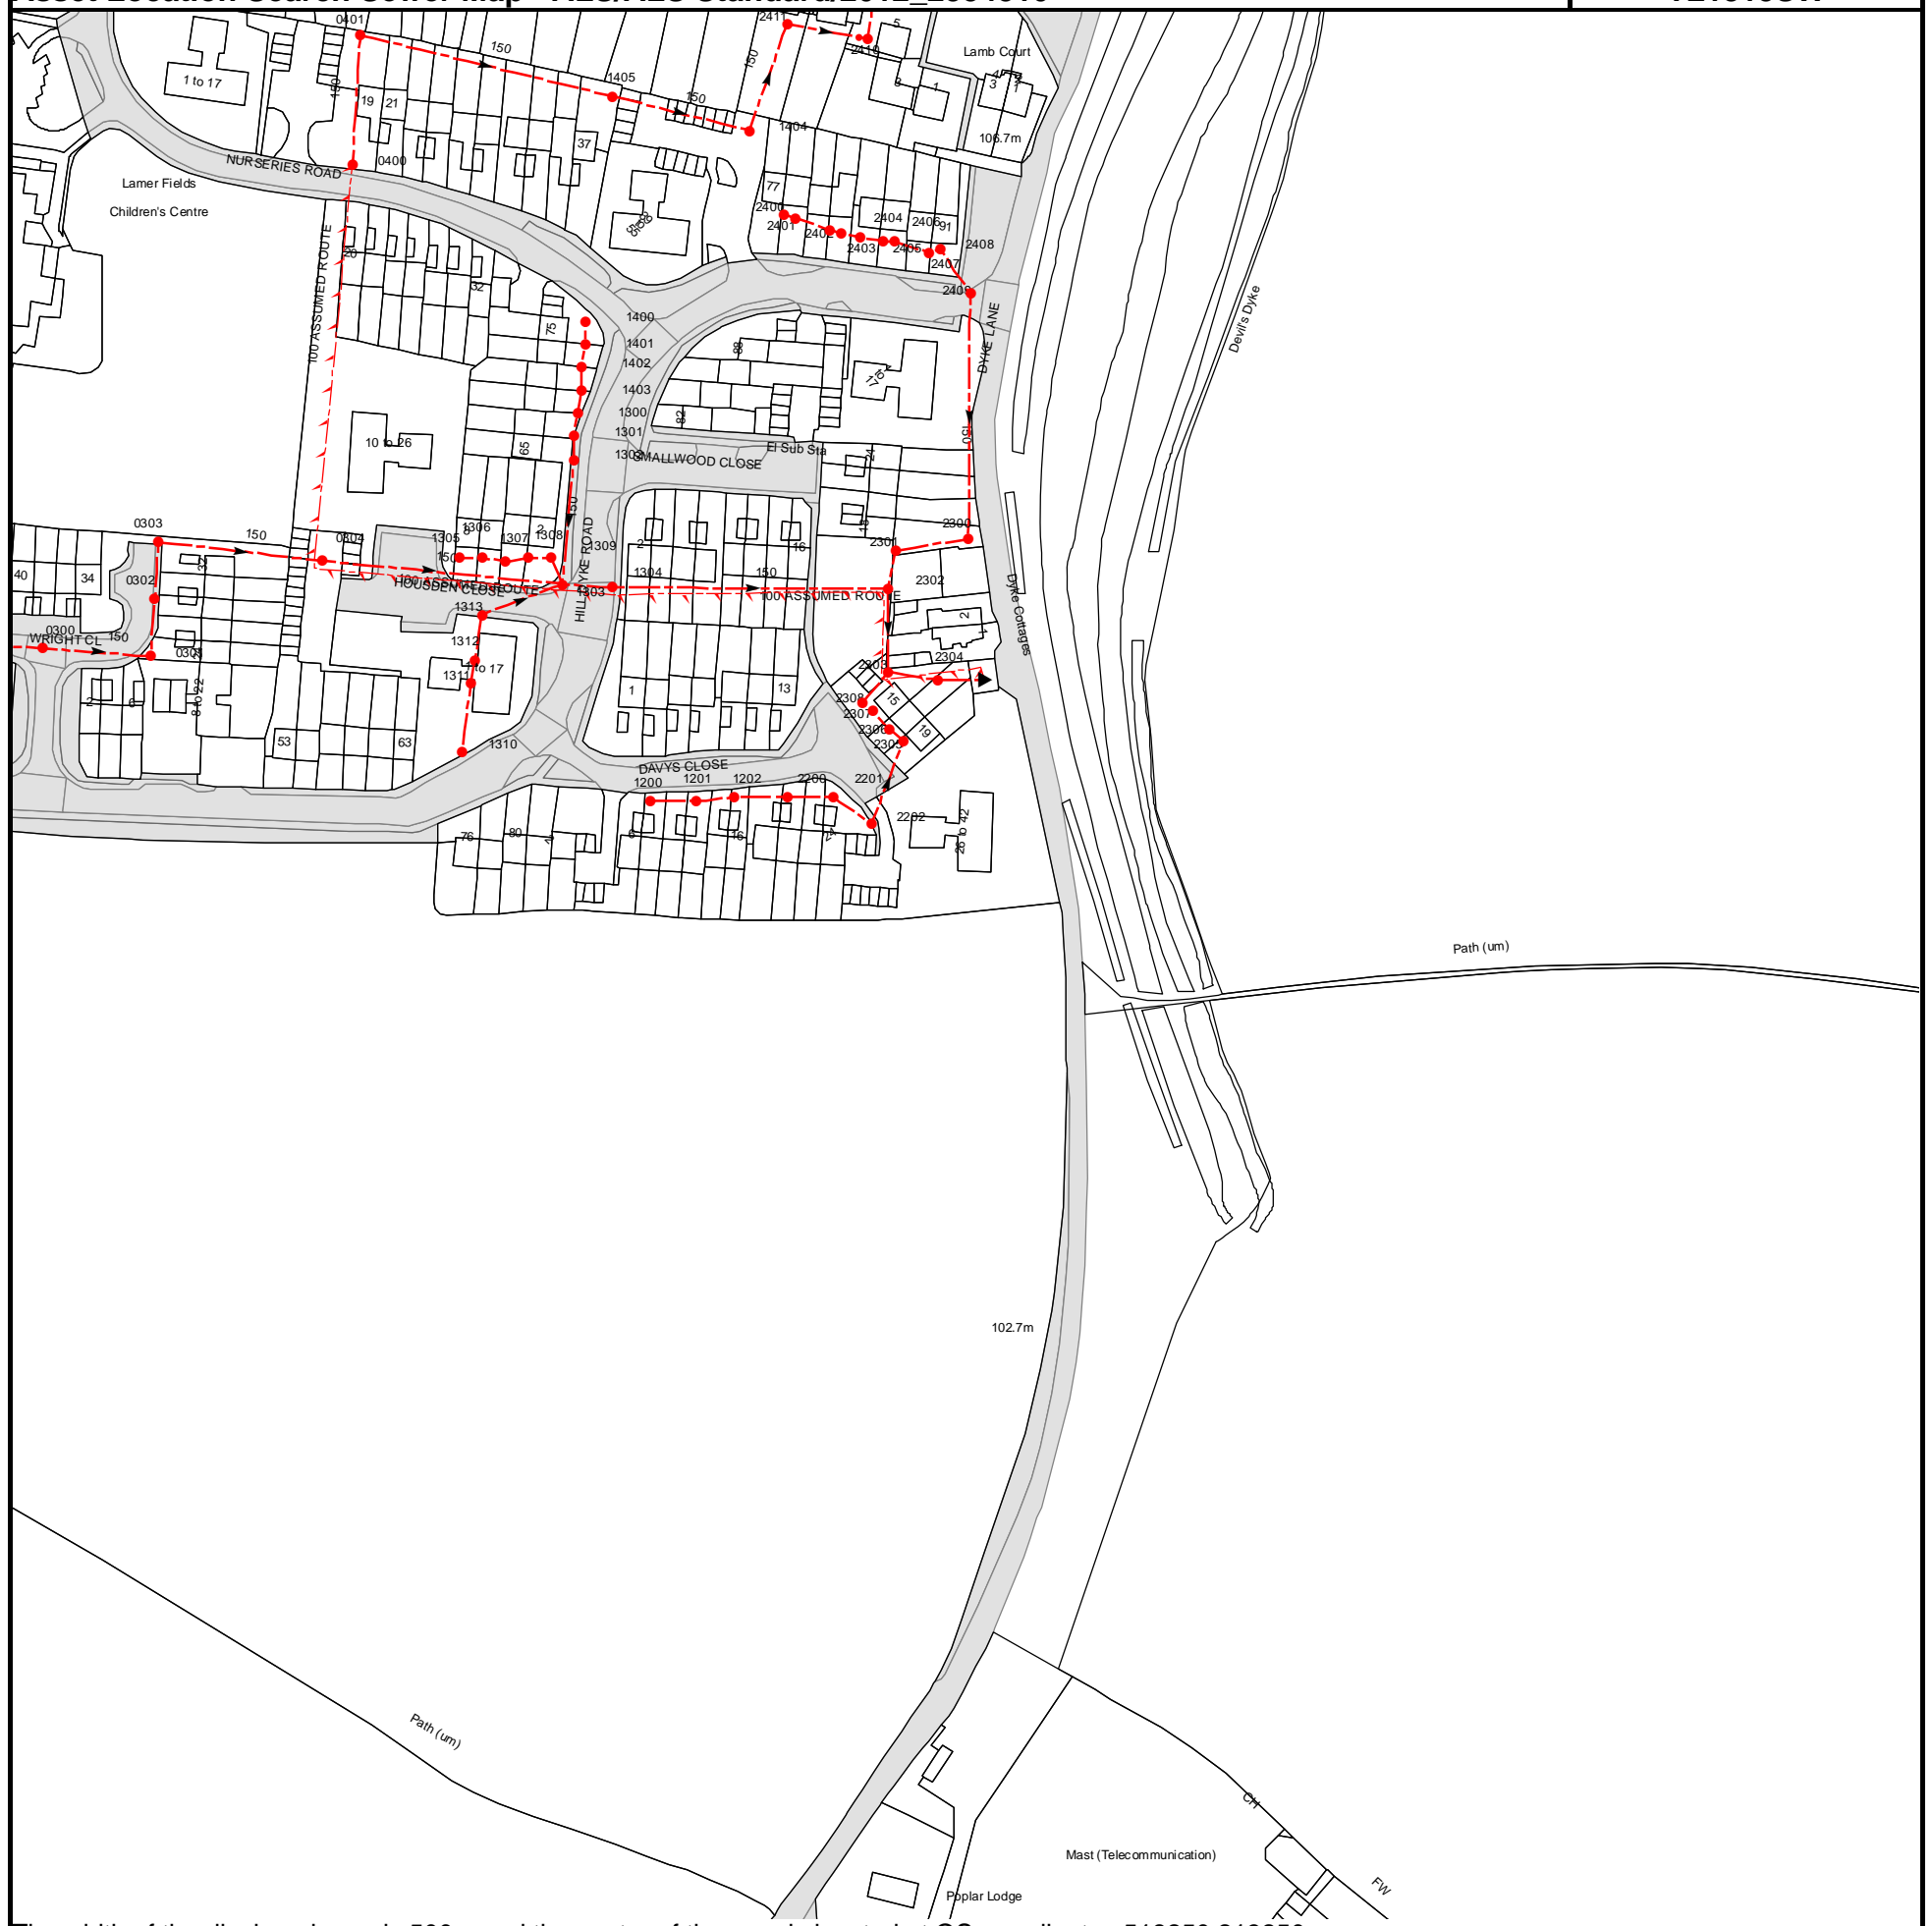
The width of the displayed area is 500m and the centre of the map is located at OS coordinates 518250,213250
The position of the apparatus shown on this plan is given without obligation and warranty, and the accuracy cannot be guaranteed. Service pipes are not shown but their presence should be anticipated. No liability of any kind whatsoever is accepted by Thames Water for any error or omission. The actual position of mains and services must be verified and established on site before any works are undertaken.
