Report prepared for: Brian Parker

For the Site of: Bricket Lodge Sport and Country Club, Lye Lane, Hertfordshire AL2
3TF

Emergence and Activity Bat Survey (EBS)

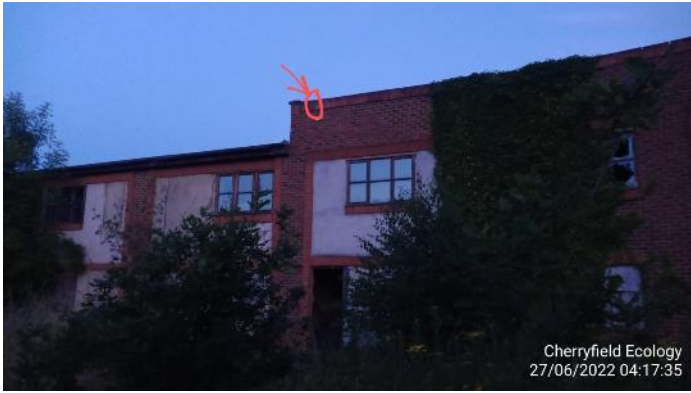
Cherryfield Ecology 27/06/2022 04:17:35

GG	B3	As above	Nyc heard from 21.20 until 21.30. CP heard from 21.42, until 22.38 passing around the grounds.
SD	B2	As above	Nyc heard from 21.20 until 21.30 flying overhead. CP heard from 21.43 until 22.42 passing through.
PH	B2	As above	Nyc heard at 21.29. CP heard from 21.41 until 22.13 passing through.
DR	B8	As above	Nyc heard from 21.21 until 21.29.
LB	B8	As above	Nyc heard from 21.21 until 21.29.
AP	B1	As above	Nyc heard from 21.21 until 21.29. CP heard from 21.41 until 22.40.
TOC	B1	As above	Nyc from 21.20 until 21.29 passing overhead.
MOC	B3	27/06/2022 03.15 to 05.00 SS: 04.45	Three Nyc passes at 03.34, 04.03 and 04.04.
TOC	B3	As above	Nyc heard three times at 03.34, 04.03 and 04.04,
HS	B3	As above	Nyc heard on three occasions passing overhead.
SD	B3	As above	Nyc heard at 04.03 passing over. CP heard and seen at 04.12, it dawn swarmed up to the building three occasions and enter under a tile at 04.12 (see Figure 2)

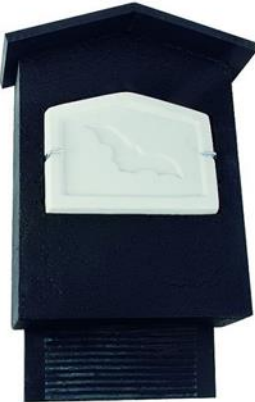
<p>Figure 4: Chillon Woodstone Bat Box (British-made)</p> <p>A minimum of two Chillon Woodstone bat boxes will be hung on the trees or the building at a minimum of 3m from ground level and face south/southwesterly. These boxes are known to be used by Brown Long-Eared bats (BLEB) and crevice-dwelling species.</p> <p>No further mitigation or compensation is required under this licence.</p> <p>Commuting bats were using the grounds and surrounds; therefore, any tree, hedges or linear feature should be retained if possible.</p>
<p>Lighting</p>	<p>Any lighting near or shining onto any trees, especially those with bat boxes in or commuting routes shown to be present at further survey stage, will be designed to minimise the impact it has on potential bat roosting and commuting.</p> <p>Lighting will be in line with the BCT lighting guidelines (Bats and Lighting in the UK (Bat Conservation Trust, 2018) https://www.theilp.org.uk/documents/guidance-note-8-bats-and-artificial-lighting/)</p> <p>This lighting were possible will be of low level, be on downward deflectors and be on PIR sensors. Using LED directional lighting can also be a way of minimizing the light spill affecting the habitat. No up-lighting should be used. Light spill must be minimized to 0.5lux.</p> <p>This will ensure that the roosting and commuting resources that the bats are likely to be using is maintained.</p>

<p>Bat boxes will be installed on retained trees or buildings; it is currently understood that there are trees to the rear of the dwelling (within the garden of the main house) that can be used for this purpose.</p>
