# Phase 1 Geo-Environmental Desk Study

## Land South of Chiswell Green Lane

Report  
Reference: BRD3604-OR1-C

Date: March 2022

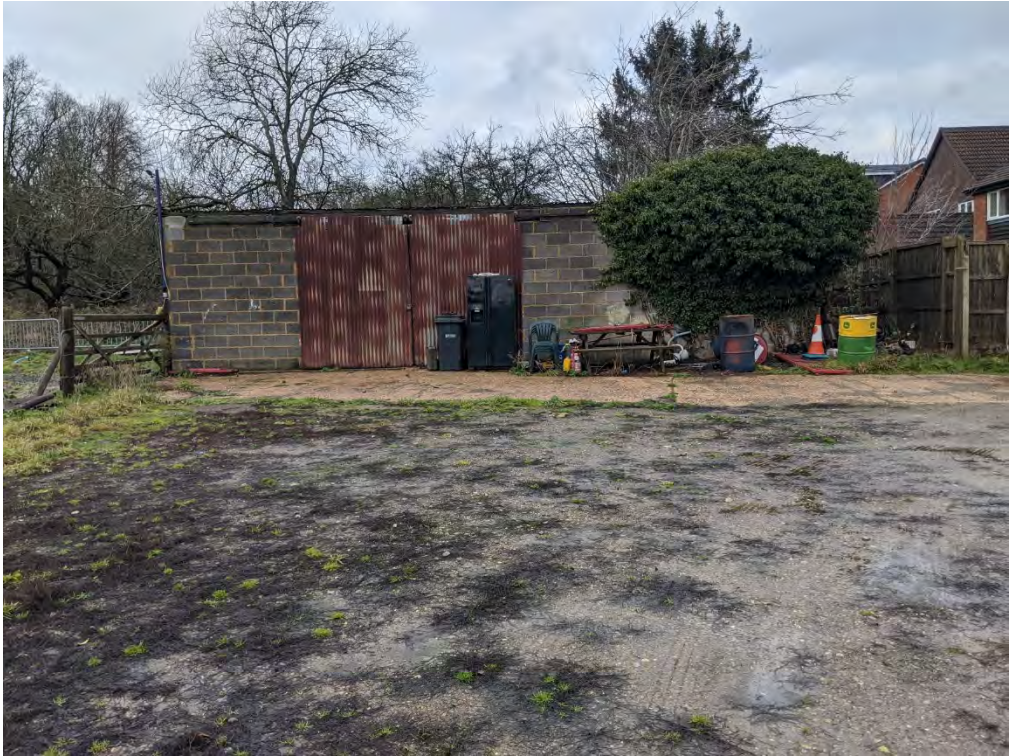
Plate 1: A breezeblock building with corrugated metal doors adjacent to the access way from Forge End on the eastern boundary.

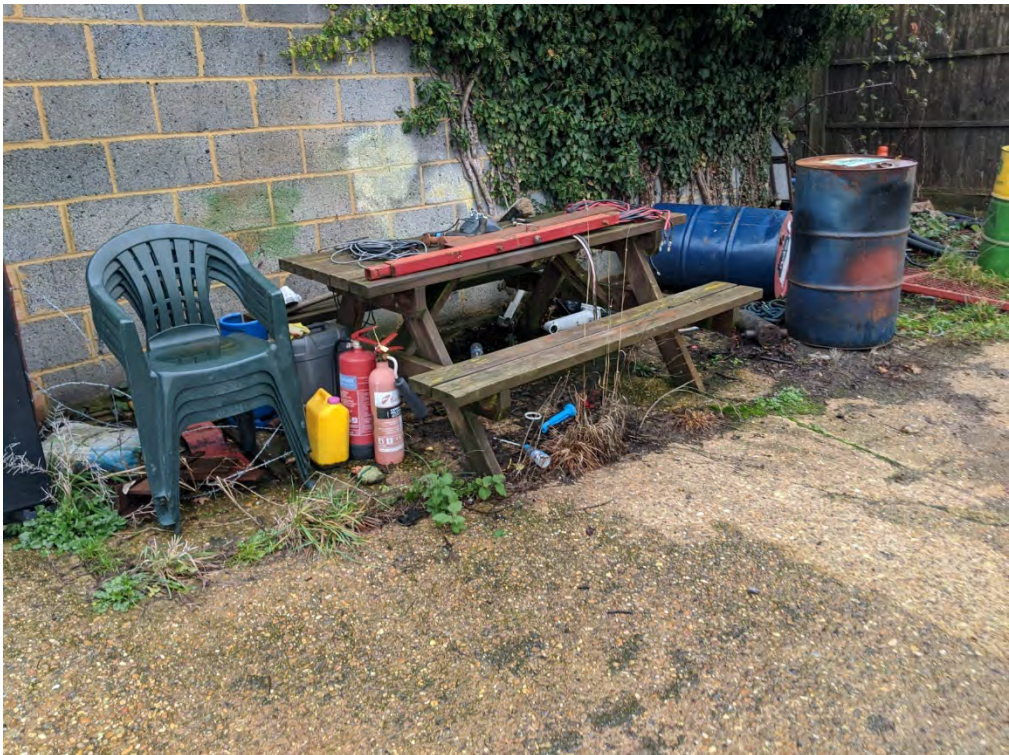
NOTABLE FEATURES AND OBSERVATIONS	<p>Waste materials, used oil / fuel barrels and canisters were observed around the breezeblock building located in the east of the site and further rubbish had been dumped in the southern section of the site, adjacent to the boundary with the northern section of the site.</p> <p>In the open area within the coppice in the southern section are several large metal storage containers. Building supplies, waste materials and an old mobile fuel tank were also noted within this area although this had been removed by the 2021 walkover. There is also a small pile of asbestos cement sheets resting upon a pile of stacked timber.</p> <p>In the south western part of the livery yard area (in the northern section) is a large muck pile and beyond this there is an 'L' shaped soil bund, although this is quite overgrown.</p> <p>In the farm yard section, it was noted that the barn buildings (where accessible) were used to store various equine equipment and feed.</p> <p>To the south west of the farmhouse is a concrete yard, which contained an old shipping container, an old enclosed lorry trailer, a skip, several bins and some piles of various waste including pallets, plastic and some old oil drums. However, there was no obvious signs of any spillages of fuel or chemicals.</p> <p>To the south of the old farmhouse is an old swimming pool which appeared to have been abandoned for several years. The water had been drained and the area had become heavily overgrown. The pool contained some fallen branches and garden waste but had not been backfilled with any soil or other waste. There is an adjacent small building accessed off the south westerly yard area and linked to the pool and this has frosted glass windows and may be a changing room or plant room. There is also a metal above ground fuel tank to the west of the pool on the edge of a heavily overgrown area adjacent to the paddock and this may have provided heating oil to power a boiler to heat the pool.</p>

Plate 2: Waste materials kept next to the building including fire extinguishers and empty fuel barrels.

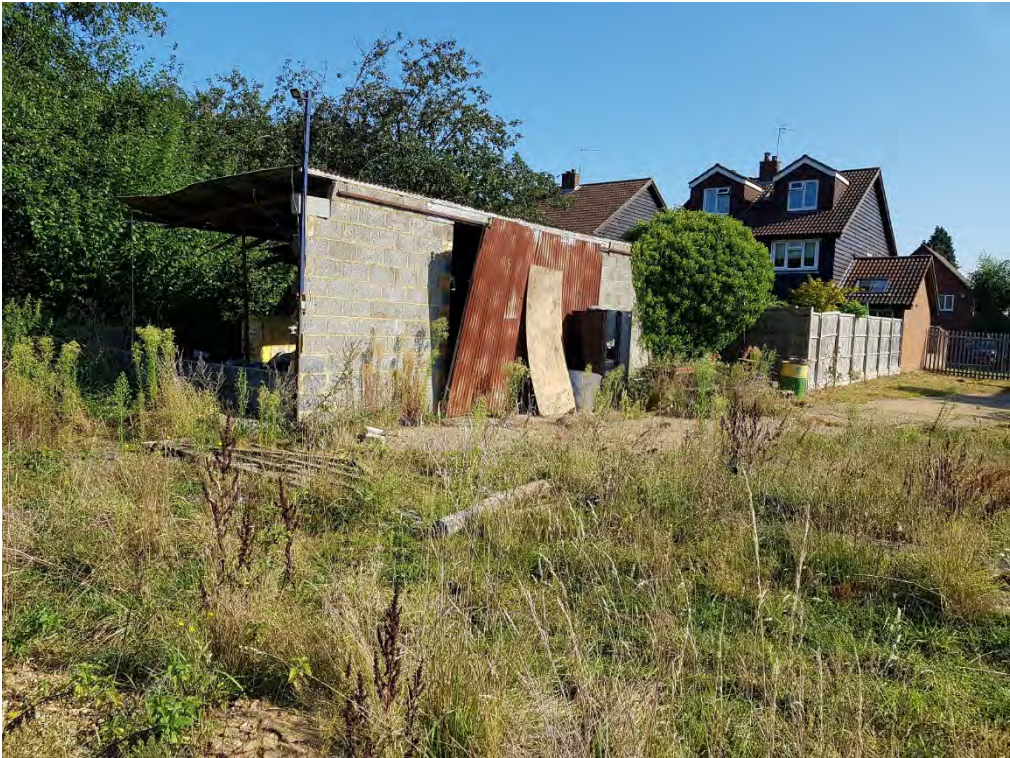
Plate 3: The northwest corner of the building is damaged and part of the roofing is has been removed.

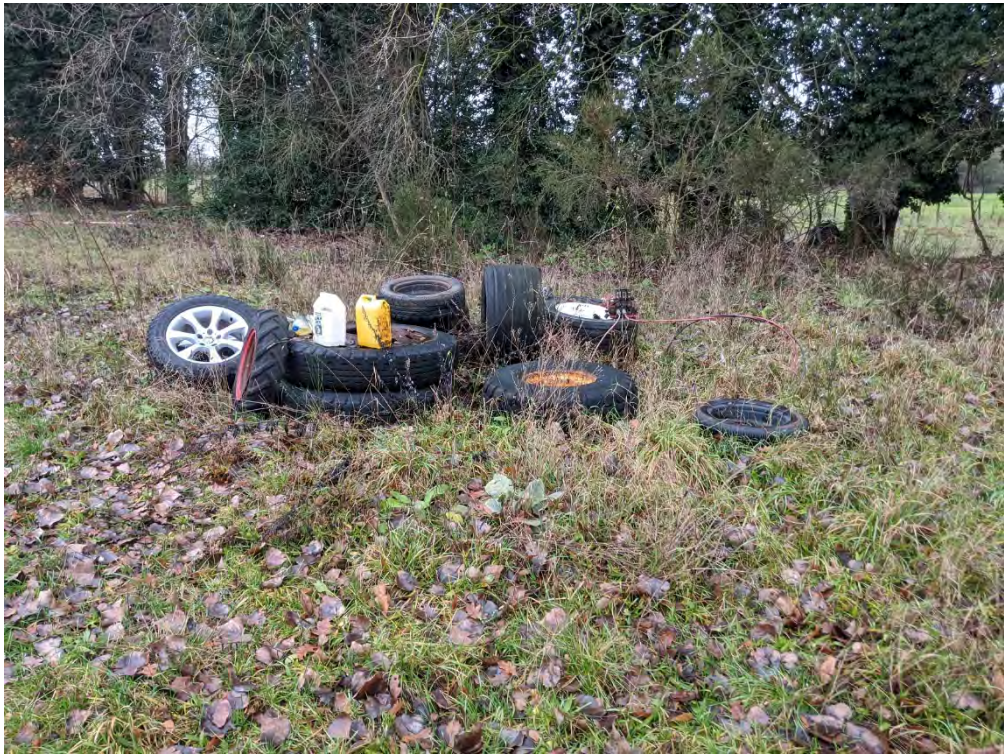
Plate 7: Several tyres and debris have been dumped in the southern area of the site.

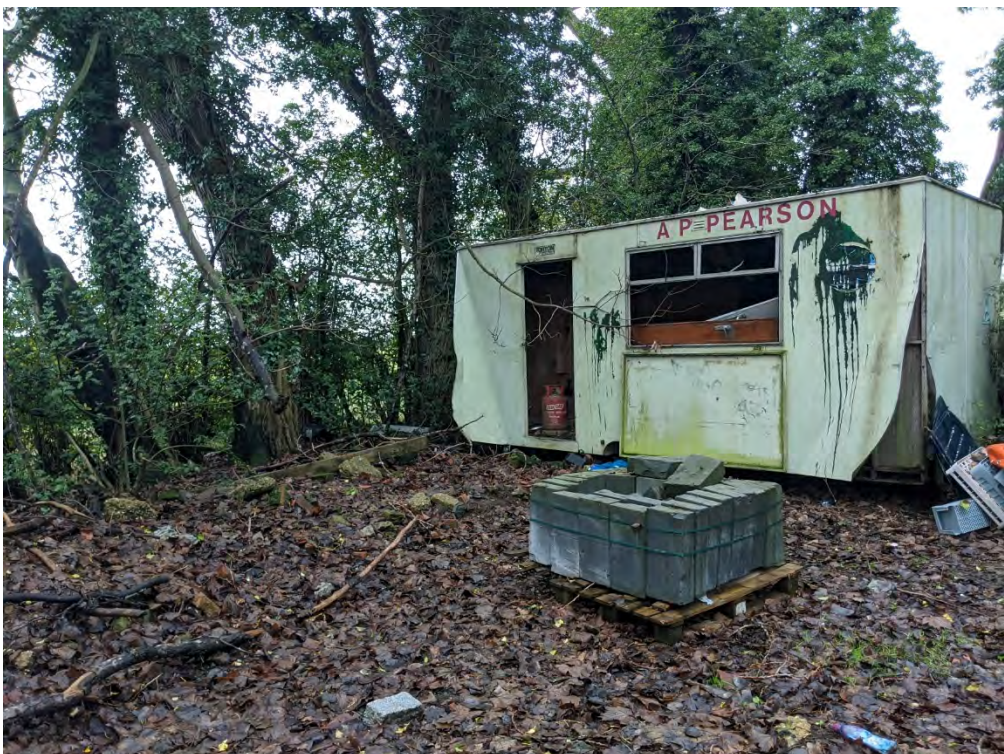
Plate 8: A unit previously used as a building contractors office, some building materials have also been left within this area of the site.

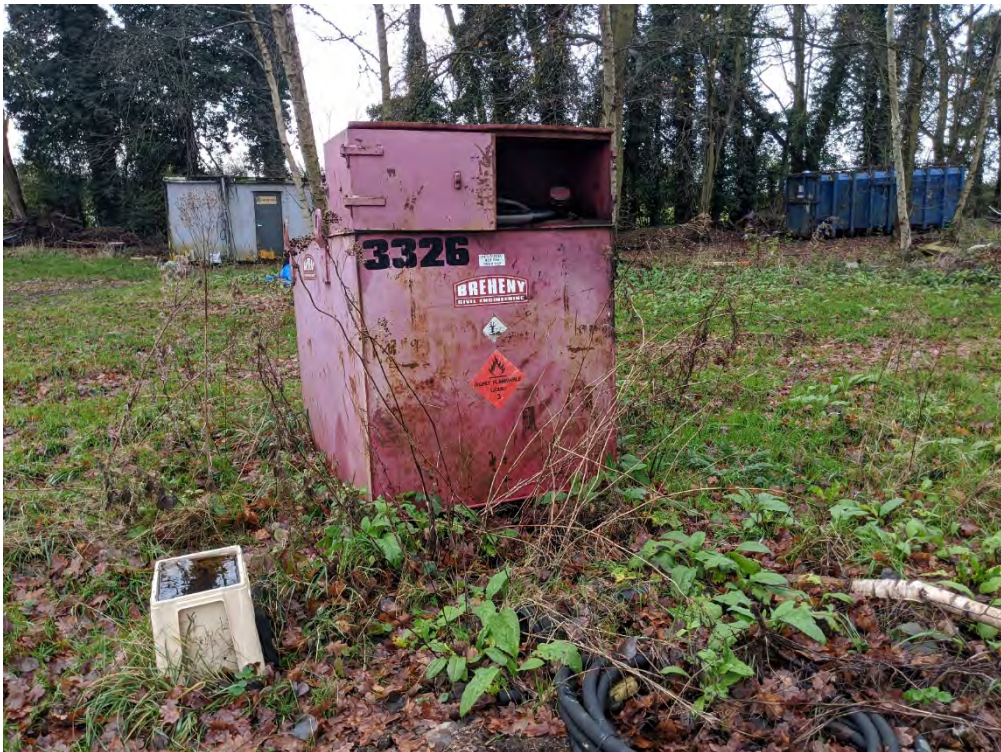
Plate 9: A fuel tank was previously located in the southern extent of the site and may have been previously used to fuel plant. Shipping containers etc can be seen in the background.

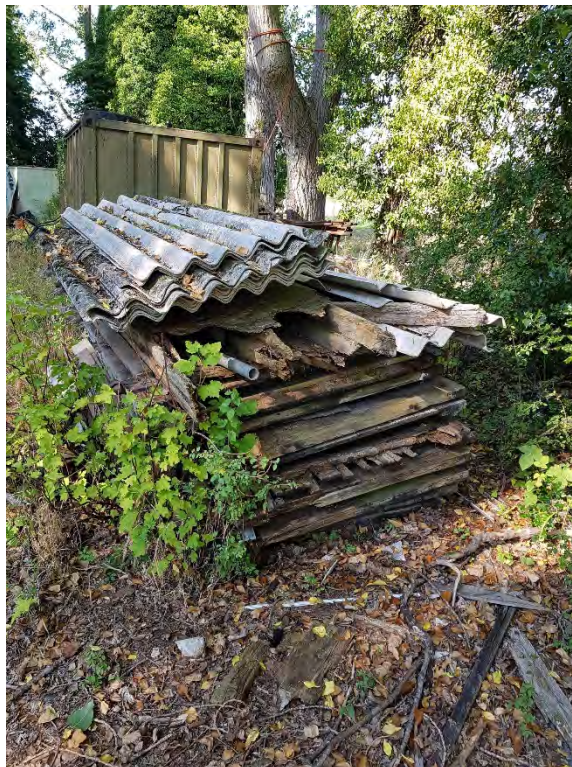
Plate 10: Stacked asbestos cement sheeting in the south eastern section of the site.

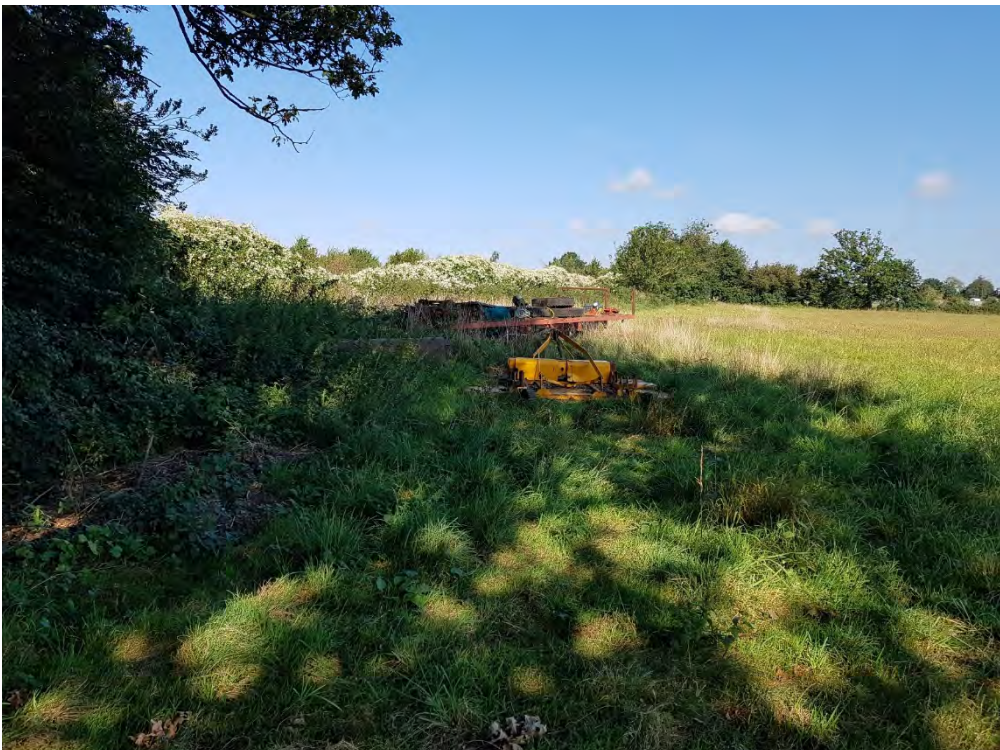
Plate 12: Along the south western boundary was a lorry with multiple bails of hay and a disused tractor. By the recent 2021 walkover, the lorry has since been removed but some agricultural machinery still remains.

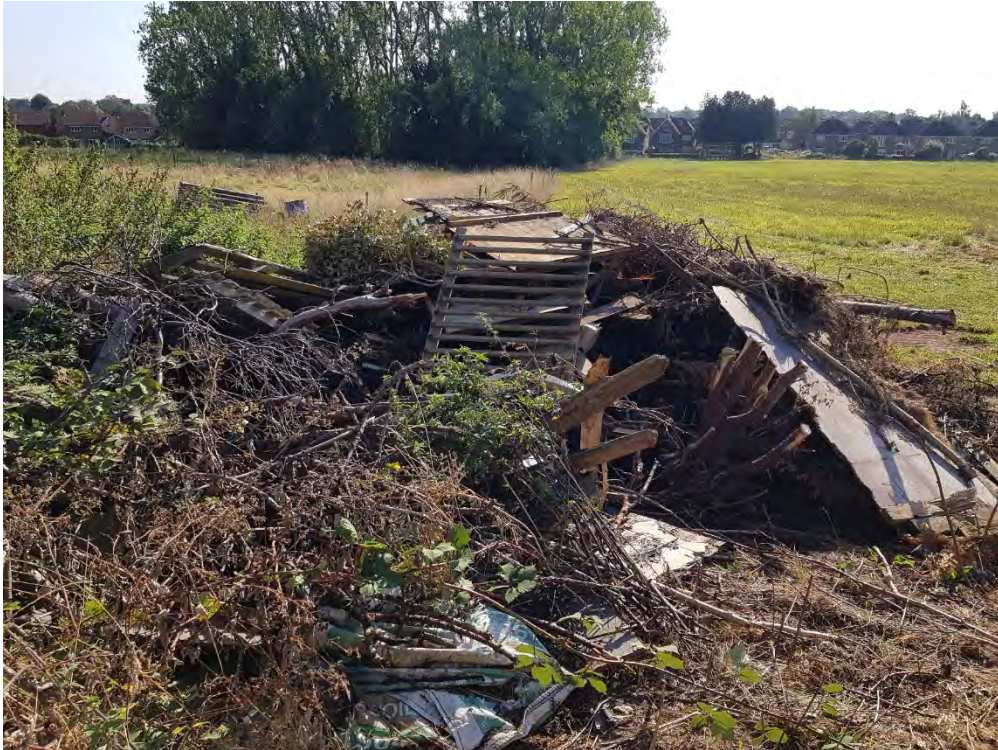
Plate 15: Along the southern fence line of the paddocks is a pile of cut branches adjacent to some dumped waste.

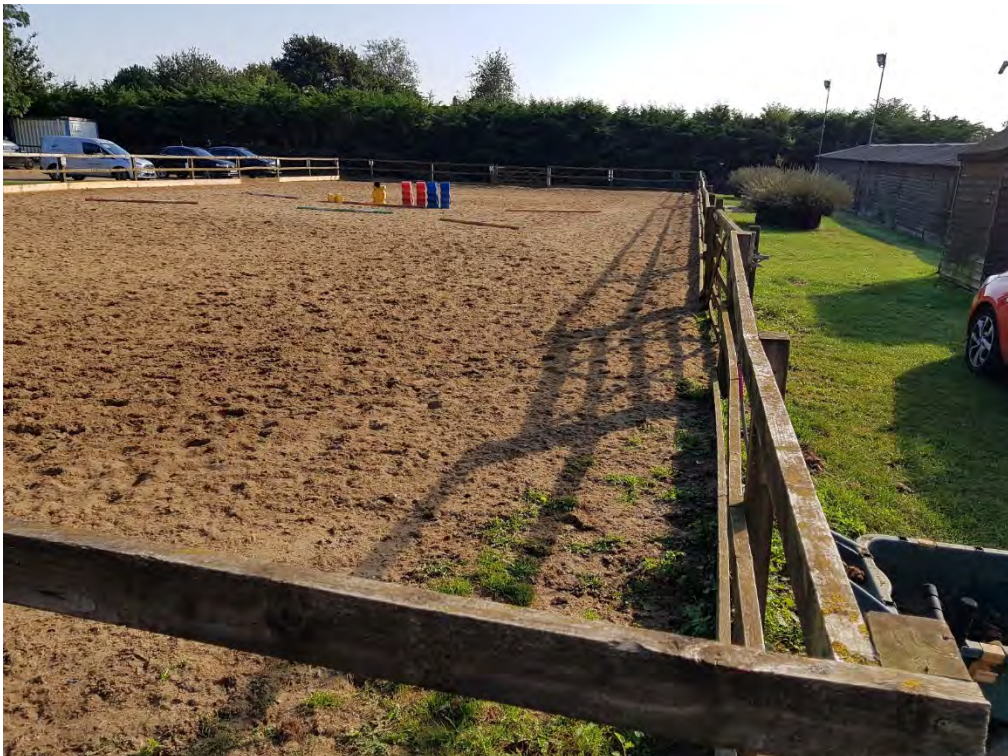
Livery yard - manège and soil bund	Manège surfacing can regularly contain recycled materials such as shredded tyres or rubber mixed with organic material or sand. The material can be layered up over the years resulting in older layers at the base. It has been known that these materials can contain elevated contaminants or materials unsuitable for re-use in a residential setting.  The soil bund is most likely made up of site derived soils, but could consist of imported waste soils which has the potential to contain hazardous substances / materials.	Metals. Polycyclic Aromatic Hydrocarbons (PAH).

Plate 18: Manège with parking area beyond.

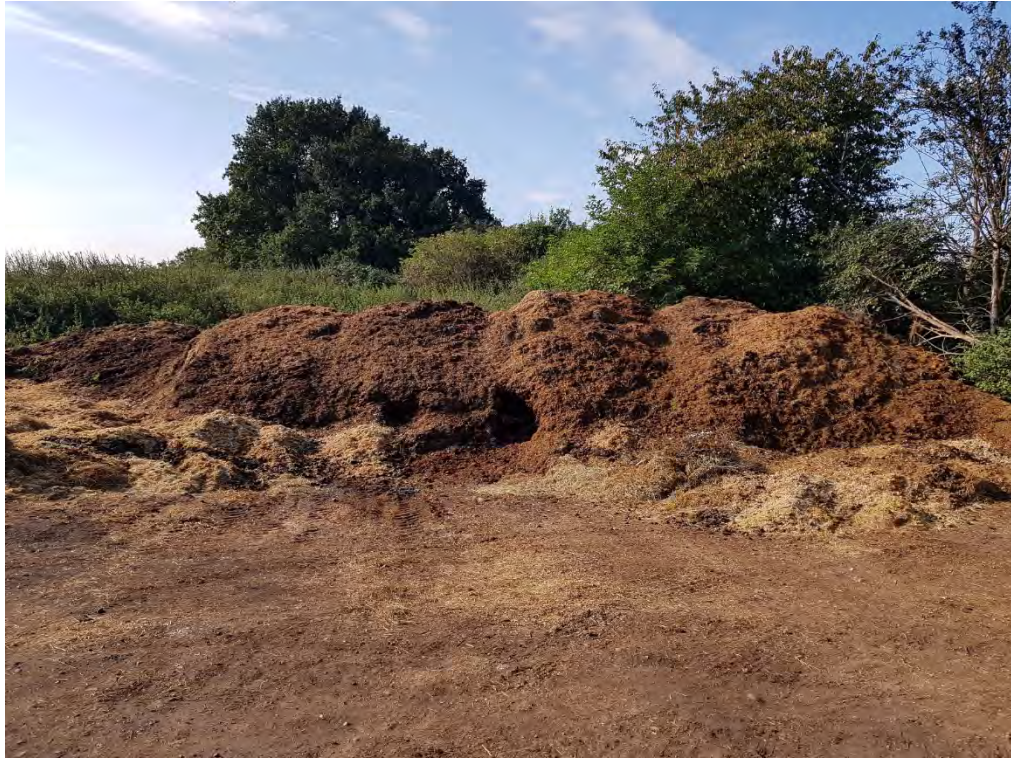
Plate 19: Muck heap with soil bund beyond.

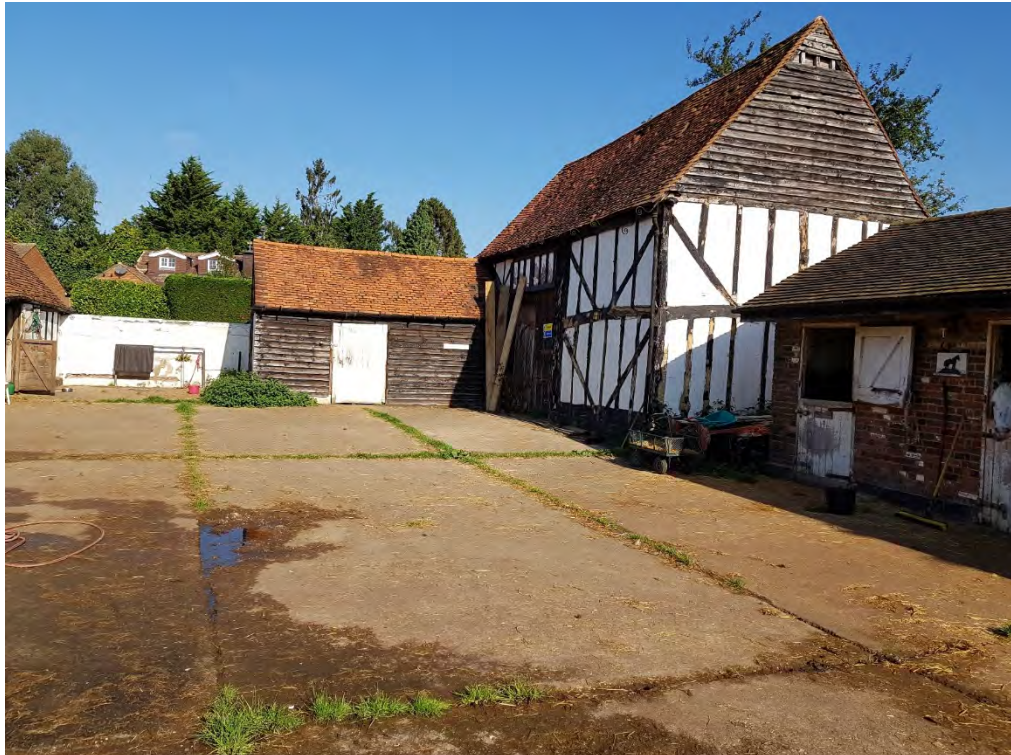
POTENTIAL ON SITE SOURCES		
HISTORIC LAND USE	DESCRIPTION OF POTENTIAL CONTAMINATION HAZARD	POTENTIAL CONTAMINANTS OF CONCERN
Farm yard in the north eastern section.	The farm in the northeast of the site appears to be a small holding however storage of plant machinery and/or a variety of chemicals in support of the agricultural operations is evident. Fuel may have been stored for the plant and therefore spilled. The small scale storage of potentially contaminative chemicals and lubricants is also common practice in farm operations and therefore can also be identified as a potential localised hazard. On site waste disposal activities and waste burning may have occurred with the potential to cause contamination by metals and Polycyclic Aromatic Hydrocarbons.	Petroleum hydrocarbons (diesel, lubricating oils, greases and/or petrol). Pesticides. Metals. Polycyclic Aromatic Hydrocarbons (PAH).
Localised dumping of waste materials.	Rubbish, used fuel containers and barrels were noted around the area of the breezeblock building, beside the eastern paddock and within the area utilised by the building contractor.  Where used fuel containers and barrels are present, spillages may have previously occurred.  Waste disposal activities and waste burning may have occurred with the potential to cause contamination by metals and Polycyclic Aromatic Hydrocarbons.	Petroleum hydrocarbons (diesel). Metals. Polycyclic Aromatic Hydrocarbons (PAH). Asbestos containing materials

Plate 22: Farm yard area with timber framed barns in the north eastern section.

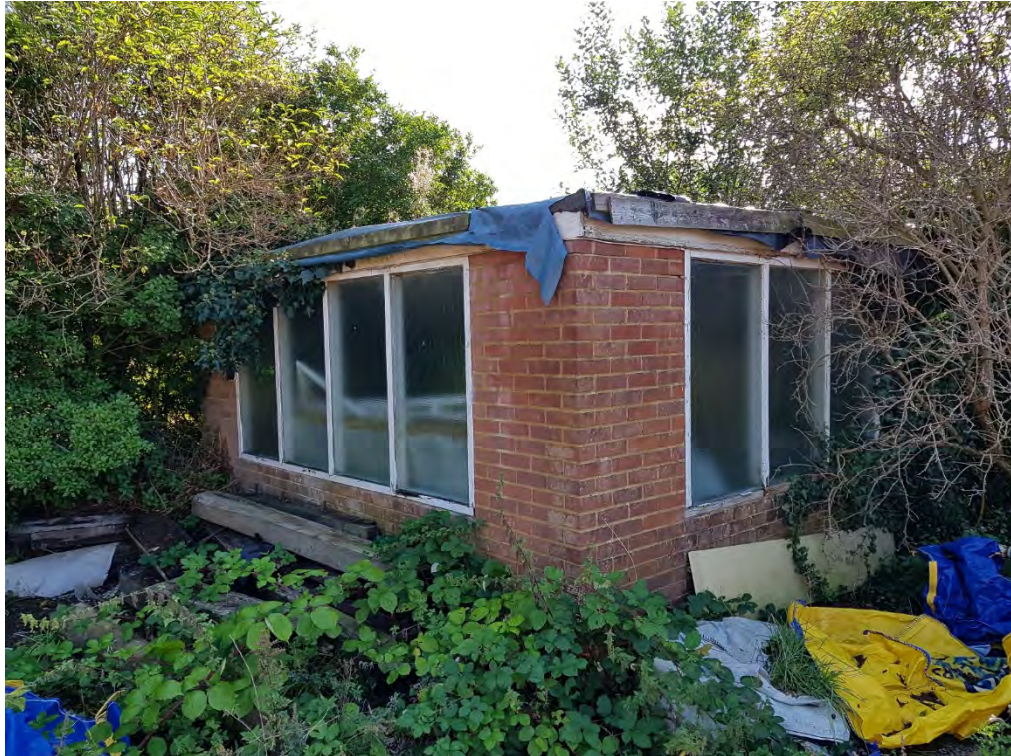
Plate 25: Possible boiler room or changing rooms for the former swimming pool.

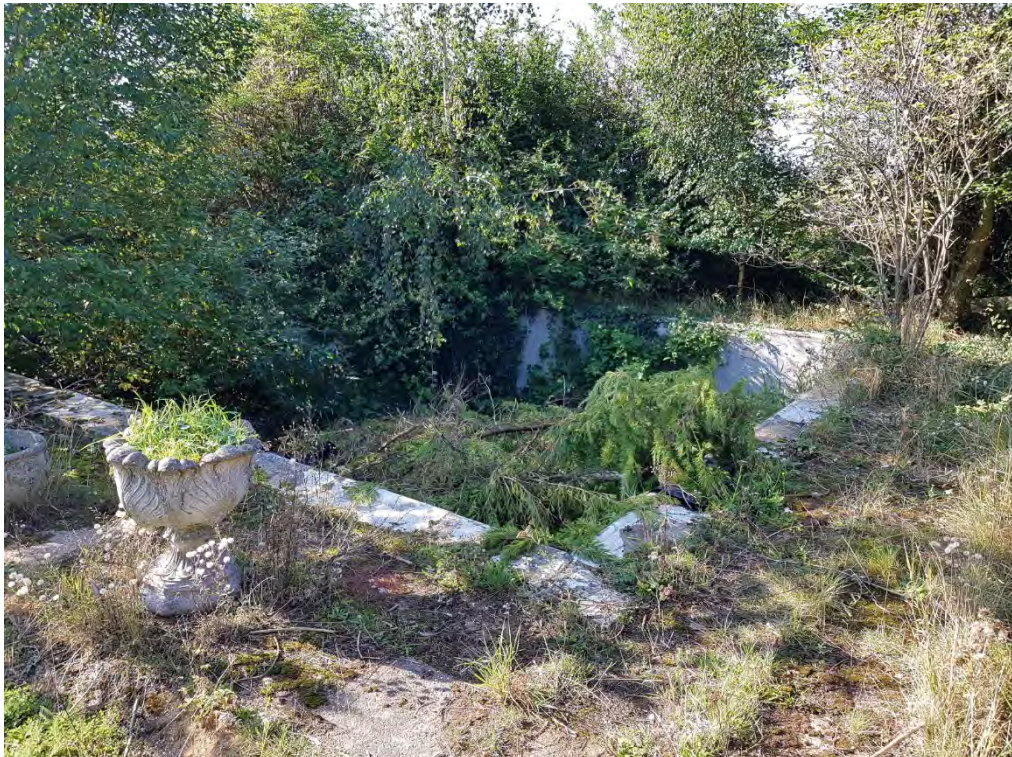
Several buildings are currently present on the site, and historically a few other buildings have been shown to be present primarily in the eastern area of the site before being demolished. Additionally, a disused swimming pool is present in the rear garden of the farm house. Complications to the design and construction of foundations may arise where removal of existing and historical structures has disturbed the subsurface.

Plate 26: Abandoned swimming pool partially filled with garden waste.

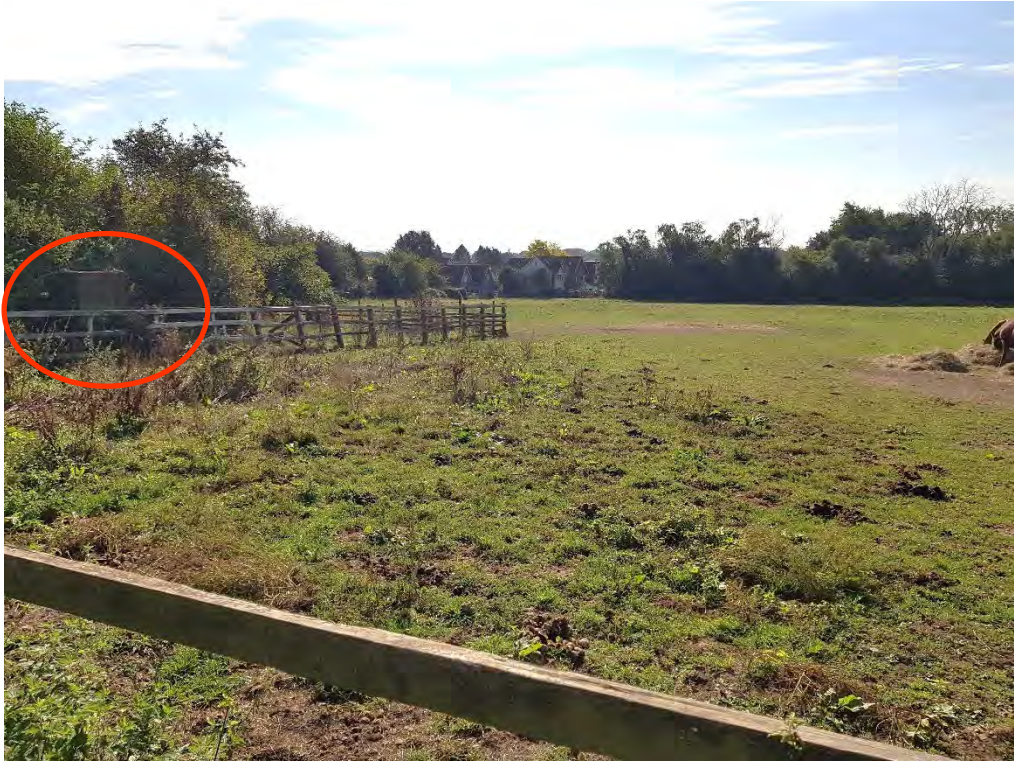
Plate 27: Adjacent paddock with oil tank beyond and swimming pool located in the overgrown area.
