## **Bat Emergence Surveys - *Full Report***

**Land south of Chiswell Green Lane, St  
Albans, Hertfordshire**

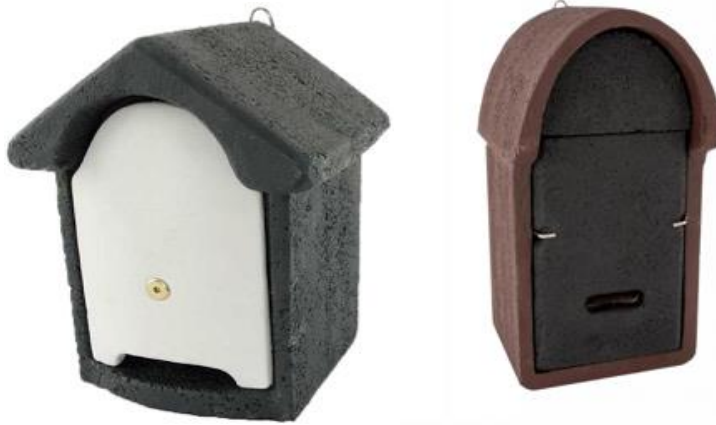
*Figure 6: Vivara Pro WoodStone Bat Box (left) and Large Multi Chamber WoodStone Bat Box (right)*

- Vivara Pro WoodStone Bat Box – A general purpose bat box that supports a range of species (Figure 6). These can be hung on trees in a variety of heights and aspects in order to provide a variety of micro-climates.
- Large Multi Chamber WoodStone Bat Box – This is a multipurpose box designed for larger colonies and a range of bat species including pipistrelles, noctules and brown long-eared bats. These should be hung on mature trees around the site (Figure 6).
