Scale at A1	Project Number
1:250	2219-2436

Project
**Land West of Watling Street
 St Albans**

Title
**Existing Ground Level Survey
 Sheet 3**

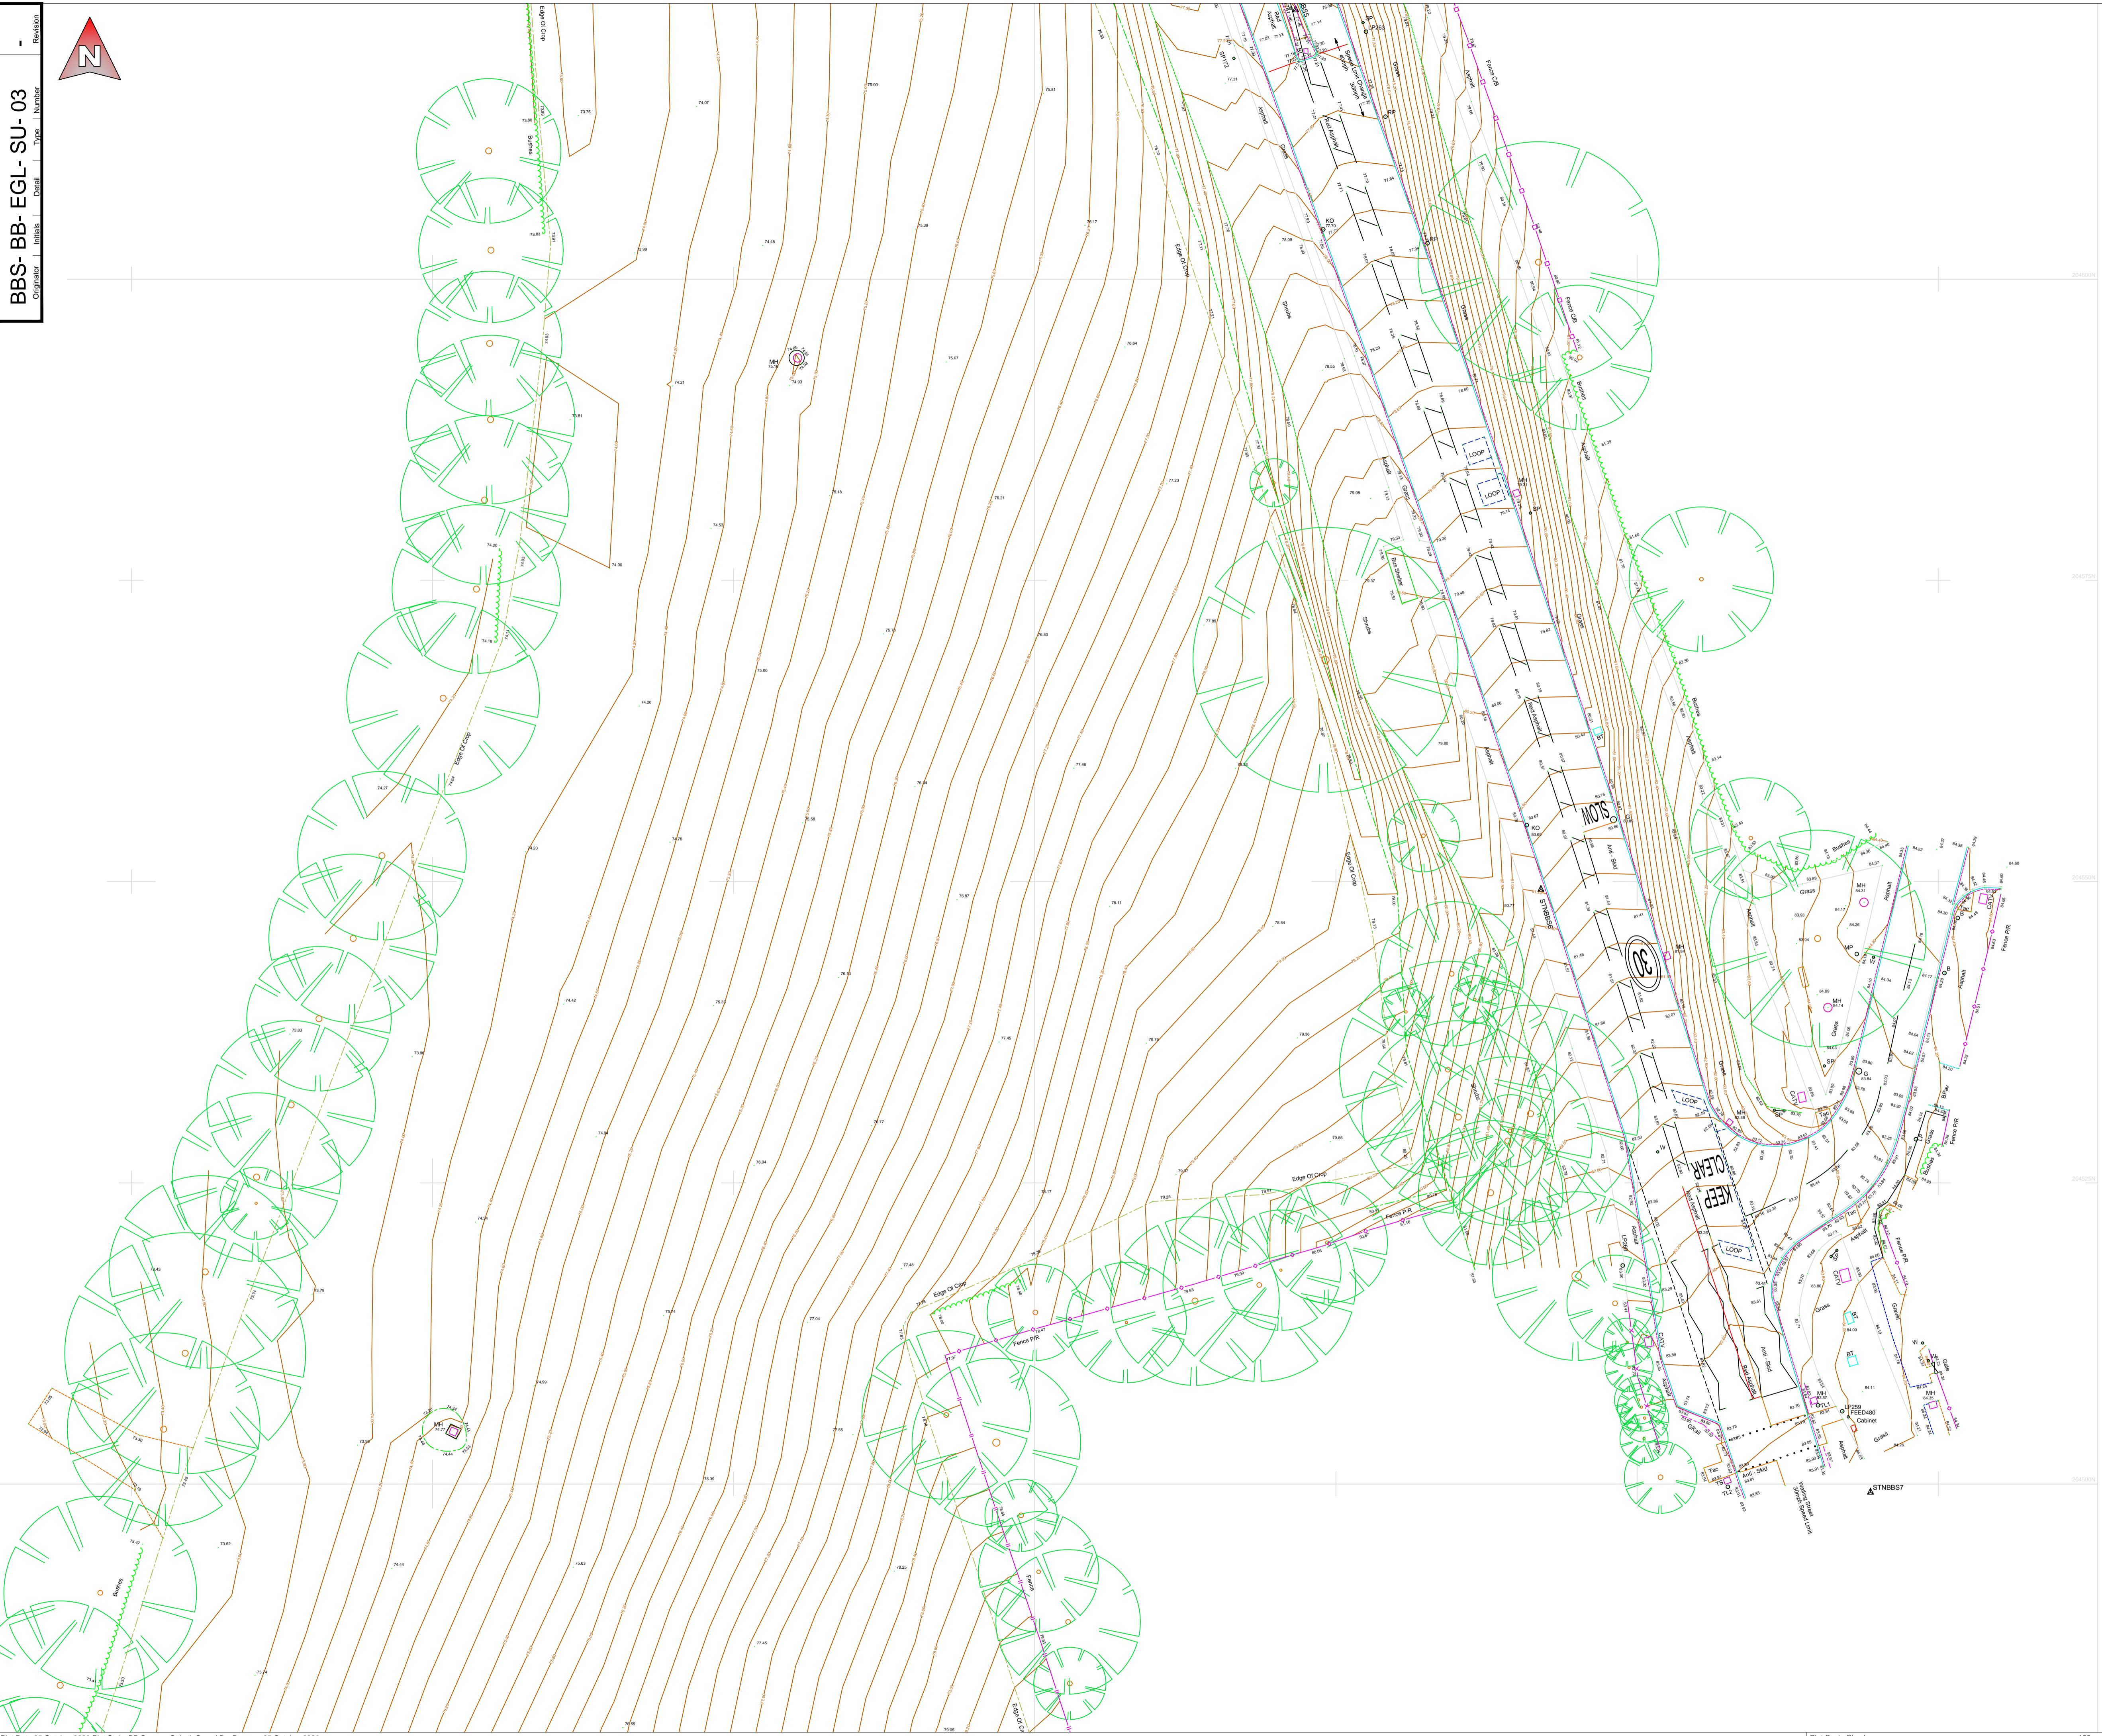
SURVEY CARRIED OUT USING TRIMBLE S6 TOTAL STATION & TRIMBLE R10 GPS.

THE SURVEY HAS BEEN ACCURATELY POSITIONED ON THE ORDINANCE SURVEY NATIONAL GRID SYSTEM USING GPS OBSERVATIONS TO THE OS ACTIVE NETWORK AND THE LATEST ORDINANCE SURVEY TRANSFORMATION (OSTN15/OSGM15).

ALL LEVELS RELATE TO ORDINANCE SURVEY DATUM (NEVLYN). VERTICAL CONTROL HAS BEEN ESTABLISHED USING GPS OBSERVATIONS TO THE OS ACTIVE NETWORK AND THE LATEST ORDINANCE SURVEY TRANSFORMATION (OSTN15/OSGM15).

NO ATTEMPT HAS BEEN MADE TO ENTER ANY CONFINED SPACES ON THIS SITE. WE HAVE MEASURED INVERT DEPTHS, ESTIMATED PIPE SIZES AND SHOWN THE DIRECTION OF FLOW ONLY WHERE DRAIN RUNS ARE ACTIVE AT THE TIME OF SURVEY. INSPECTION COVERS WHICH WE WERE UNABLE TO LIFT BY MANUAL METHODS ARE DENOTED AS MH (UTL). WE DID NOT QUOTE FOR THE USE OF HYDRAULIC LIFTING EQUIPMENT.

DRAINAGE RUNS BETWEEN INSPECTION COVERS HAVE NOT BEEN INVESTIGATED. ANY SHOWN ARE ESTIMATED AND NOT CONFIRMED. ALL DRAINAGE RUNS SHOULD BE PROVED BY DYE TRACING AND IF NECESSARY BY RADIO DETECTION METHODS PRIOR TO ANY DESIGN WORK. ALL PIPE SIZES AND CONNECTIONS SHOULD ALSO BE CONFIRMED WITH YOUR LOCAL DRAINAGE AUTHORITY PRIOR TO ANY DESIGN WORK.
