Land West of Watling Street, Park Street, Hertfordshire

Stage 1 Road Safety Audit
M Scott Properties Ltd

October 2023

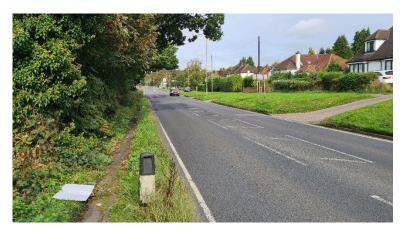
The drawings show a 2m wide footway to the north of the access and 3m wide cycleway to the south of the access are proposed. During the site visit it was noted that at the proposed access location, the existing footway is a very narrow track as shown in Figures 2-1 and 2-2 below.

Figure 2-1 - View of the narrow footway to the north of the proposed access

There is a considerable amount of vegetation at ground level and low hanging branches which could pose a hazard to pedestrians and pedal cyclists using the route with a risk of pedestrians tripping over or cyclists falling from their bikes. There is also a risk of users of the footway spilling into the carriageway, increasing the risk of collisions with road users.

It is recommended that vegetation clearance is undertaken to the north of the proposed access, extending to the existing section of clear footway, and to the south of the access to allow a clear route to the existing bus stop.

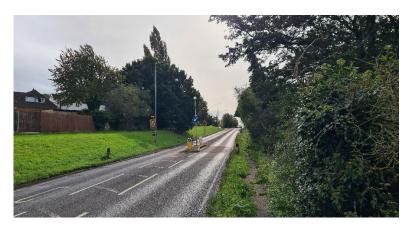
Figure 2-2 - View of the narrow footway to the south of the proposed access
