Report prepared for: Brian Parker

For the Site of: Bricket Lodge Sport and Country Club, Lye Lane, Hertfordshire AL2  
3TF

# Ecological Appraisal (EA)

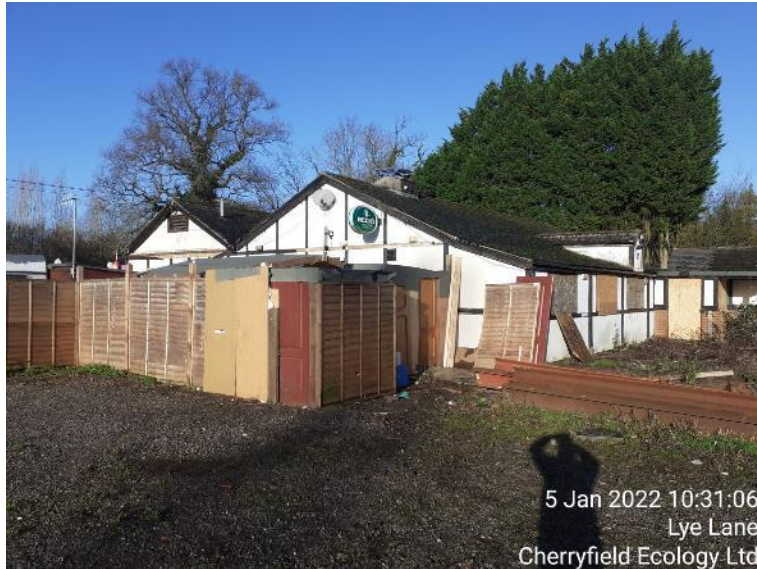
- The site provides **negligible** potential for badger due to the lack of suitable habitat and limited connectivity to more suitable habitats.
- **Bat presence is confirmed** through dropping evidence that was found in Loft Space 1 of **B1**. Furthermore, open access was found at multiple points across the building including through an air vent and broken windows and in addition, potential roosting features found between the roof tiles across the roof of **B1**. Due to the aforementioned access points and roosting features B1 is considered to have **high** potential.

Figure 2: Front elevation of B1

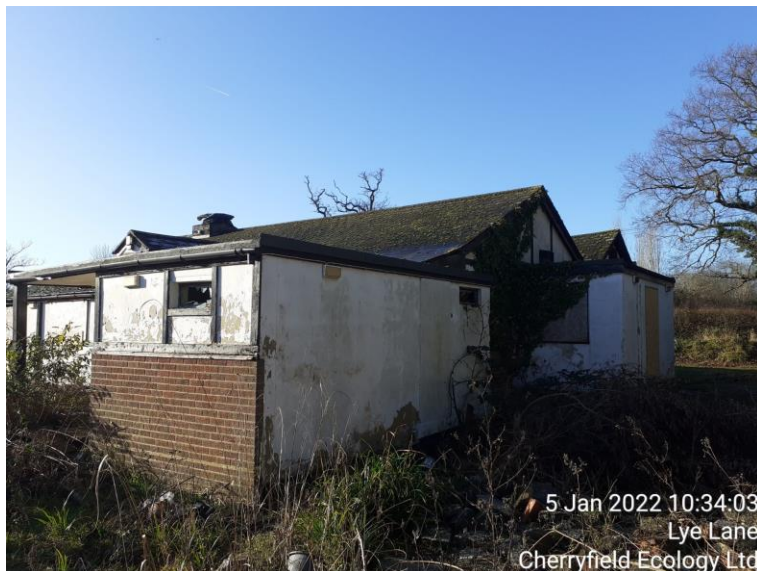
Figure 3: Rear elevation of B1

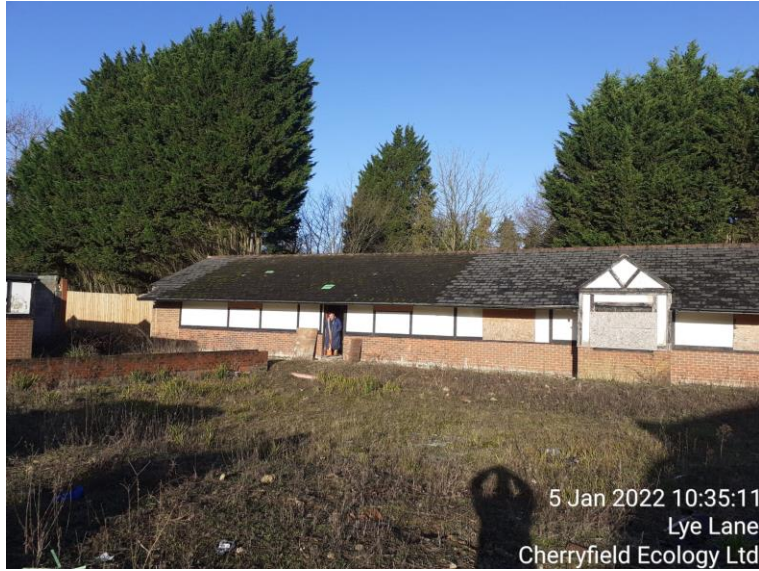
- The buildings **B2** and **B8** provide **low** potential for bats due to limited gaps and access/exit points under the eaves and between loose roof tiles.

Figure 4: Front elevation of B2

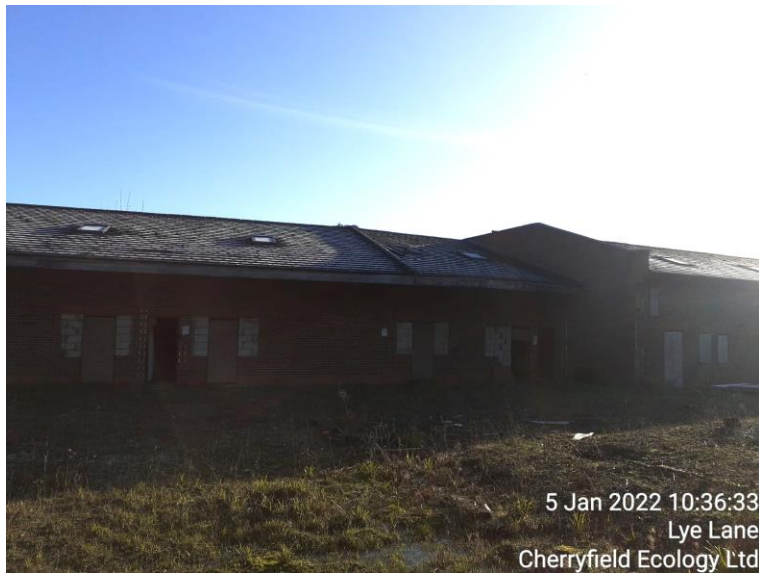
- The building **B3** provides **moderate** potential for bats due to numerous gaps and access/exit points under the ridge tiles, within the external brick wall, and through broken windows found across this building.

Figure 5: Front elevation of B3

**B3 - Presence/likely absence surveys** will be required (two surveys, at least two weeks apart), four surveyors will be required to cover building **B3**; one of these surveys must be undertaken between May to August. If bats are found to be using B3, one further survey will be required.

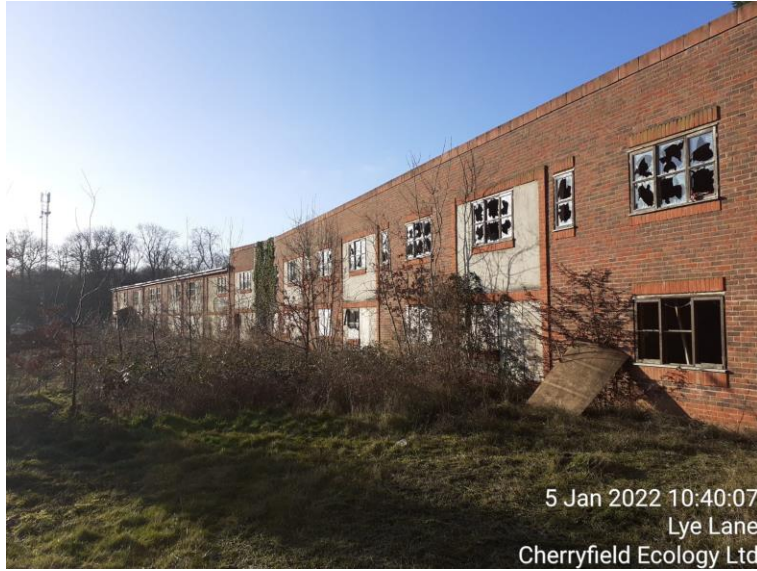
Figure 6: Rear elevation of B3

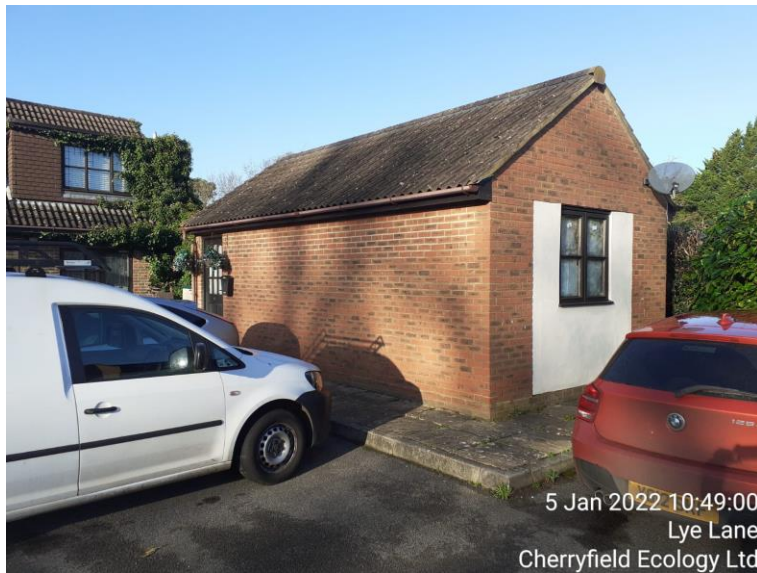
B8 is a brick-built single-storey residential building with an open gable roof structure. The roof has overhanging eaves, interlocking concrete roof and concrete ridge tiles. Timber weatherboards and soffits are also present. B8 also has plastic rainwater goods.

Figure 11: Front elevation of B8

cover building **B8**; this survey must be undertaken between May to August. If bats are found to be using B2 and/or B8, two further surveys will be required.

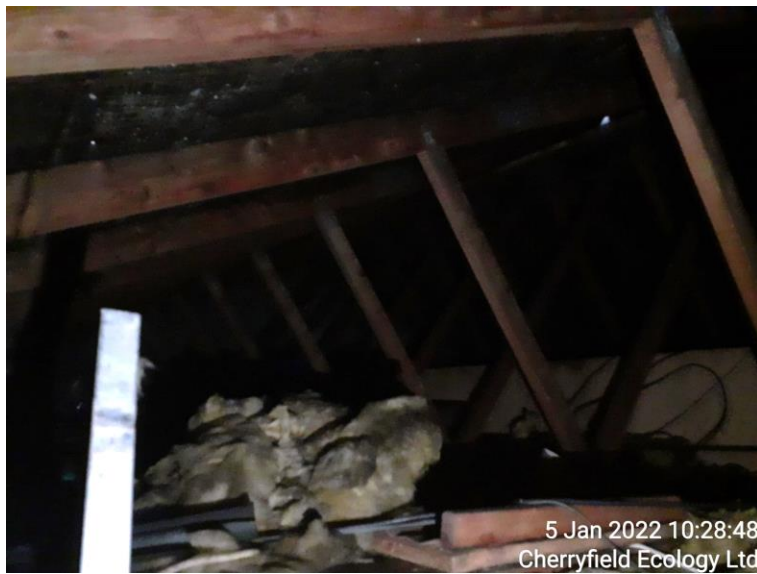
Internally, B1 has two loft spaces (Loft Space 1 and Loft Space 2). Both loft spaces have a king post beam structure. The underside of the roof of Loft Space 1 was fully lined with sarking boards. The underside of the roof of Loft Space 2 is lined with bitumen felt. The floor of both loft spaces was lined with insulation and boards which have significant damage due to flooding.

Figure 14: Loft Space 2 of B1

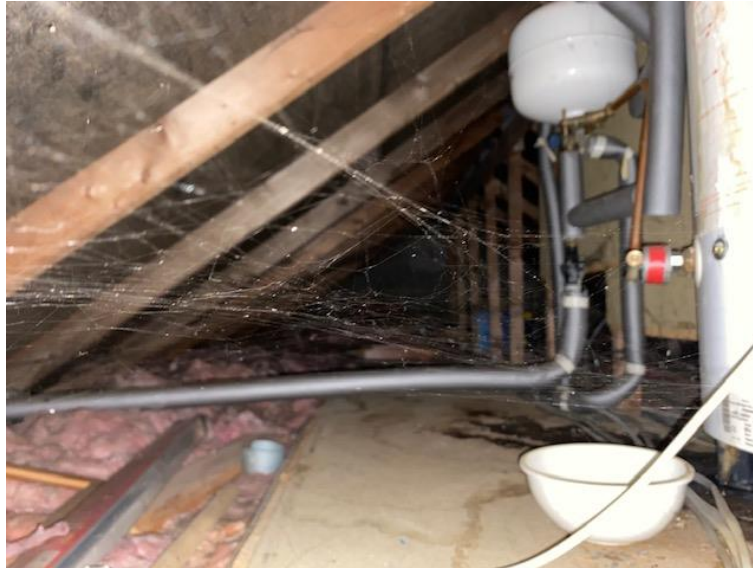
Figure 19: Example of a loft space within B8

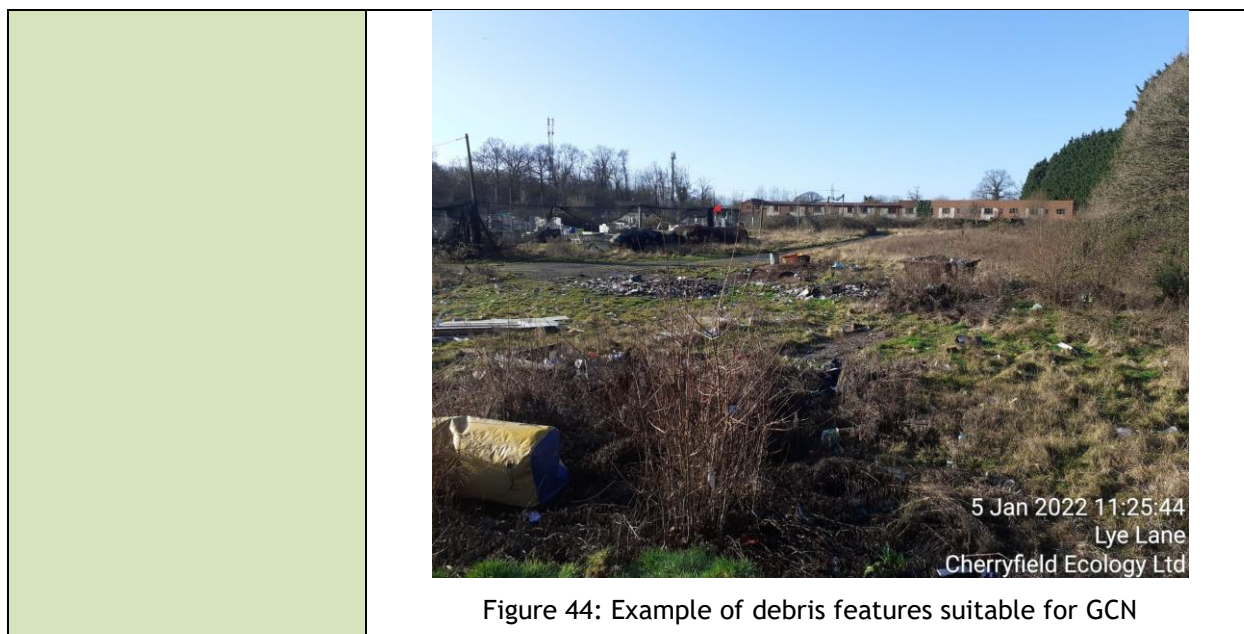
Amphibians found	No Great Crested Newt (GCN) were found at the time of the survey.
Evidence of amphibian use	No evidence of GCN was found at the time of the survey.
Potential for amphibian use	<p>Level of likelihood of presence - Low.</p> <p>The log piles and debris features found on site provide potential refugia habitat for GCN. In addition, some of the other terrestrial habitat on site also has low potential for GCN, but it should be noted that there are no nearby water bodies in the immediate vicinity of site. The closest water body to site is located 750m south-east, however, this is separated from site by both the M25 motorway and low-density urban sprawl.</p> <div data-bbox="613 867 1365 1432" data-label="Image">   <p>5 Jan 2022 11:16:57 Cherryfield Ecology Ltd</p> </div> <p>Figure 43: Example of log piles suitable for GCN</p>

Figure 44: Example of debris features suitable for GCN

**GCN** - No further survey is necessary. A qualified ecologist will be required to supervise the clearance, via a destructive search, of potential hibernacula such as the log piles and debris on site. If GCN are found all works must stop and advice sought from a qualified ecologist.

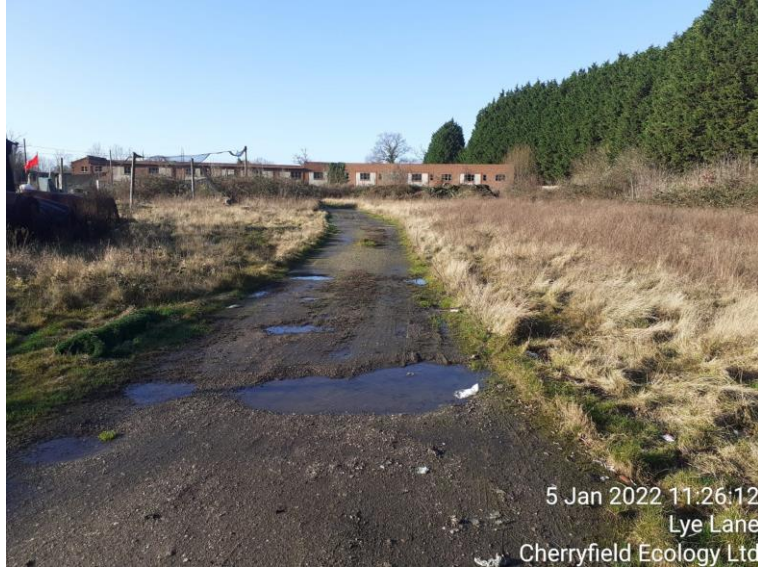
Reptiles found	No reptiles were found at the time of the survey.
Evidence of reptile use	No evidence of reptiles was found at the time of the survey.
Potential for reptile use	Level of likelihood of presence - High.  The scrub, tall ruderal, bare ground, improved grassland and hedgerow habitats found on site form a mosaic which is known to be used by common reptile. Additionally, the log and debris piles also found on site have the potential to act as hibernaculum.

Figure 45: Example of bare ground and improved grassland suitable for reptiles

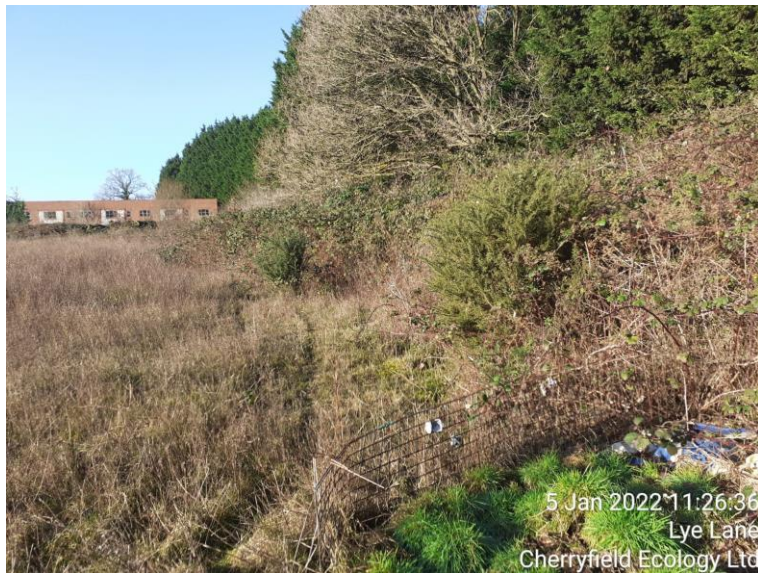
Figure 46: Example of tall ruderal, scrub and hedgerow suitable for reptiles
