Groundsure Geoinsight

Address: TOWNSEND NURSERY, 96, TOWNSEND LANE, HARPENDEN, AL5 2RH
Date: Aug 3, 2015
Reference: GS-2321708
Client: Geo-Environmental Investigations

Aerial Photograph Capture date: 21-Sep-2006
Grid Reference: 512248,214432
Site Size: 10.68ha

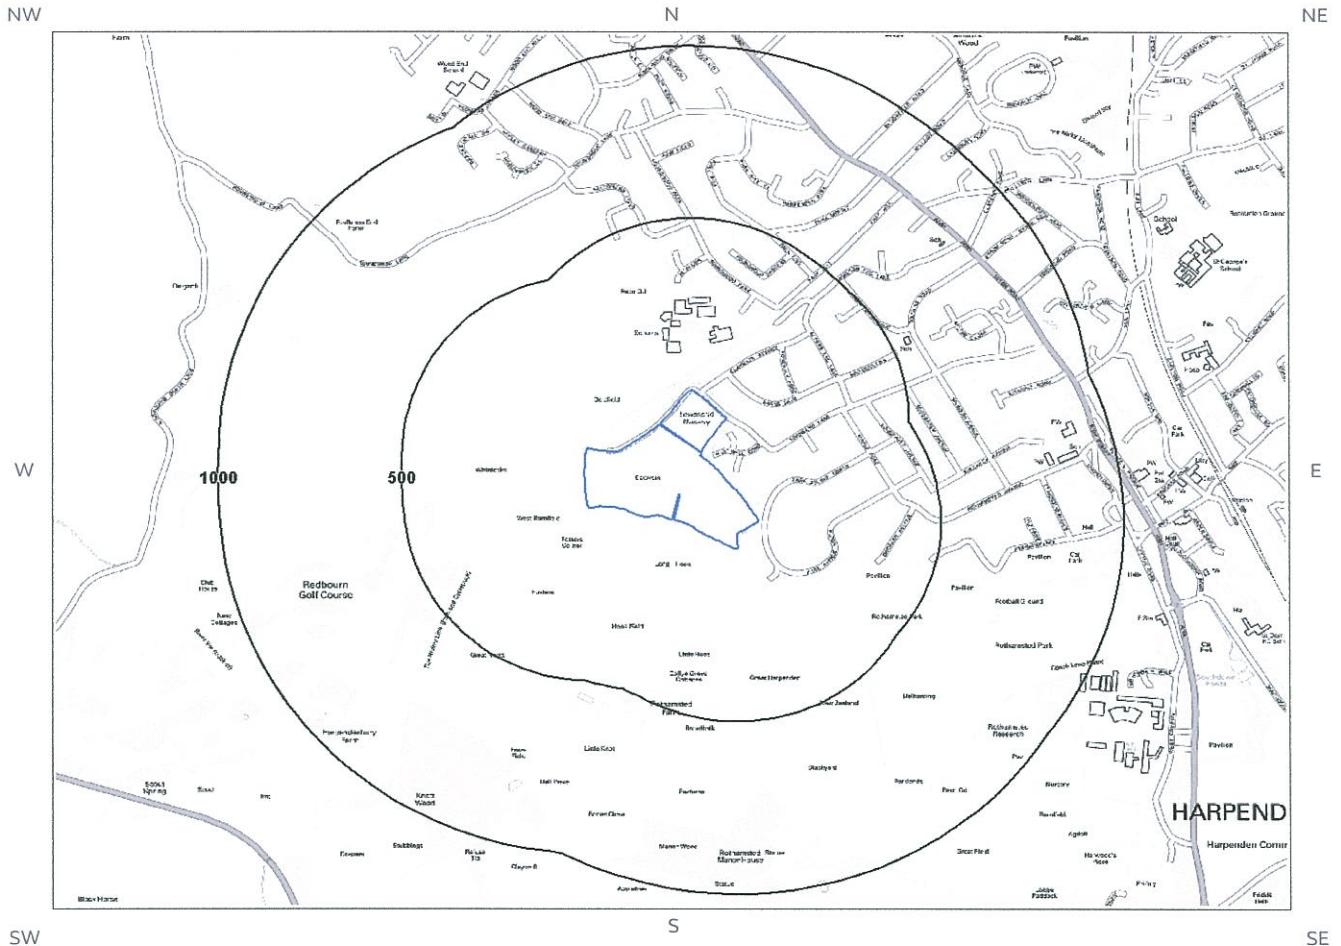
1.1 Artificial Ground Map

Are there any records of Artificial/Made Ground within 500m of the study site boundary? No

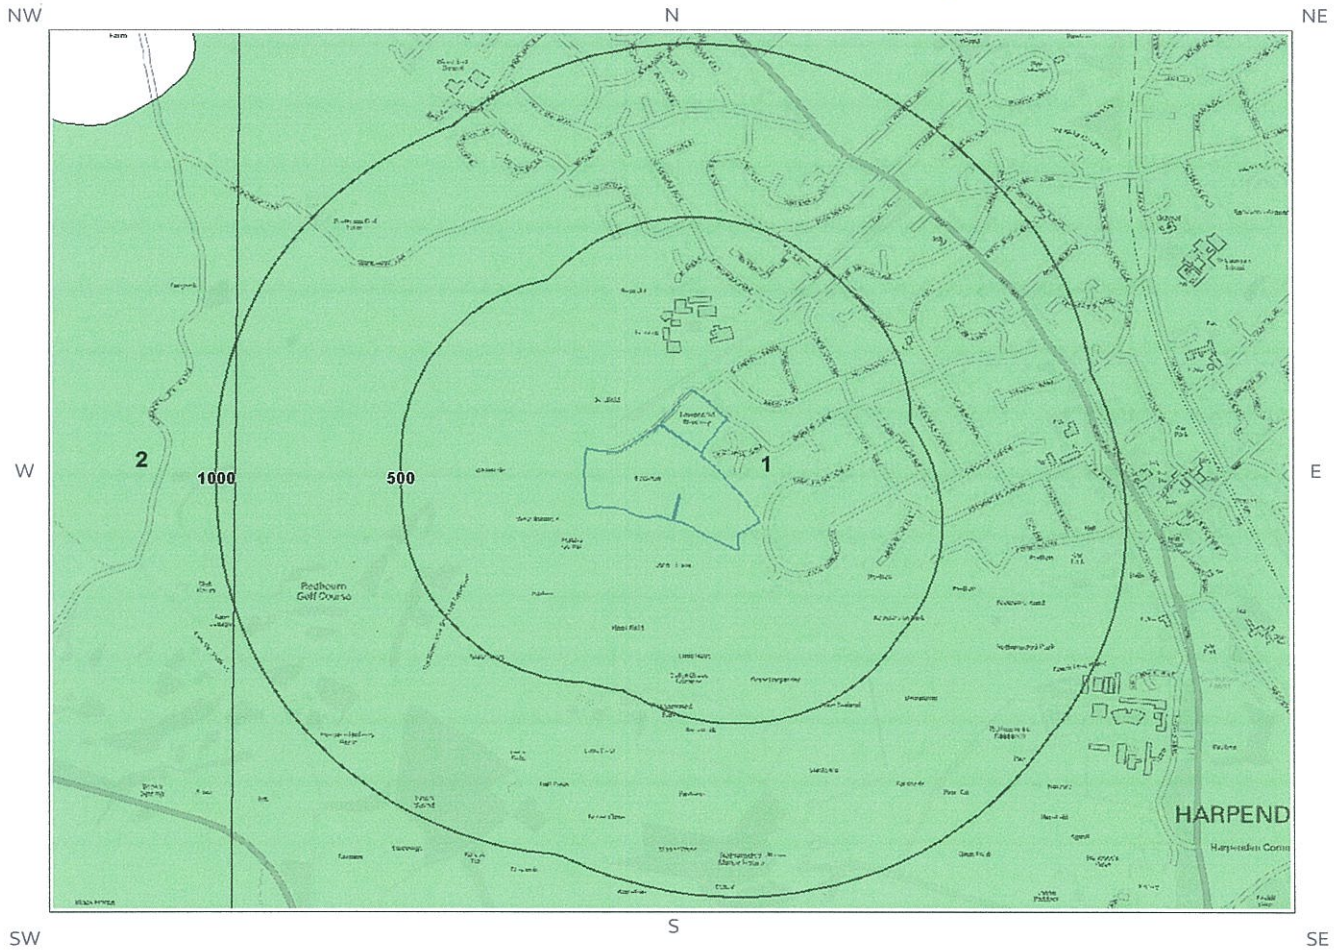
1.3 Bedrock and Faults Map

ID	Distance (m)	Direction	LEX Code	Description	Rock Age
1	0.0	On Site	LESE-CHLK	Lewes Nodular Chalk Formation And Seaford Chalk Formation (undifferentiated) - Chalk	Santonian / Turonian

Distance (m)	Direction	Flow Type	Maximum Permeability	Minimum Permeability
0.0	On Site	Fracture	Very High	Very High

Are there any records of Faults within 500m of the study site boundary? No

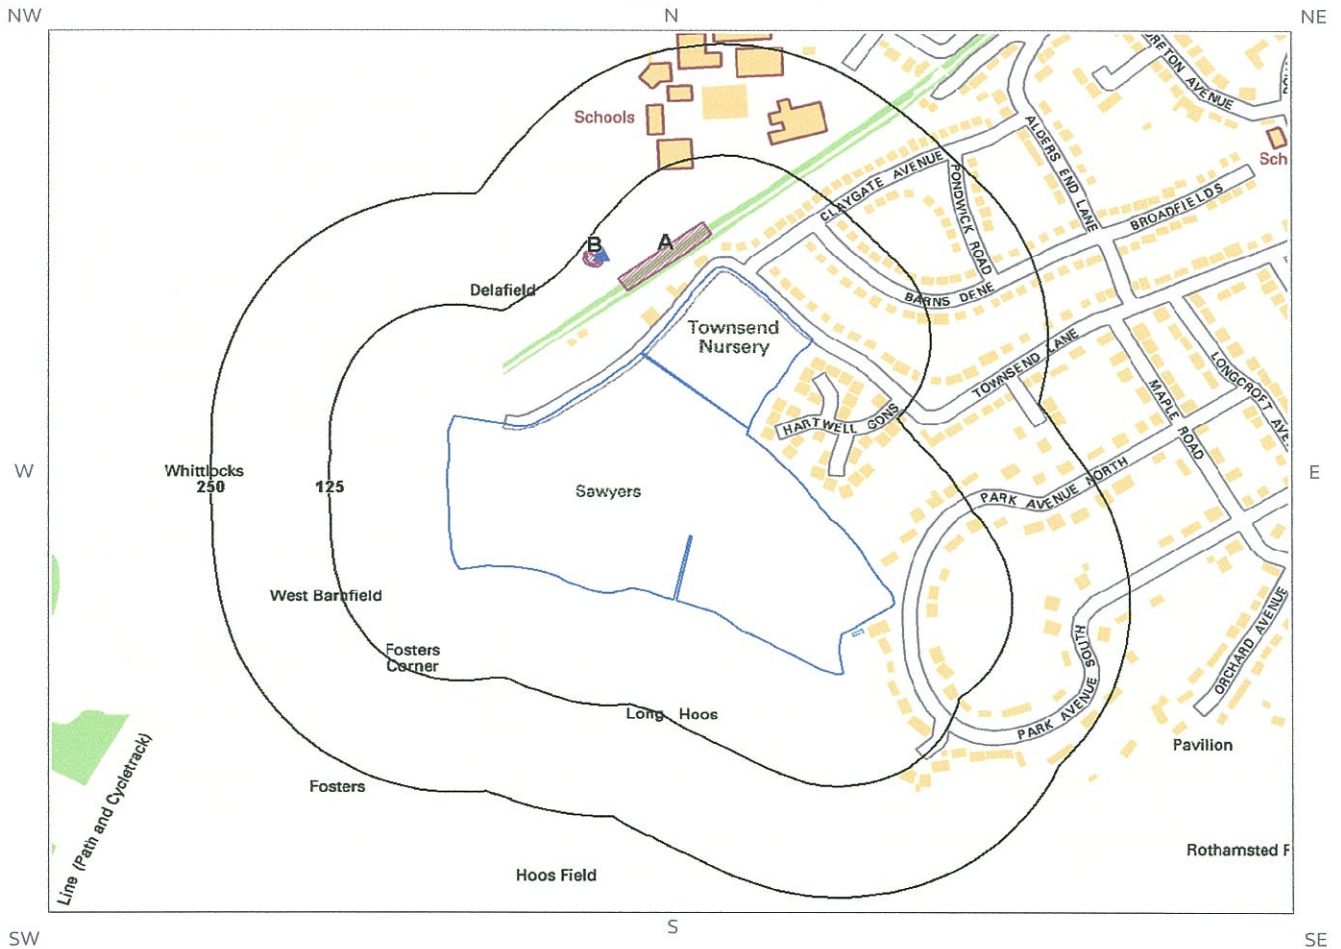
2 Ground Workings Map

ID	Distance (m)	Direction	NGR	Use	Date
1A	33.0	NW	512173 214553	Cuttings	1922
2A	33.0	NW	512173 214553	Cuttings	1878
3B	97.0	NW	512098 214550	Gravel Pit	1899
4B	97.0	NW	512098 214550	Unspecified Pit	1922
5B	97.0	NW	512098 214550	Unspecified Pit	1878
6B	99.0	NW	512097 214552	Unspecified Pit	1951
7B	101.0	NW	512093 214550	Gravel Pit	1899

ID	Distance (m)	Direction	NGR	Commodity Produced	Pit Name	Type of working	Status
8B	103.0	NW	512105 214556	Sand & Gravel	Fatcornersend Farm Gravel Pit	A surface mineral working. It may be termed Quarry, Sand Pit, Clay Pit or Opencast Coal Site	Ceased
Not shown	835.0	S	511743 213394	Chalk	Knot Wood Chalk Pit	A surface mineral working. It may be termed Quarry, Sand Pit, Clay Pit or Opencast Coal Site	Ceased
Not shown	836.0	NE	512802 215162	Sand & Gravel	Harpenden Gravel Pit	A surface mineral working. It may be termed Quarry, Sand Pit, Clay Pit or Opencast Coal Site	Ceased
Not shown	884.0	N	512467 215395	Sand & Gravel	Harpenden Gravel Pit	A surface mineral working. It may be termed Quarry, Sand Pit, Clay Pit or Opencast Coal Site	Ceased
Not shown	904.0	NE	512782 215265	Chalk	Harpenden Gravel Pit	A surface mineral working. It may be termed Quarry, Sand Pit, Clay Pit or Opencast Coal Site	Ceased
Not shown	916.0	SW	511256 213610	Chalk	Harpendenbury Farm Chalk Pit	A surface mineral working. It may be termed Quarry, Sand Pit, Clay Pit or Opencast Coal Site	Ceased

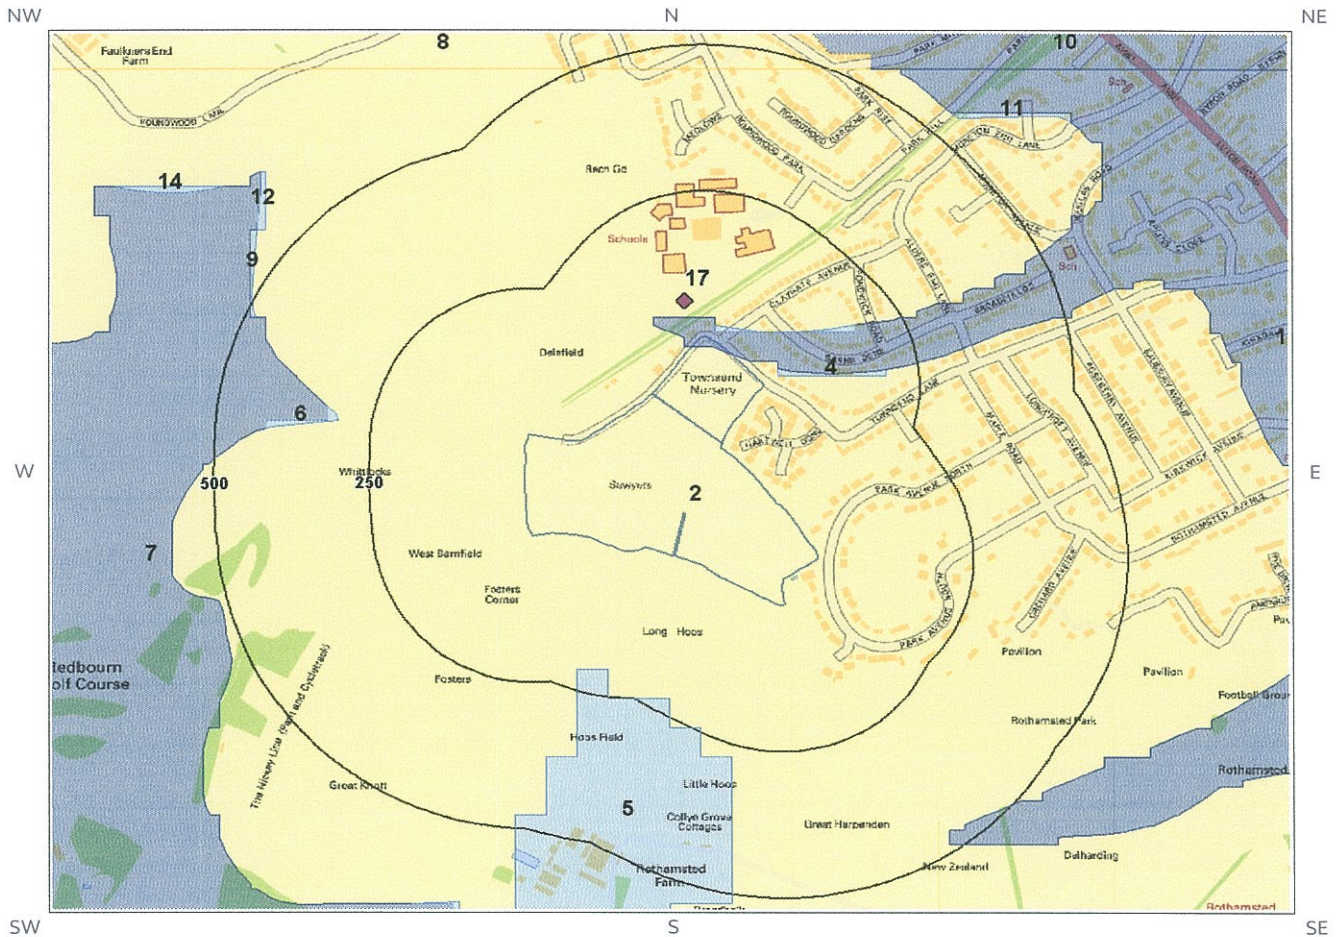
3 Mining, Extraction & Natural Cavities Map

ID	Distance (m)	Direction	Name	Commodity	Assessment of likelihood
1	0.0	On Site	Not available	Chalk	Occasional minor mining may have occurred but of restricted extent.
2	0.0	On Site	Not available	Chalk	Small scale mining may have occurred but restricted in extent.
3	14.0	NE	Not available	Chalk	Rare and localised small scale mining may have occurred.
4	26.0	NE	Not available	Chalk	Rare and localised small scale mining may have occurred.

ID	Distance (m)	Direction	NGR	Superficial Deposits	Bedrock Deposits	Cavity Type and Number
17	65.0	NW	512200 214600	Clay-with-Flints	Chalk Group	Sinkhole x 1, Solution Pipe x 1

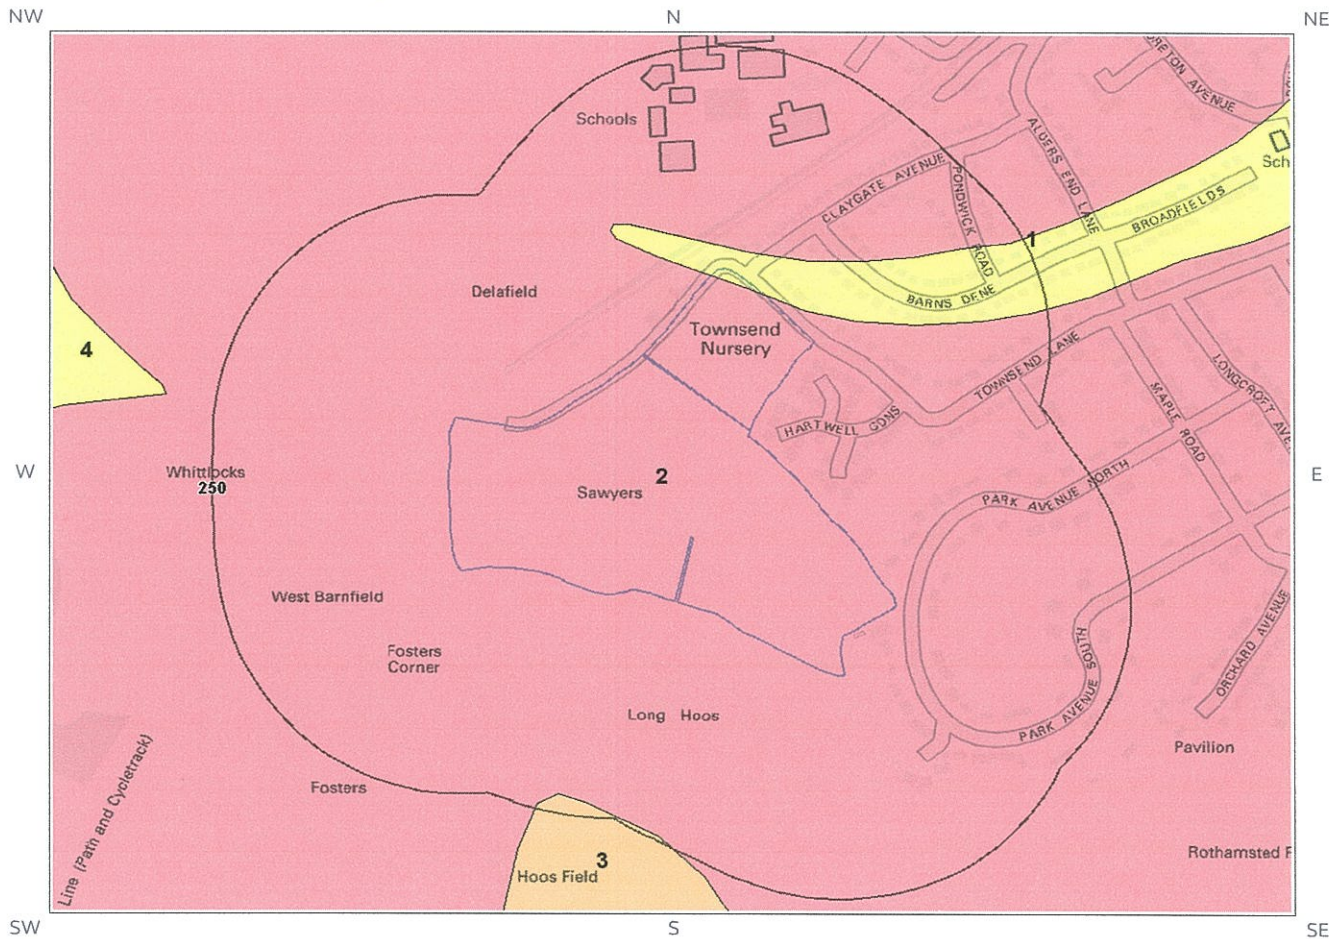
4.3 Ground Dissolution Soluble Rocks Map

ID	Distance (m)	Direction	Hazard Rating	Details
1	0.0	On Site	Very Low	Significant soluble rocks are present. Problems unlikely except with considerable surface or subsurface water flow. No special actions required to avoid problems due to soluble rocks. No special ground investigation required, or increased construction costs are likely. An increase in financial risk due to potential problems with soluble rocks is unlikely.
2	0.0	On Site	Moderate	Very significant soluble rocks are present with a moderate possibility of local natural subsidence due to high surface or subsurface water flow. Do not load the land or undertake building work before obtaining specialist advice. Do not dispose of drainage to the ground. Some possibility groundwater pollution. Maintain drainage infrastructure. For new build, specialist site investigation and stability assessment may be necessary before construction. Construction work may cause subsidence. Increased construction costs are likely. For existing property, probable increase in insurance risk due to soluble rocks.

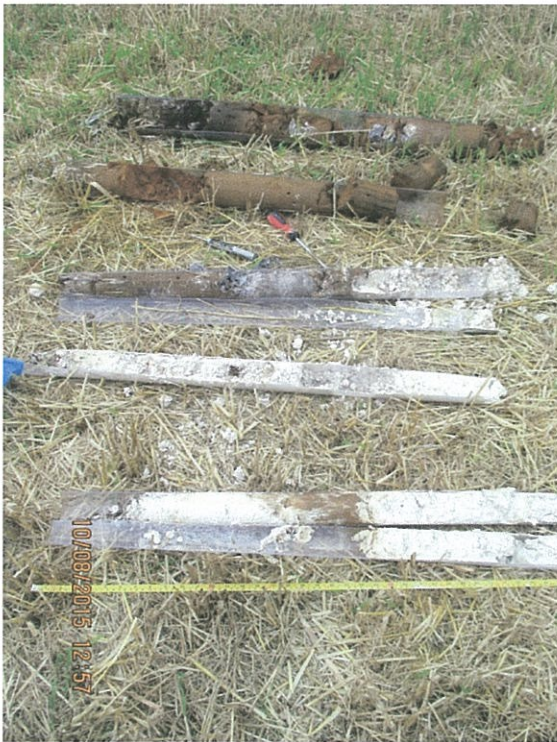
Photo 5: view of the arisings from WS1, showing the boundary between Clay-with-Flints and the underlying Chalk.

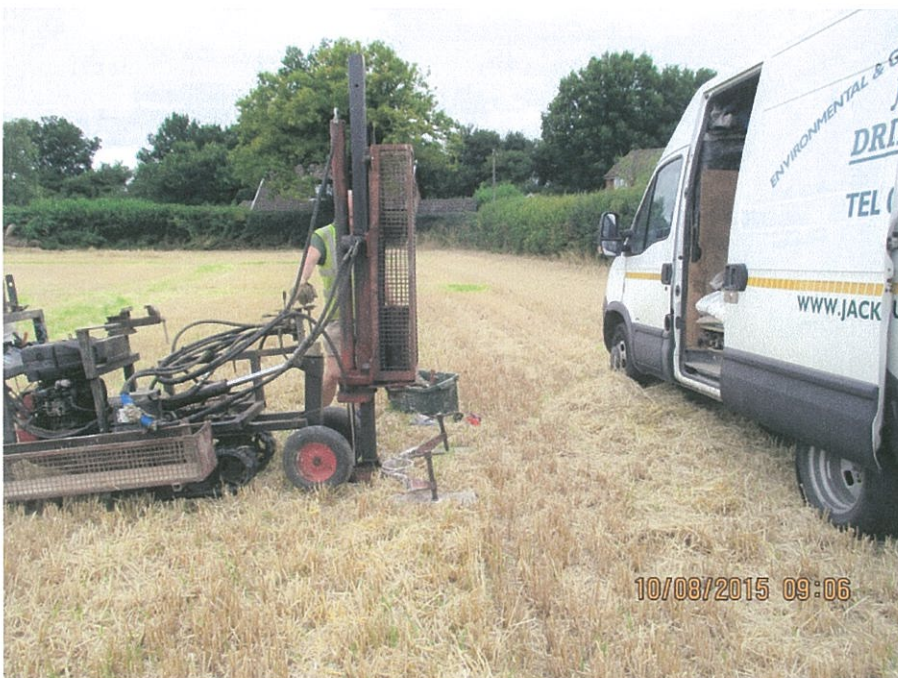
Photo 6: view of WS2 during drilling, looking north.
